Subject: Buncombe County Landfill – Permit # 11-07
MW-3 Gas Issue – Construction Certification

CDM Smith Construction Inspection Daily Reports

PROJECT: BUNCOMBE COUNTY SOLID WASTE FACILITY LANDFILL GAS TRENCH

AS-BUILT SURVEY
BUNCOMBE COUNTY SOLID WASTE FACILITY

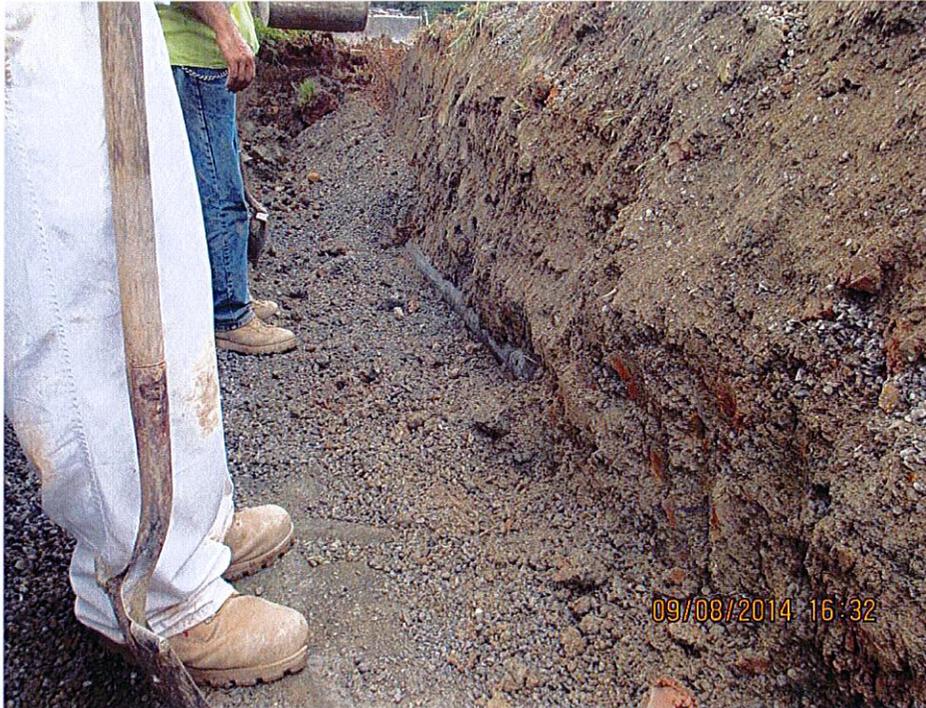
Force main pipe is exposed in trench as excavation works around bend toward west end.

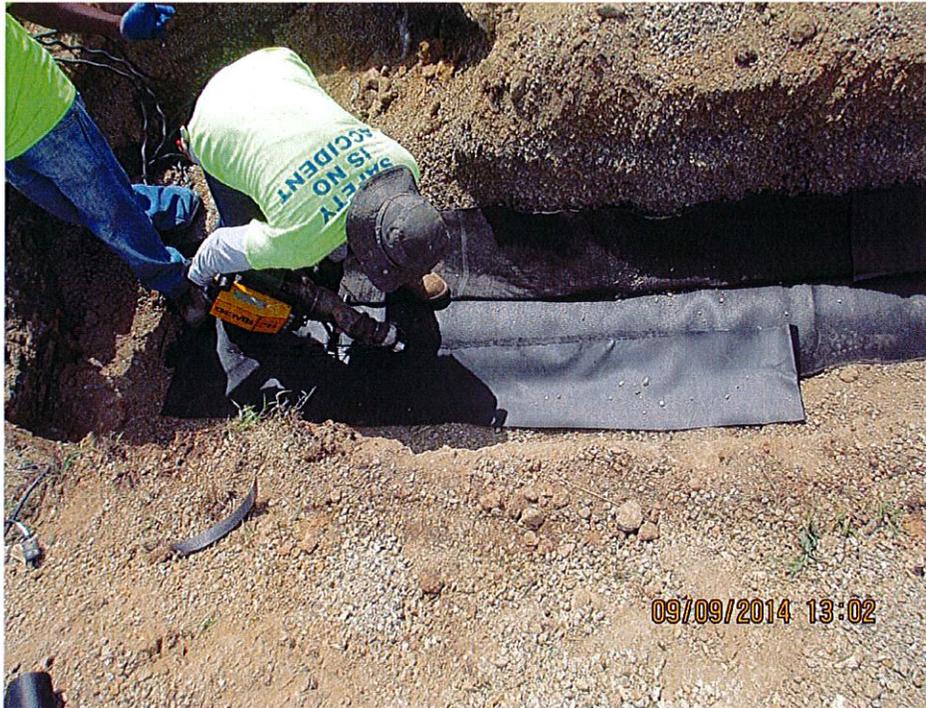
Looking down at 24" EFI doing a practice weld of tarp strip to existing 60 mil liner, weld was satisfactory to all participating, real welding to get going, EFI has suggested bonding with a special double sided tape for tarps.

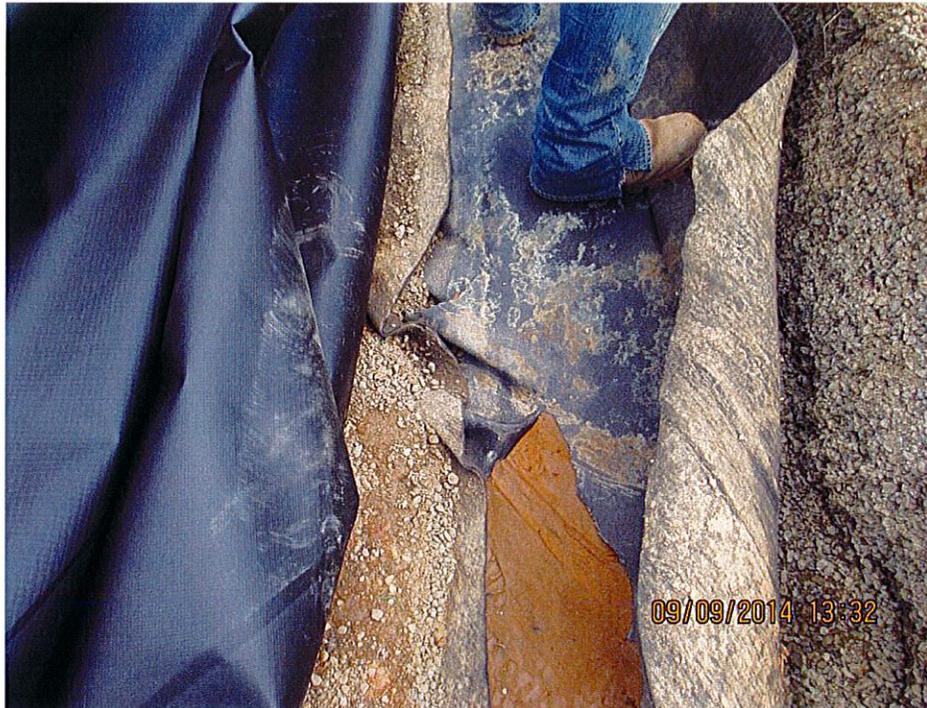
NHM while cutting the existing geotextile and folding out of the way for the tarp weld finds torn liner under the in place textile. The crew digs around as needed to expose and clean the limits of the tears on the cell top of berm location. JCM recovers 60 mil HDPE from the facility bone yard, EFI welds the patch and vacuum tests those patches, JCM documents locations, first repair to 60 mil is 145'-148' east about 1 PM, second repair was 76'-93' east about 3 PM, third location was not welded by the end of the day.

As existing textile is folded back for tarp welding torn 60 mil liner was exposed and repairs made into anchor trench.

Deficiencies and Corrective Actions: Damaged liner is found under the existing geotextile as seen in above photo, 60 mil repairs are made and vacuum tested before the tarp is placed and welded by EFI.

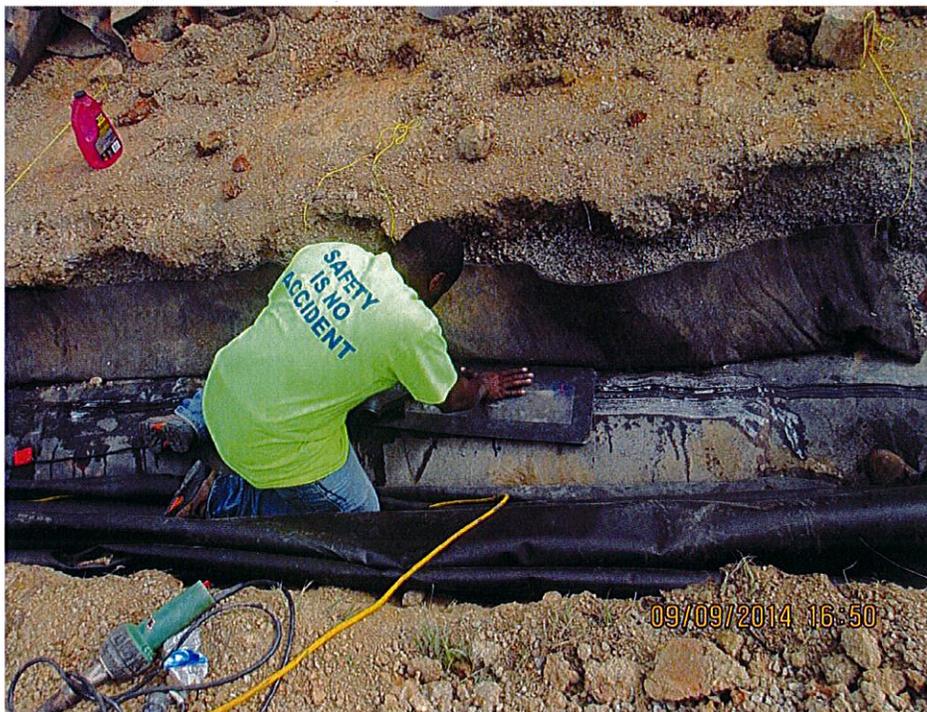
EFI technician vacuum tests 60 mil repair after welding it, looking down and south.

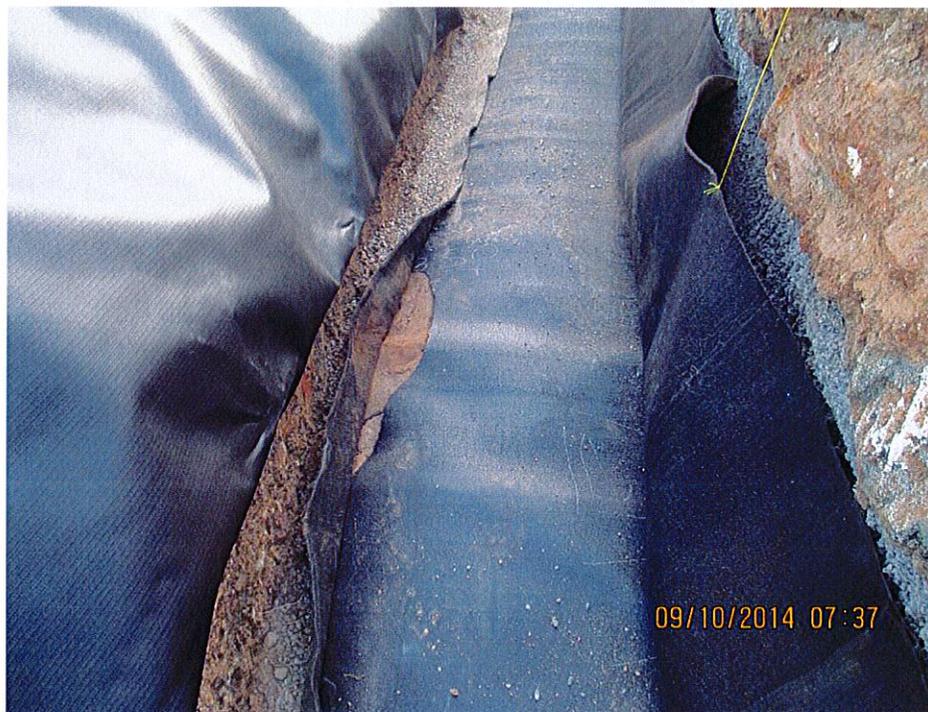
Another small tear in the 60 mil liner is uncovered, patched and vacuum tested 18-23' east, looking down and northeast.

Deficiencies and Corrective Actions: Damaged liner is found under the existing geotextile as seen in above photo, 60 mil repairs are made and vacuum tested before the tarp is placed and welded by EFI.

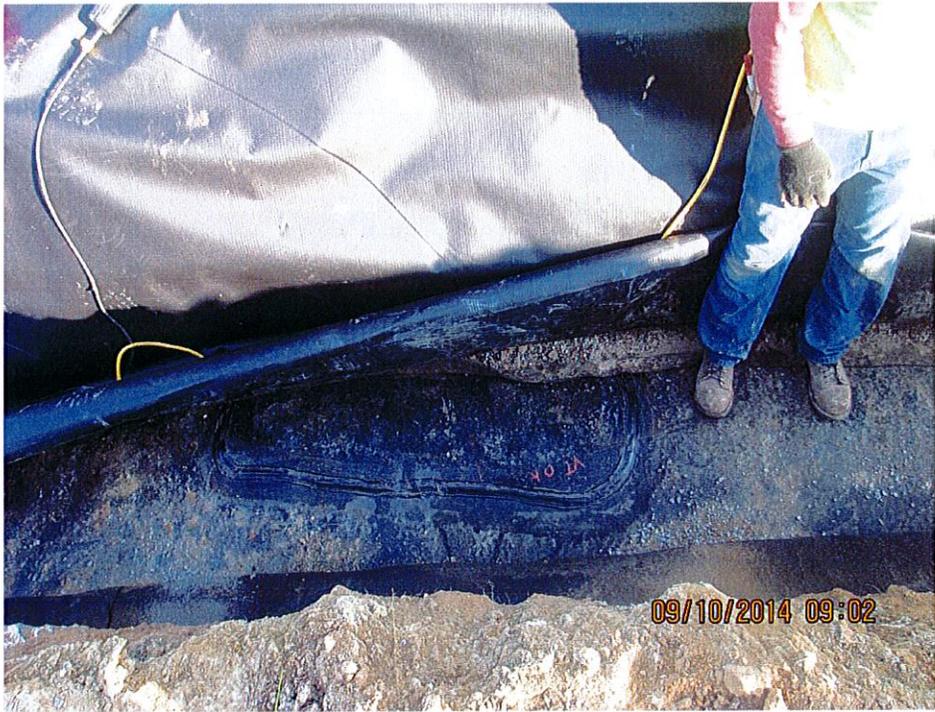
Looking down at 18-23' east repair after EFI did the patch and vacuum test.

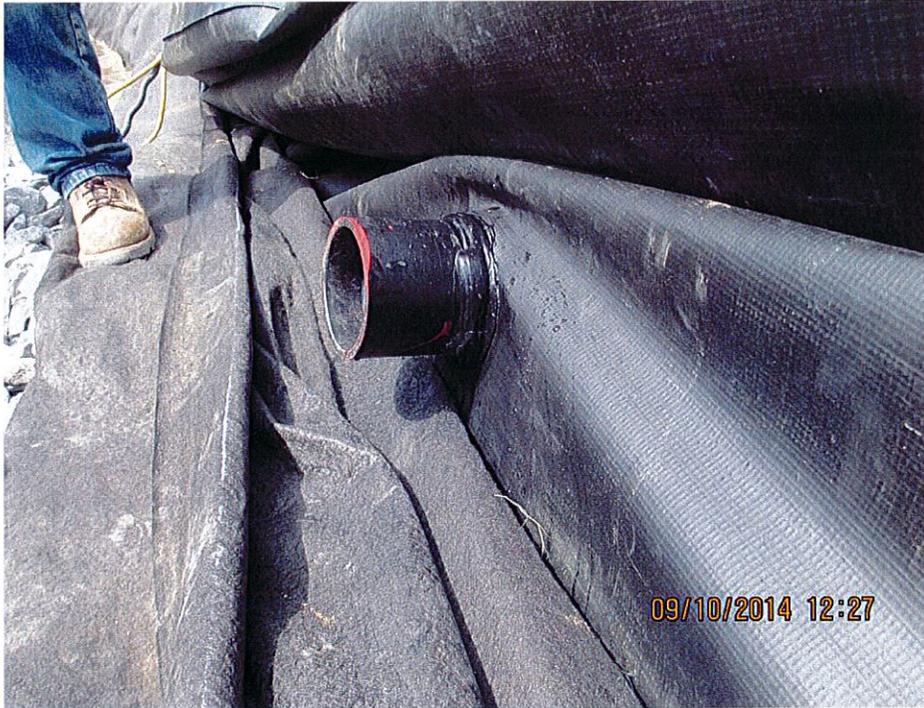
The tarp is extrusion welded to the 4-6" fitting instead of using a boot that would not fit the prefabricated HDPE assemblies, looking west from inside the trench.

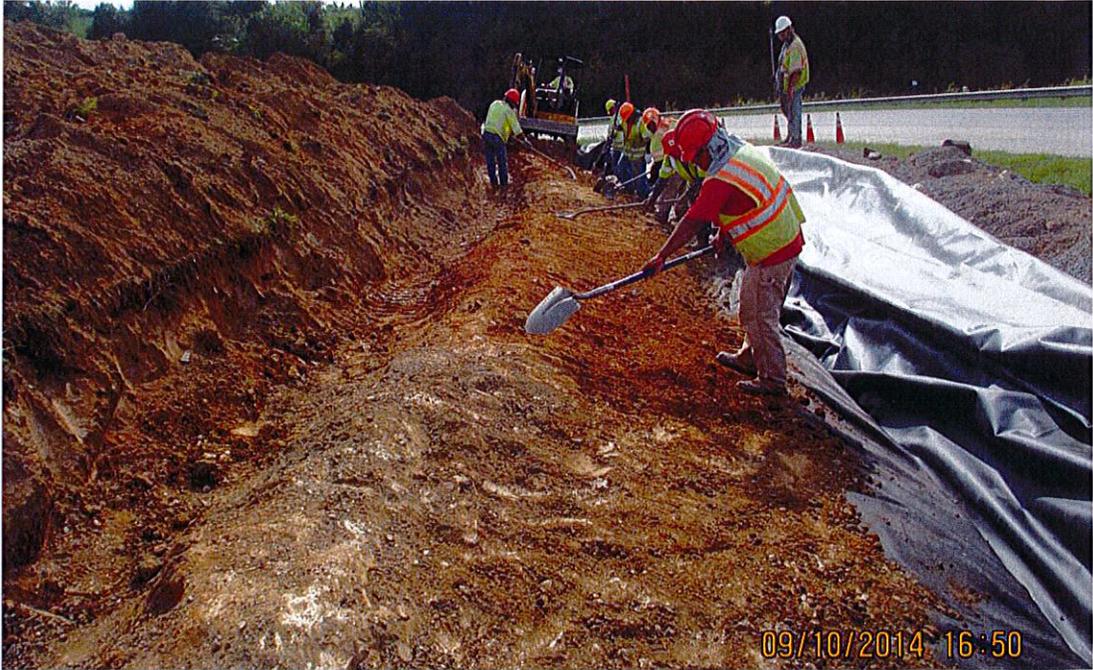
The soil upslope from the rocked trench is regarded to remove a hump from the depth to existing liner that got deeper to the west half, looking west.

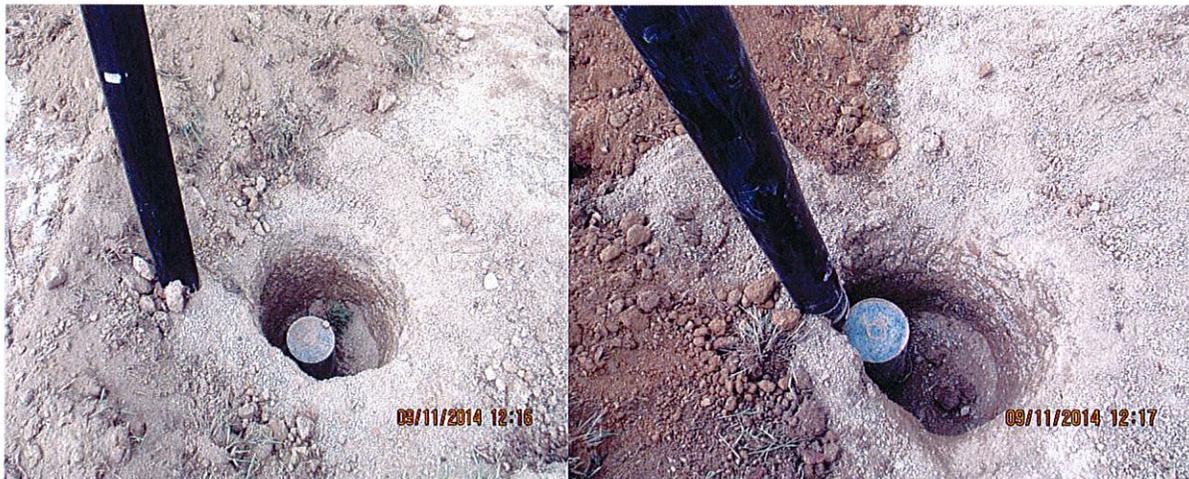
After assembling the trench materials in place the saddles on the 24" gas header are dug back up. At the west location (right side) the 6" riser is almost right next to the 4" riser location, at the east (left side) the expected location can be seen. Looking down and west in both photos.

Deficiencies and Corrective Actions: The west well location has the 6" and 4" pipes within inches so the well head is set up in a "U" shape.

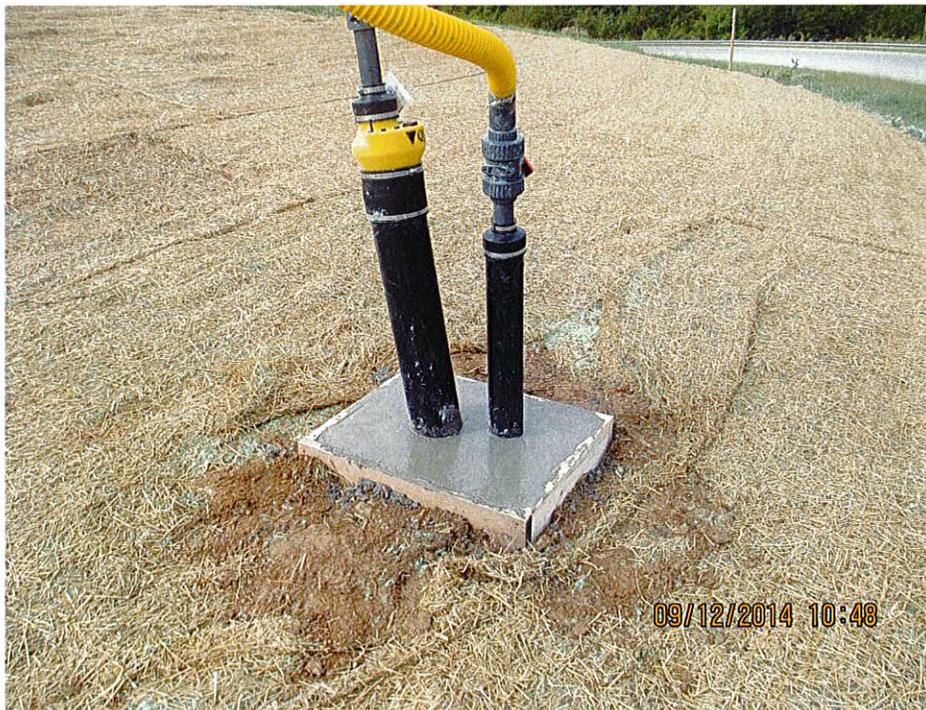
Looking west at west housekeeping pad, because the risers were so close together one larger pad was used to include both risers.
