FACILITY COMPLIANCE INSPECTION REPORT
Division of Waste Management
Solid Waste Section

Date of Inspection: 11 March 2015

Carteret County MSW Landfill
 Landfill Road
 Newport, NC

1602-20150311INSP

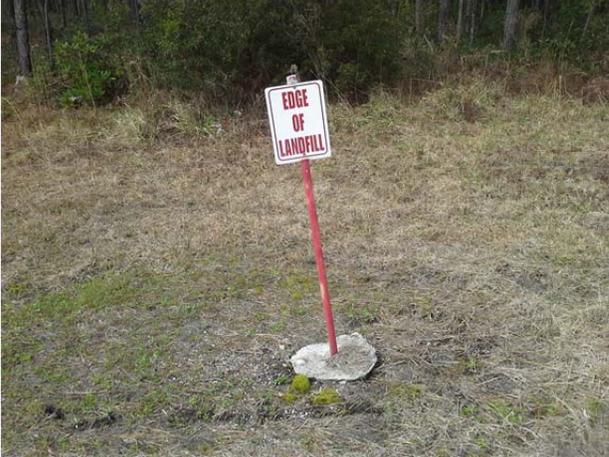
- 8) Overall, the landfill has a well established and well maintained cover crop of native warm season grasses.

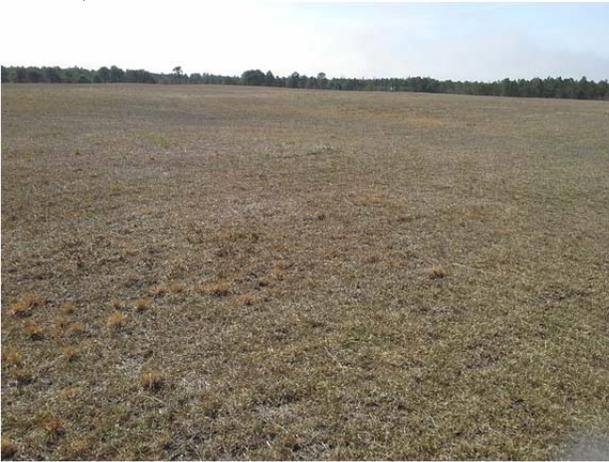
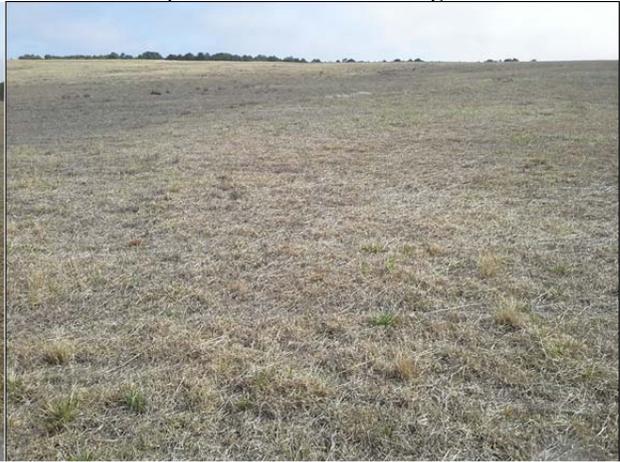
- 9) This Facility is mowed three times per year.

- 10) The landfill sideslopes are being maintained clear of trees and other woody vegetation.

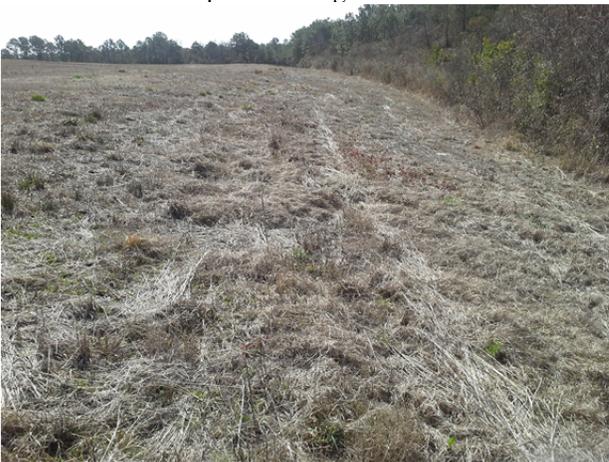
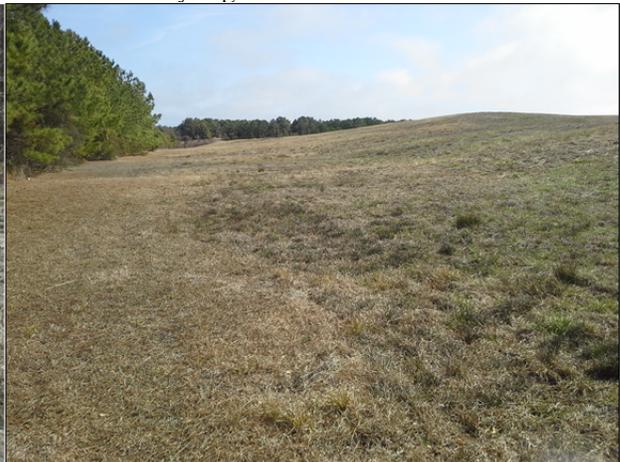
- 11) Several areas of sparse cover crop were noted in various places around the top lift of the landfill. *Please repair these areas by seeding and mulching to establish a cover crop suitable to prevent erosion of your landfill cap system.

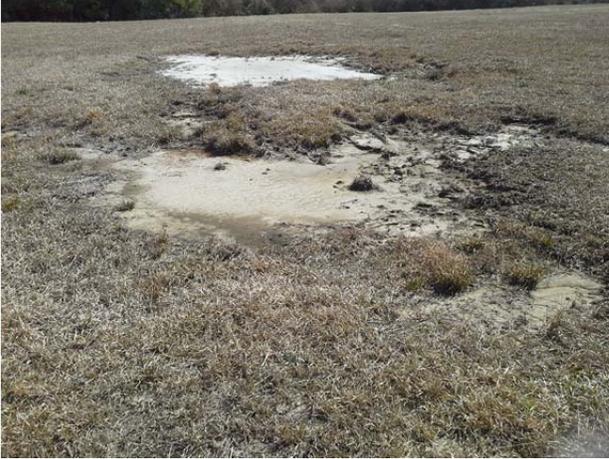
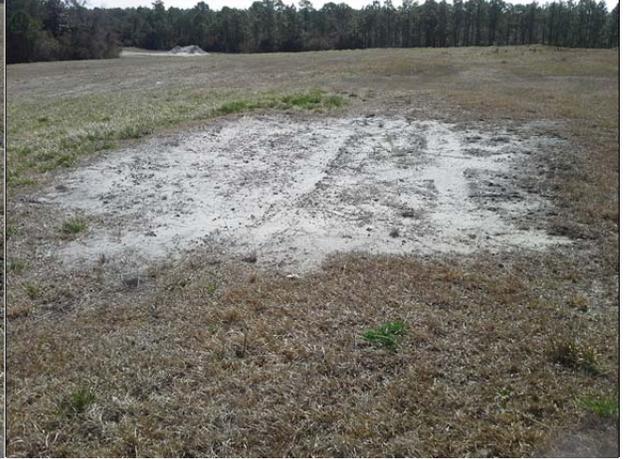
- 12) Areas of erosion were noted on the southeastern and northwestern landfill sideslopes. *Please work to repair these eroded areas by grading, seeding, and mulching as necessary to establish a groundcover suitable to prevent erosion of your landfill cap system. All repaired areas should be graded at a slope not greater than 3:1.

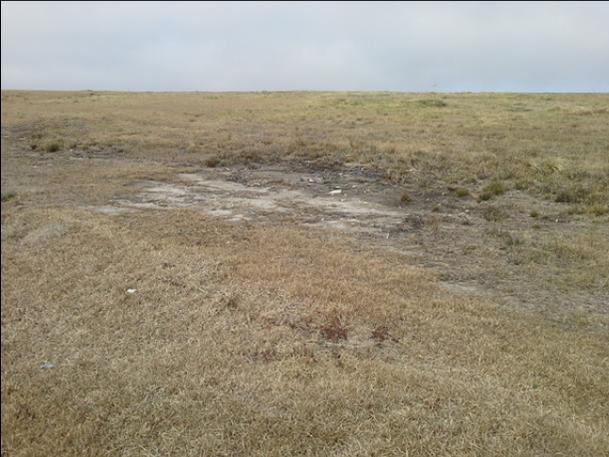
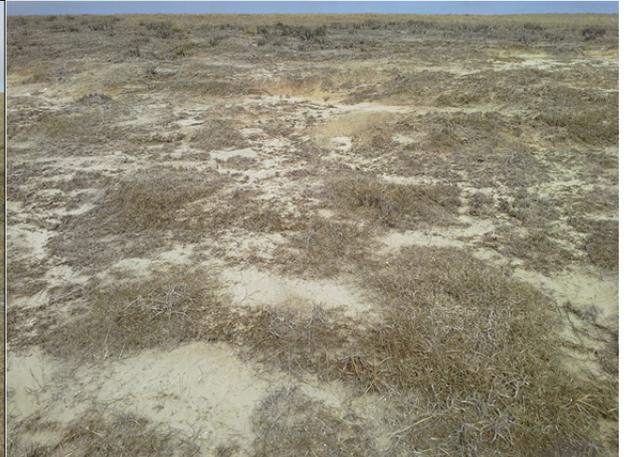
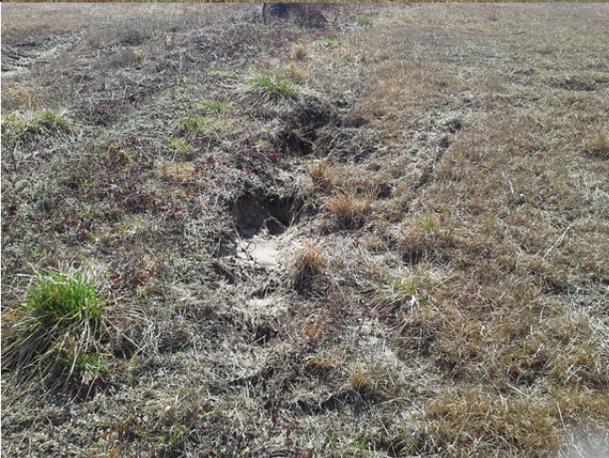
- 13) Areas of differential settlement were observed around the top lift of the landfill. Some of these areas were observed as retaining surface waters. *To prevent the ponding of surface waters on the landfill, please fill and grade these areas at a slope not greater than 3:1. All filled and graded areas should be seeded and mulched to establish a groundcover suitable to prevent erosion of your landfill cap system.

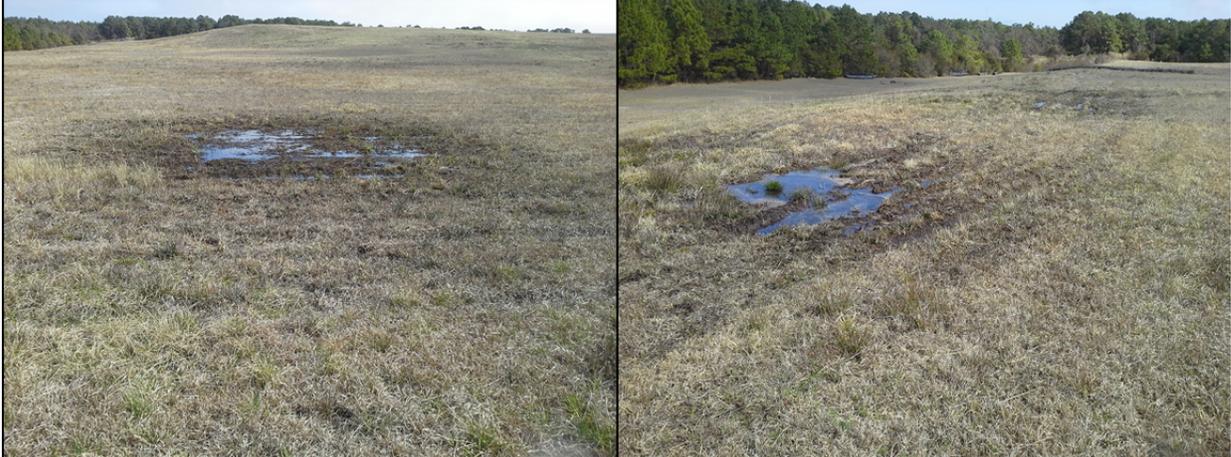
- 14) Some damage to the cover crop from mowing equipment was observed on the top lift of the landfill near the Facility Access Road. *Please repair these areas by grading, seeding, and mulching as soon as possible.

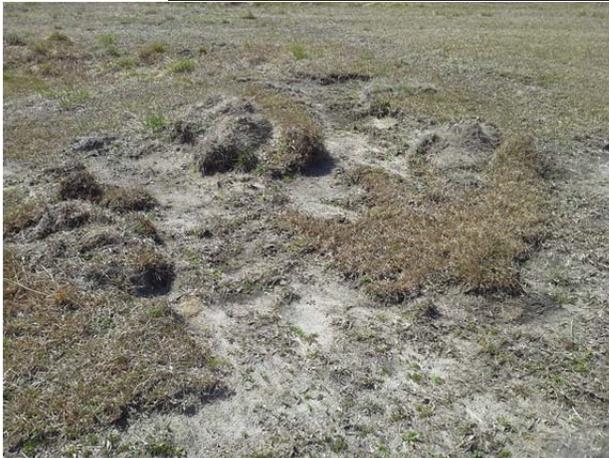
- 15) A hole has been dug on the northeastern sideslope by wildlife. *Please fill and compact this area with suitable soil and then seed and mulch the repair to establish a groundcover suitable to prevent erosion.
