FACILITY COMPLIANCE INSPECTION REPORT
Division of Waste Management
Solid Waste Section

Date of Site Inspection: February 10, 2015

City of Durham Closed MSW Landfill
 2115 East Club Boulevard
 Durham, NC 27704

Post Closure Inspection

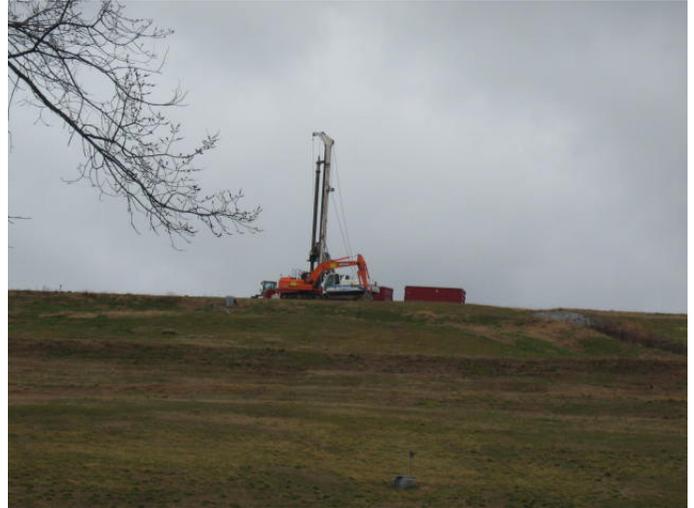
25. The LFGCC system extraction well drilling machine and an assembled extraction well (laterally atop the landfill cap) were observed.
26. Ensure SWS has approved the LFGCC system modification prior to operation.

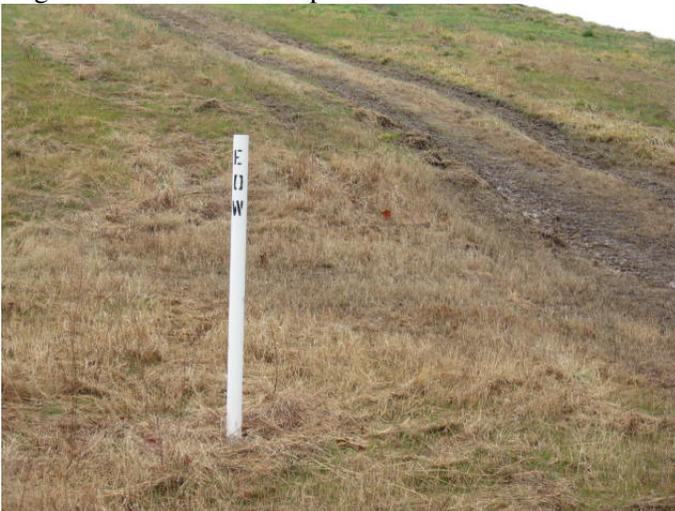
Edge of waste marker – representative

- 36. The facility submitted fiscal year end 2014 financial assurance – currently under review by SWS.
- 37. Edge of waste markers have been installed. The edge of waste markers are white PVC pipe placed over metal fence stakes.

- 38. Mr. Lobdell stated that the edge of waste markers are set ~ 5 to 10 feet off of waste.
- 39. Mr. Lobdell stated that the landfill cap is mowed twice a year, last mowed December 2014.

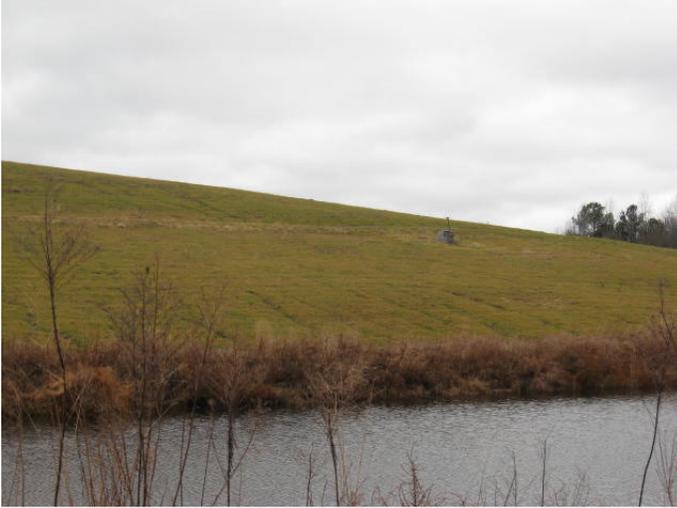
32. Ensure rill erosion along a section of the north side of the landfill is repaired and erosion control installed.
33. A foam-like substance was observed in one of the rills. The source of the foam-like substance could not be verified. The inspection was conducted during inclement weather. Mr. Lobdell was asked to take a sample of the liquid and provide results to Ervin Lane, Compliance Hydrogeologist - SWS.

Erosion rills on north external side slope/rear of landfill

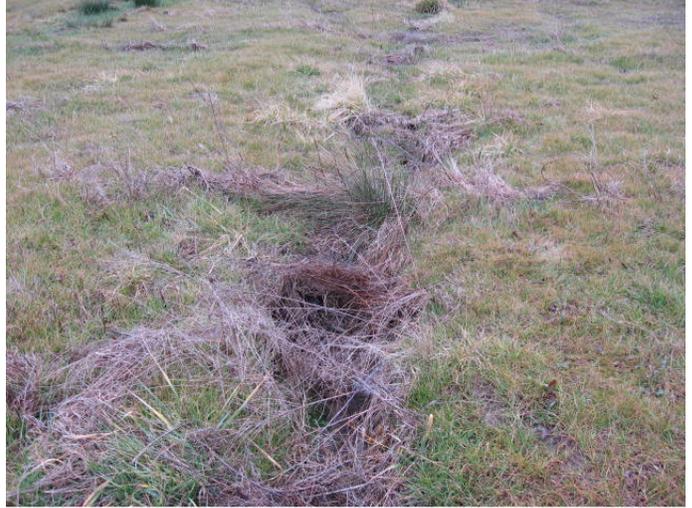
Erosion rill to be repaired accordingly - representative

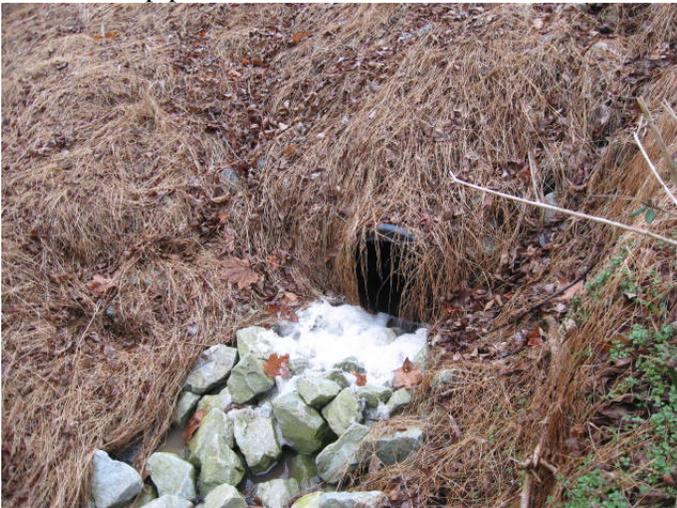
27. The facility has a Division of Air Quality (DAQ) permit No. 08456R04 issued on June 26, 2012, expiration date May 31, 2017.
28. A foam-like substance was observed at a stormwater pipe outlet on the southwest side of the landfill. On February 22, 2013, the facility had a discharge of a foam-like substance during the stormwater pipe repair. SWS determined in a letter dated 07/29/13 that the constituents present are thought to be naturally occurring.

Stormwater pipe outlet -foam like substance

30. The stormwater pipe inlet and surrounding area and the stormwater pipe outlet should be routinely inspected.
31. It is suggested that the grass along the northwest side of the landfill service road is routinely mowed and vehicle ruts filled-in/graded accordingly.

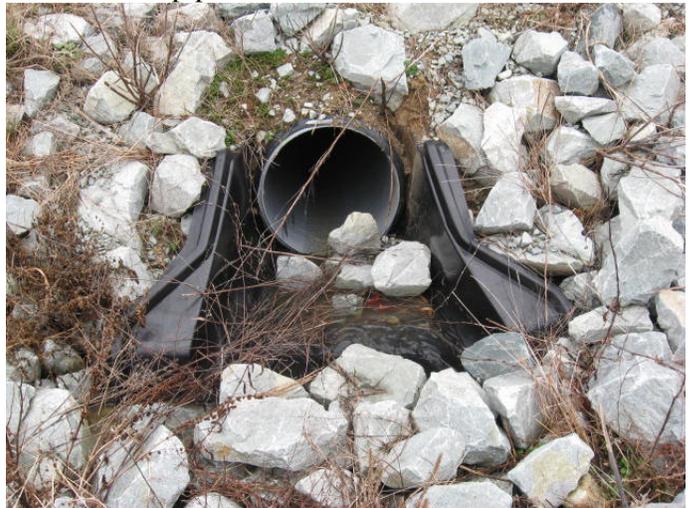
Stormwater pipe inlet

29. During the inspection the stormwater pipe inlet and adjacent area were inspected. The source of the foam-like substance could not be verified. The inspection was conducted during inclement weather. The stormwater entering the stormwater pipe inlet appeared to be surface runoff. Mr. Lobdell was asked to take a sample of the liquid at the stormwater pipe outlet to confirm results from the 2013 event and provide the results to Ervin Lane, Compliance Hydrogeologist - SWS.

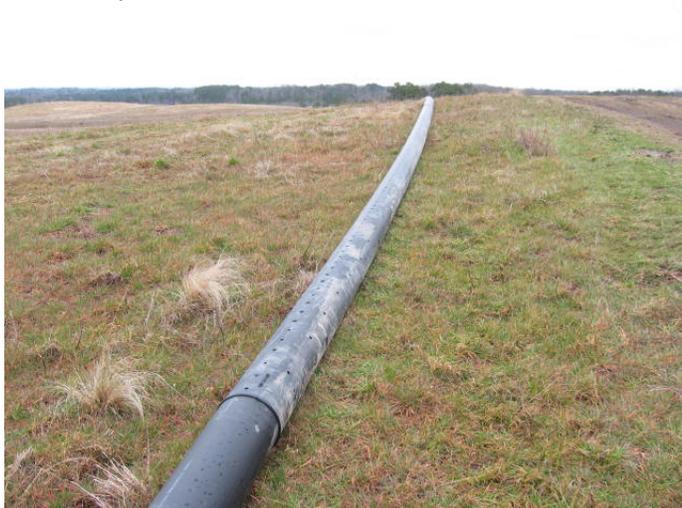
LFGCC system extraction well (to be installed)

20. Ensure the LFGCC system outdoor monitor panel is repaired to properly display flare temperature.
21. The facility has been approved to install 16 additional extraction wells as part of the LFGCC system and replace/repair an existing well. It is expected that 2,850 feet of header pipe will be installed.

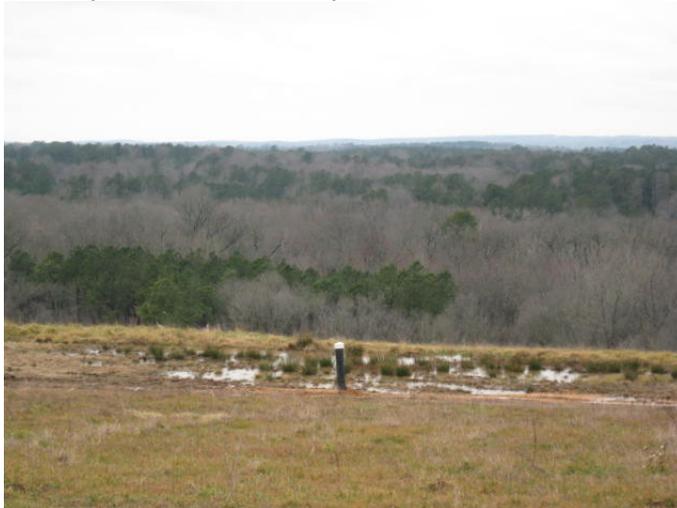
Newly installed LFGCC system extraction well

24. During the inspection the LFGCC system expansion project was not in operation. A small number of extraction wells have been installed. An open trench was not observed. Containers were available for the [off site] disposal of solid waste. Asbestos work area signage was posted.

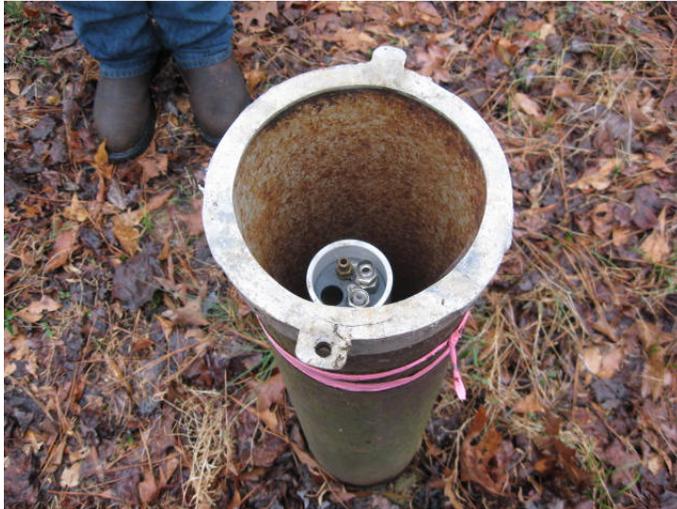
Groundwater monitoring well MW-2

7. Mr. Lane stated that an exceedance of vinyl chloride is noted in groundwater monitoring well MW-2 and that it will be discussed further if noted in the next semi-annual monitoring event.
