**RE: SUMMARY OF GROUNDWATER MONITORING WELL MW-5 REPAIRS
CLOSED CITY OF DURHAM LANDFILL
DURHAM, NORTH CAROLINA**

TITLE
WELL REPAIR PHOTOS OF MW-5

WELL UPGRADE PHOTOS OF NES-3

Monitoring Well Report

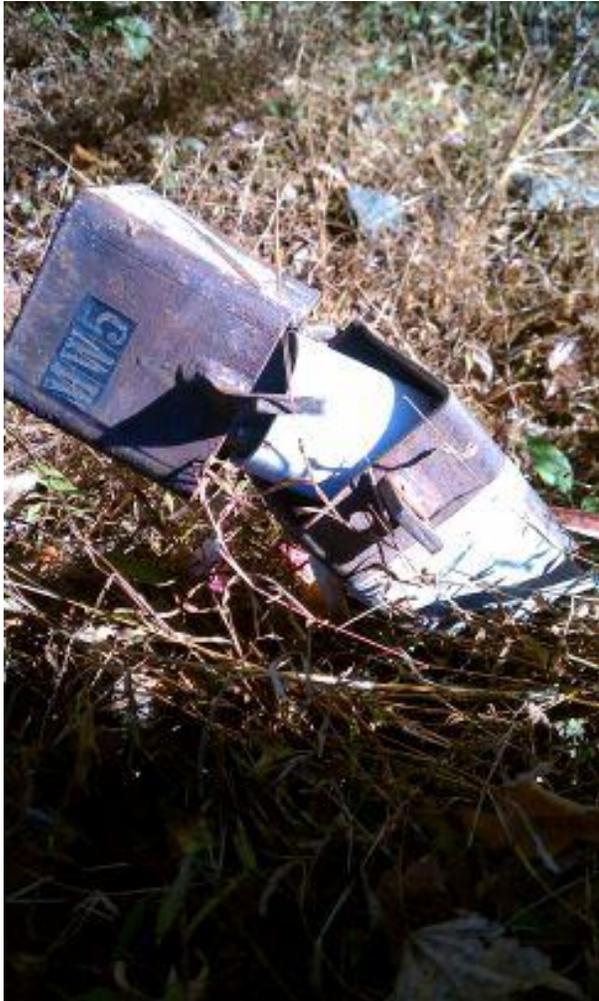
Golder Associates NC, Inc. (Golder) is submitting this summary of the repair of groundwater monitoring well MW-5 and upgrades to Nature and Extent Study (NES) well NES-3. During the second semi-annual water quality monitoring event performed on November 7, 2013, personnel from Golder discovered that groundwater monitoring well MW-5 had been damaged and was unable to be sampled. It is speculated that it was damaged during mowing activities at the facility. Damage to the above-grade steel protective casing and the polyvinyl chloride (PVC) riser extended to approximately 2 feet below ground surface. A photograph of the damaged well is provided on Figure 1.

Discovery of damaged Well MW-5 on November 3, 2013

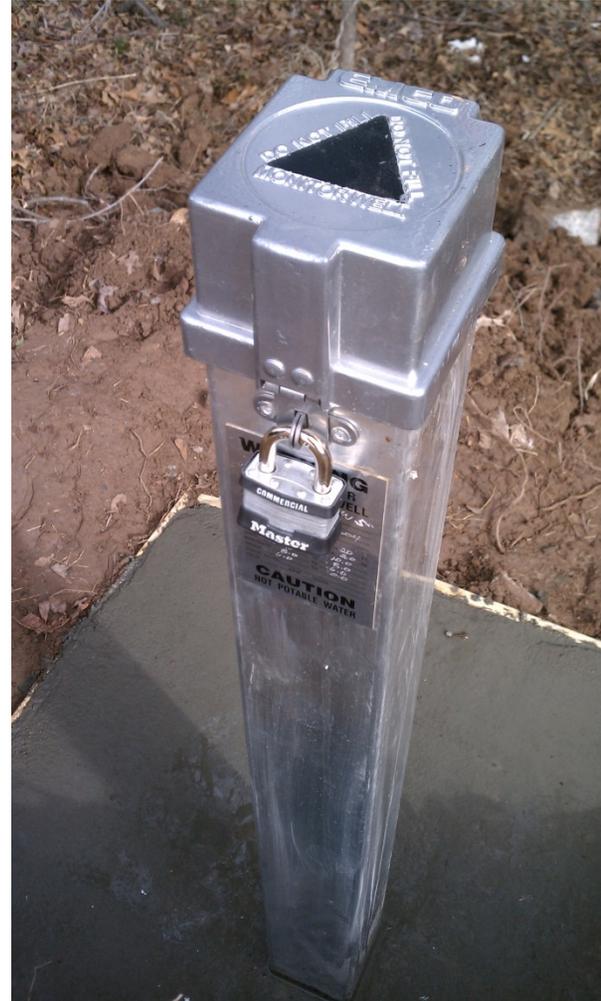
Well MW-5 after repairs on March 5, 2014

Well MW-5 was excavated approximately 2 feet below ground surface, which was the depth that the steel protective casing and PVC riser was bent. The casing and riser were cut below the bend. The PVC riser was replaced using a slip coupling (without glue). A 4-inch by 4-inch square anodized aluminum protective casing was installed and a 3-foot by 3-foot by 0.5-foot concrete apron was poured. A photograph of the repaired well is provided on Figure 1.

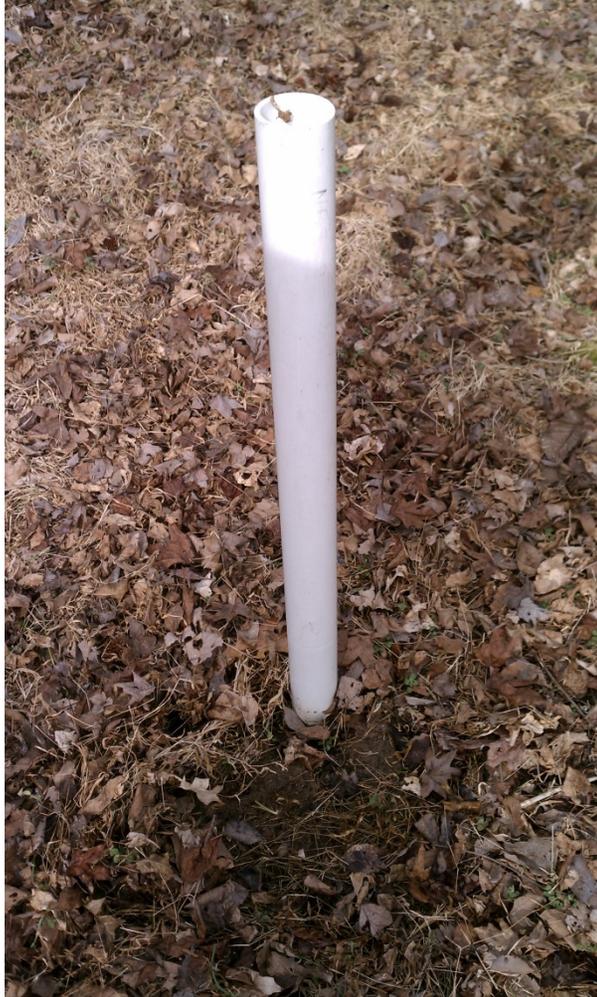
Well NES-3 was installed with a PVC stickup and a locking expansion cap during the NES on July 31, 2009, by S&ME. The City will be submitting a request to the North Carolina Department of Environment and Natural Resources (NC DENR) to allow NES-3 to replace MW-10 in the water quality compliance network. In order to be considered an acceptable monitoring point, NES-3 required a protective casing and concrete apron.

Well NES-3 on before upgrades on March 5, 2014

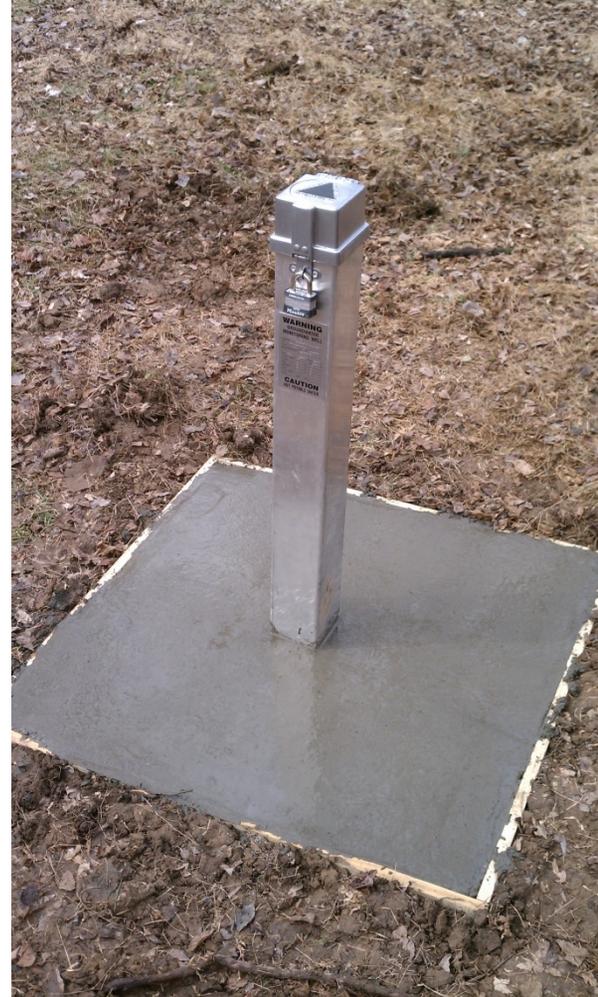
Well NES-3 after upgrades on March 5, 2014

At NES-3, the area around the well was excavated approximately 4-inches in order to construct the concrete well apron just above ground surface. Then, a 4-inch by 4-inch square anodized aluminum protective casing was installed and a 3-foot by 3-foot by 0.5-foot concrete apron was poured. The height of the PVC riser of NES-3 was not modified and therefore no additional survey was required. Photographs of NES-3 before and after the upgrades are provided on Figure 2.

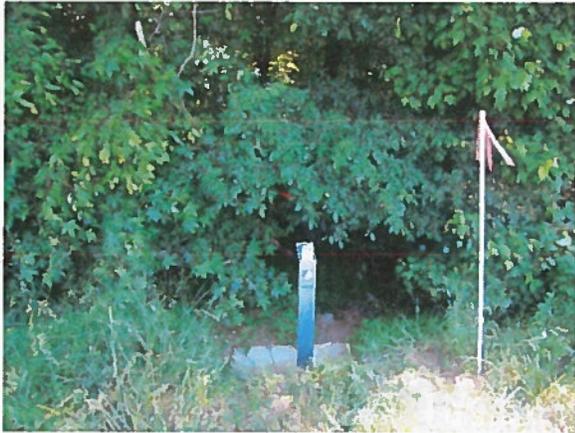
Photo looking northeast

Structure Number: Monitoring Well #5 (MW-5)
Northing: 832227.07
Easting: 2043380.96
Elevation - PVC Riser: 300.26 ft.
Elevation - Concrete Pad: 296.67 ft.
