FACILITY COMPLIANCE INSPECTION REPORT
Division of Waste Management
Solid Waste Section

Date of Site Inspection: February 5, 2015

B&B Top Soil Mine, Inc. Treatment and Processing Facility
 1800 Hamlin Road
 Durham, NC 27704

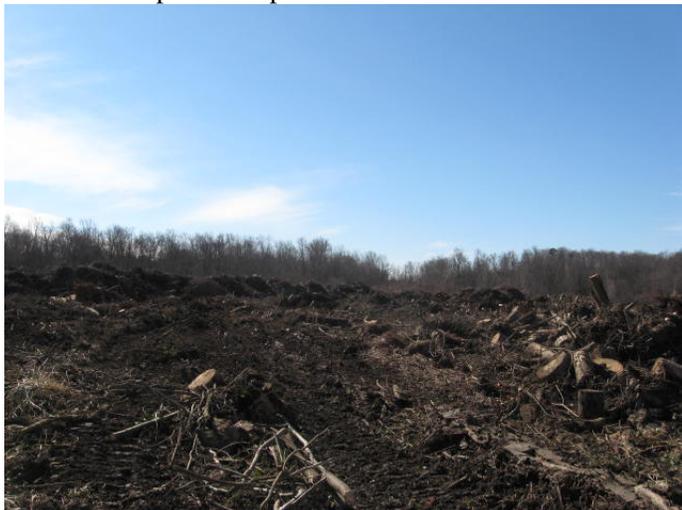
9. During the inspection material for use in dry method treatment cells was observed along portions of the access road. Material was not placed in a treatment cell to be constructed into lifts. See "Observed Violations" for remediation requirement.

Material not placed in piles/active cells

By March 5, 2015, all material received shall be placed in piles/active cells upon receipt. It shall not be staged at the entrance to the access road or placed along the access road. Active cells shall be reconfigured to include material that has become dislodged. The access road and operations area that hold water due to ruts and depressions shall be graded prior to inclement weather to ensure positive drainage. The area along the leaf storage pile and access road shall be graded to ensure positive drainage. The area adjacent to the soil screener shall be continually graded to ensure positive drainage. Leaves received for storage should be incorporated into the leaf pile/piles in a timely manner. Ensure the leaf receiving area does not hold water.

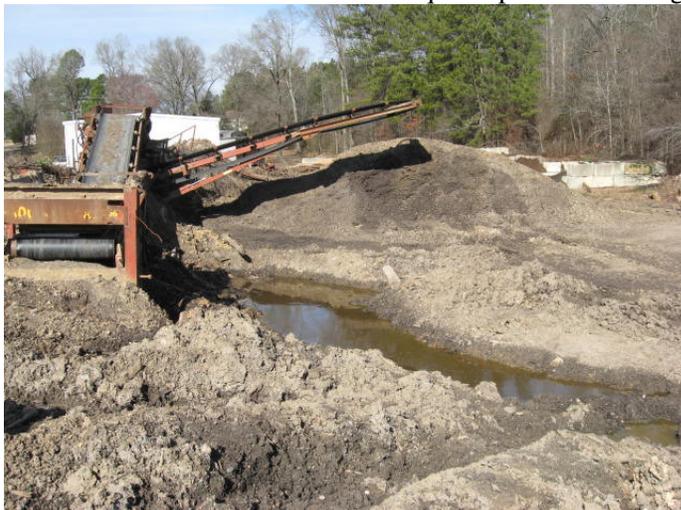
12. During the inspection ponded water was observed along access roads in ruts and depressions. Ponded water adjacent to the leaf storage pile was observed. Ponded water adjacent to the soil screener was observed. See "Observed Violations" for remediation requirement.

Ponded water at soil screener – requires positive drainage

13. It is suggested that the accumulated soil built-up around the soil screener is mined.
14. It is suggested that staff are cross-trained to effectively utilize personnel to meet the requirements of the facility permit and operations plan.

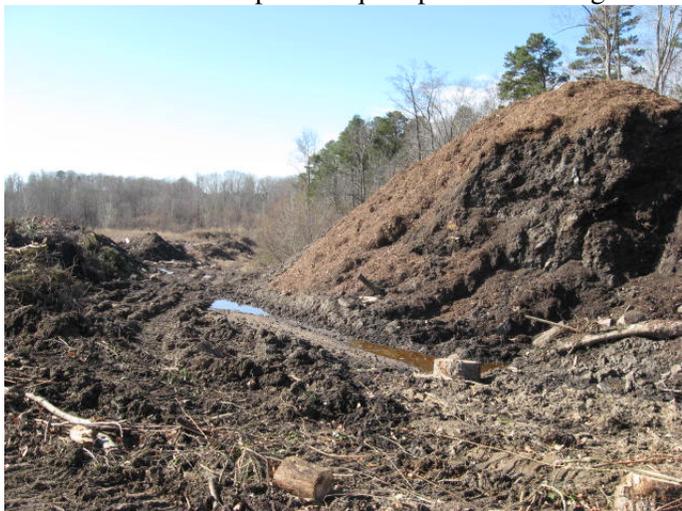
Access road and leaf pile – require positive drainage

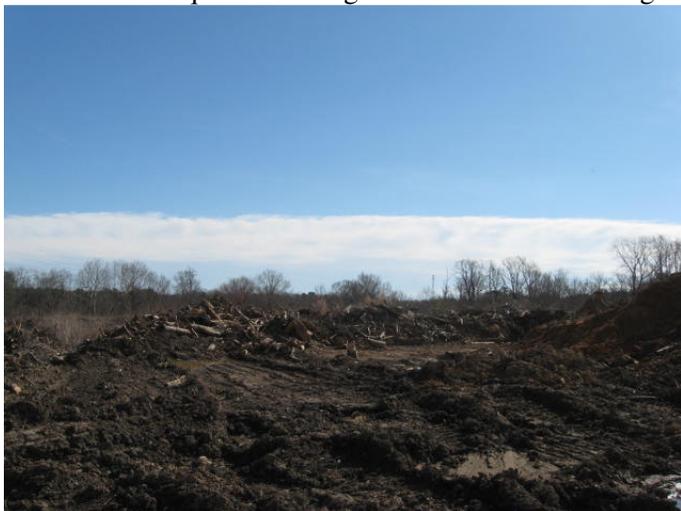
11. During the inspection active cells that had material removed were not re-constructed back into uniform cell structure for the dry method to perform optimally. See "Observed Violations" for remediation requirement.

Active cell requires reconfiguration - material dislodged

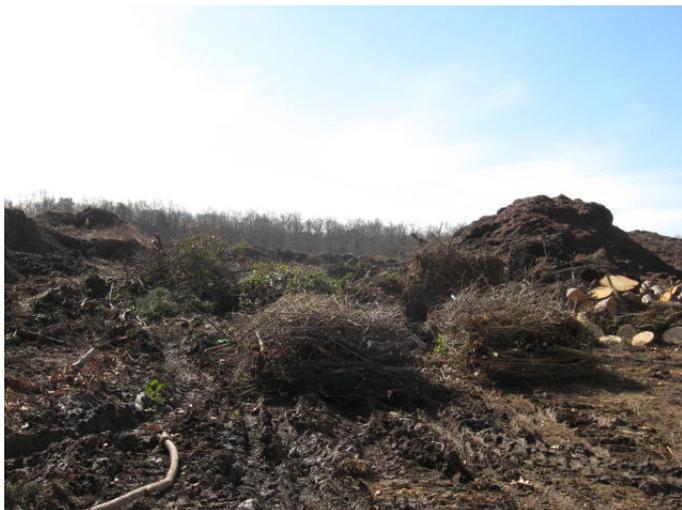
Material received offloaded at access road entrance

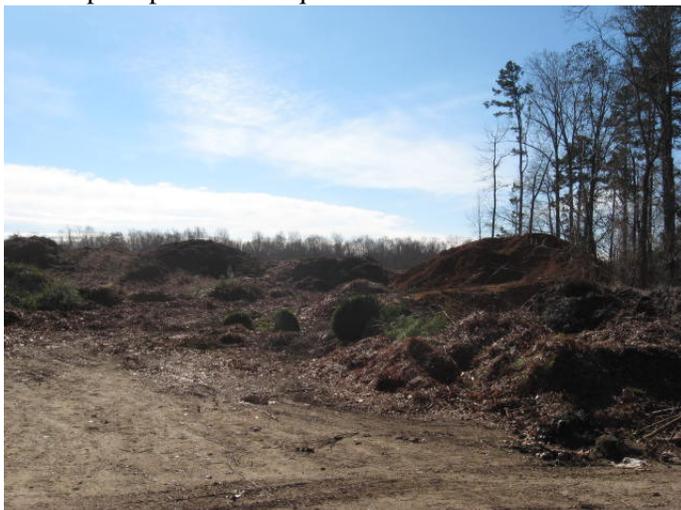
Leaf pile spread-out/requires consolidation

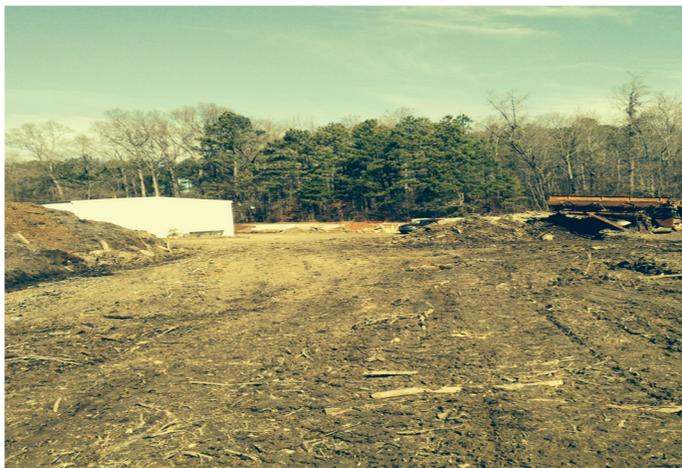
Material offloaded at access road entrance removed

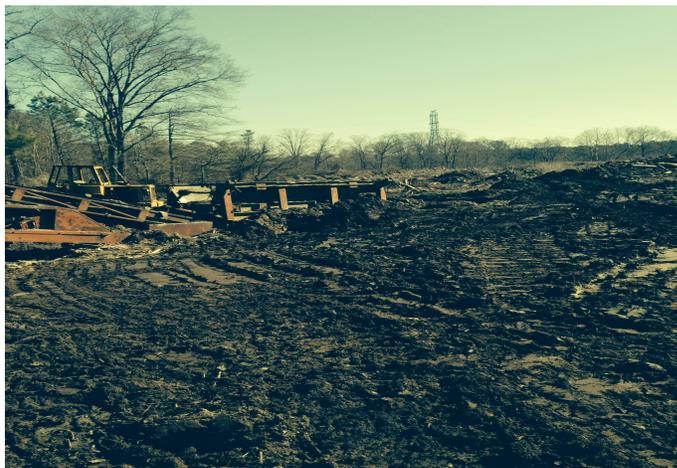
Area on left side of screener graded/soil placement
although soil needs to be removed and positive drainage
obtained

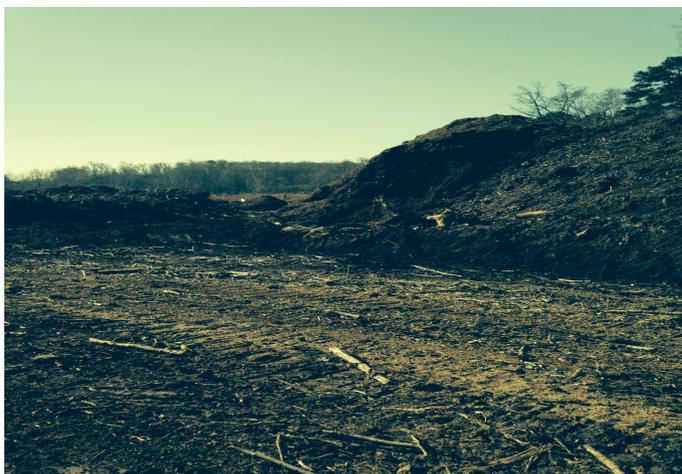
Ponded water removed from access road and leaf pile

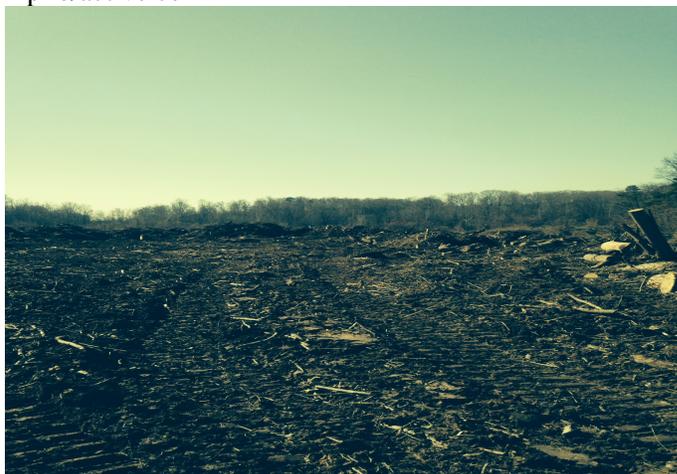
Operational area graded although material on right not in
pile/active cell
