FACILITY COMPLIANCE INSPECTION REPORT
Division of Waste Management
Solid Waste Section

Date of Site Inspection: December 22, 2014

B&B Top Soil Mine, Inc. Treatment and Processing Facility
 1800 Hamlin Road
 Durham, NC 27704

Partial Inspection

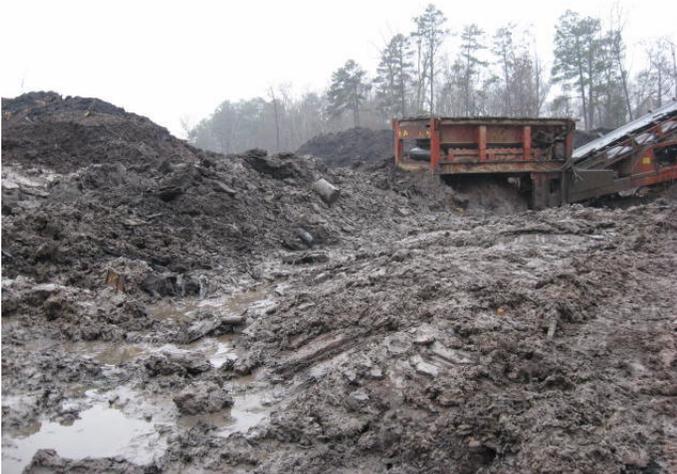
10. It is suggested that areas commonly impassible during prolonged periods of wet weather are mined. There should not be a thick layer of topsoil/decomposed LCD atop the ground that prohibits normal facility operation during adverse weather conditions.

Thick layer of topsoil/decomposed LCD atop ground

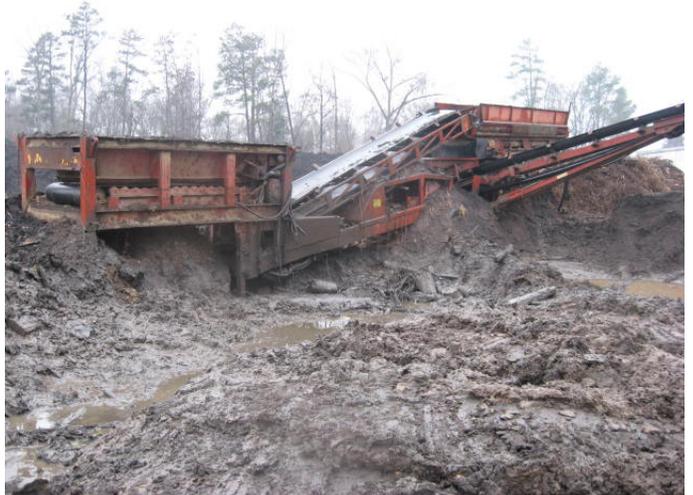
On December 22, 2014, SWS conducted an inspection of the B&B Top Soil Mine, Inc. Treatment and Processing Facility. Material for use in dry method treatment cells remains along portions of the side of the access road. The material was not placed in treatment cell areas to be constructed into lifts. Active cells that had material removed were not re-constructed back into uniform cell structure for the dry method to perform optimally and new windrows/piles constructed were not uniform in that material alongside needed to be incorporated. Pondered water was observed along access roads in ruts and depressions and along the access road and leaf storage pile. Access roads were impassible due to prolonged periods of wet weather. Pondered water was observed adjacent to the soil screener.

16. During the inspection ponded water was observed in and along access roads in ruts and depressions. Ponded water adjacent to the leaf storage pile was observed. Ponded water adjacent to the soil screener was observed, although flowing out slowly. See "Observed Violations" for remediation requirement.

ponded water adjacent to soil screener draining slowly

By February 1, 2015, the facility shall remove material along the access road to an area suitable for treatment cell construction. Active cells shall be reconfigured to include material that has become dislodged. Areas of the access road that hold water (ruts and depressions) shall be graded to ensure positive drainage. The area along the leaf storage pile and access road shall be graded to ensure positive drainage. The area adjacent to the soil screener shall be graded to ensure positive drainage. Water should not pond in ruts, depressions, and voids.

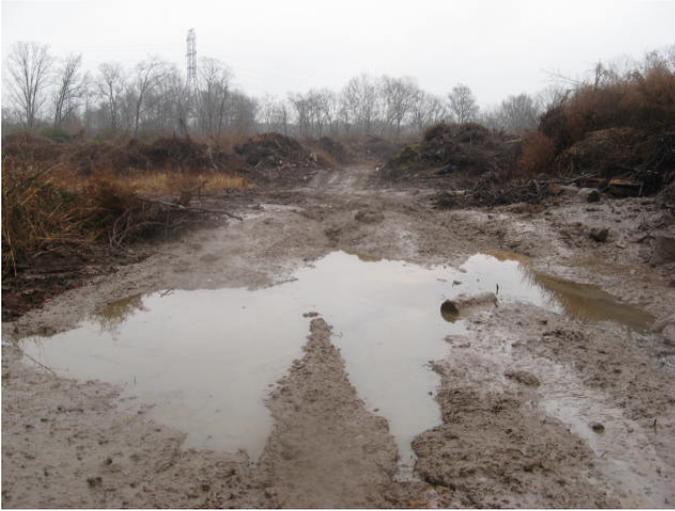
Ponded water in access road – left side

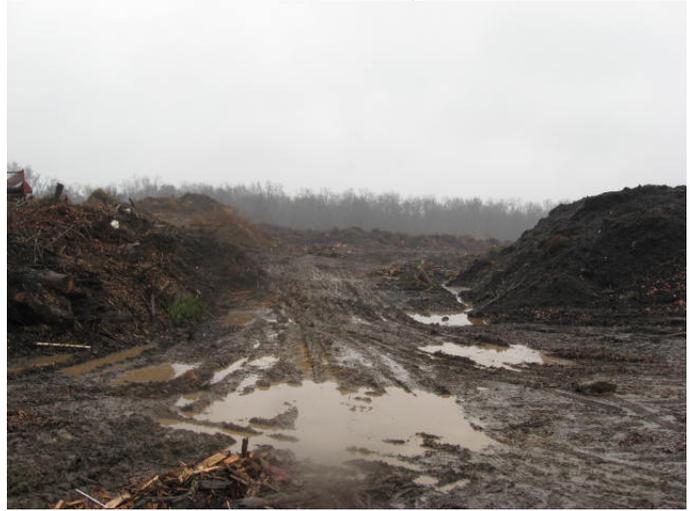
Ponded water in access road – right side

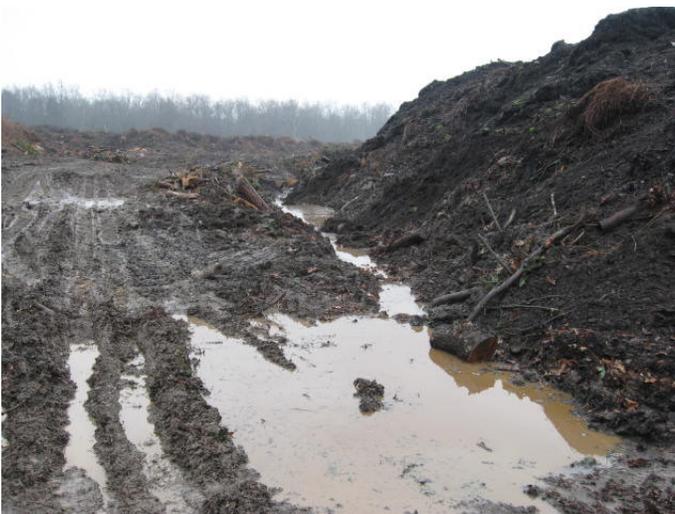
Ponded water along access road and leaf storage pile

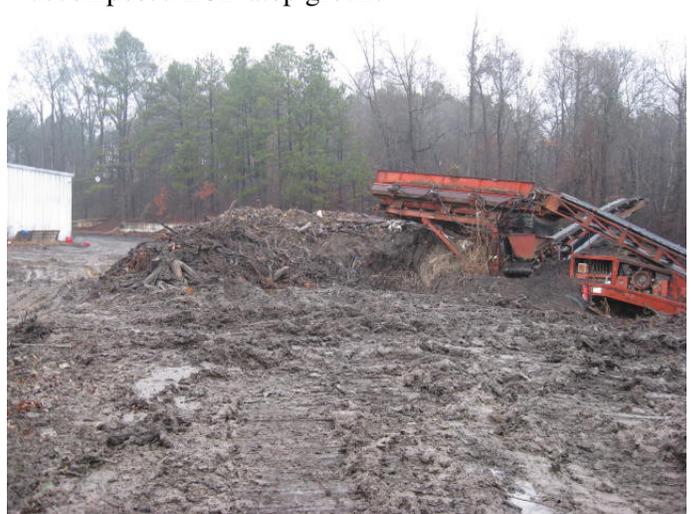
17. Screened overs are required to be routinely placed back into active cells.
18. The Dry Method row/pile size appeared to be < 50 feet wide and 30 feet high.

Accumulated overs at soil screener, thick layer of topsoil/
decomposed LCD atop ground

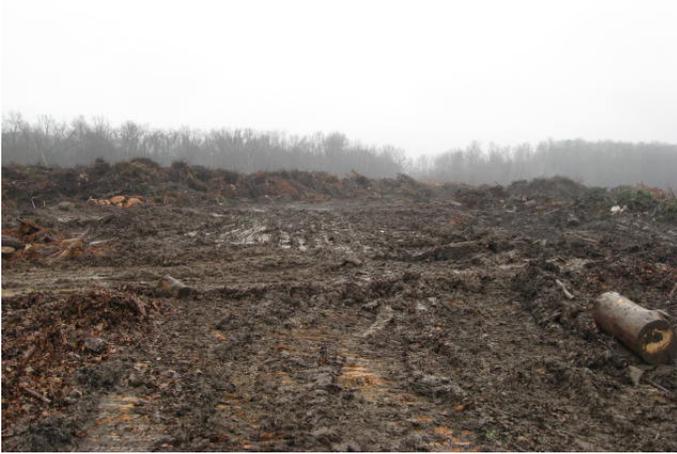
14. Mr. Andrews stated that he is in the process of constructing three long windrows of LCD atop much of the open operational area that has become impassible. When complete, the material will be left to decompose via the Dry Method active process.

Open operational area where windrows will be constructed Material not placed in windrow/pile – representative

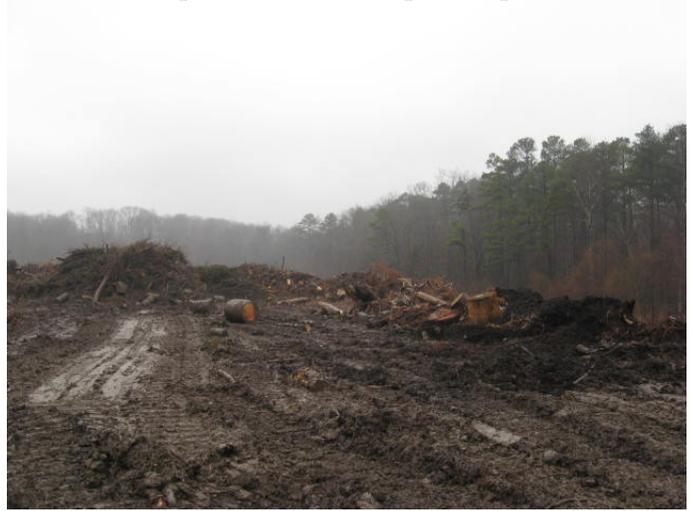
12. Mr. Andrews stated that the bulldozer is able to operate in thick mud but that it leaves ruts and depressions.
13. During the inspection material for use in dry method treatment cells was observed along portions of the access road. Material was not placed in a treatment cell to be constructed into lifts. See "Observed Violations" for remediation requirement.

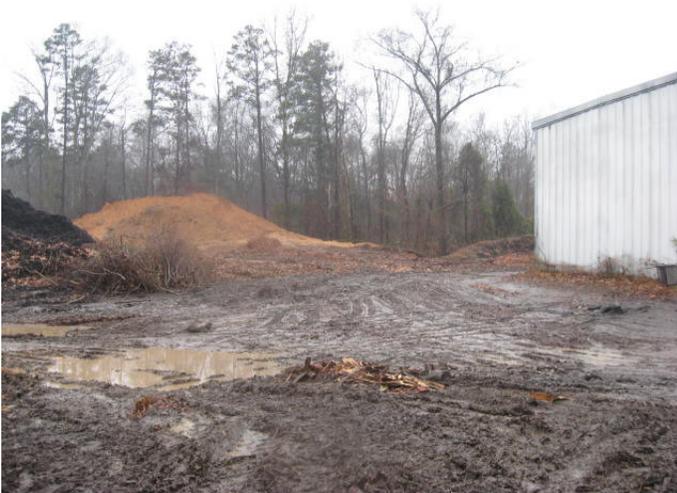
9. Mr. (Brandon) Andrews stated that during prolonged periods of wet weather customers commonly offload LCD behind the maintenance building adjacent to the access roads leading to the operational areas. This operation should be noted in the facility operations plan upon permit modification or renewal.

Material adverse weather offload area –
behind maintenance building
