FACILITY COMPLIANCE INSPECTION REPORT
Division of Waste Management
Solid Waste Section

UNIT TYPE:											
Lined MSWLF		LCID		YW		Transfer		Compost	<input checked="" type="checkbox"/>	SLAS	COUNTY: Edgecombe PERMIT NO.: SWC-33-03 FILE TYPE: COMPLIANCE
Closed MSWLF		HHW		White goods		Incineration		T&P		FIRM	
CDLF		Tire T&P / Collection		Tire Monofill		Industrial Landfill		DEMO		SDTF

Date of Site Inspection: May 6, 2014

Eastern Composting LLC
 8487 Battleboro-Leggett Rd
 Battleboro, North Carolina 27809

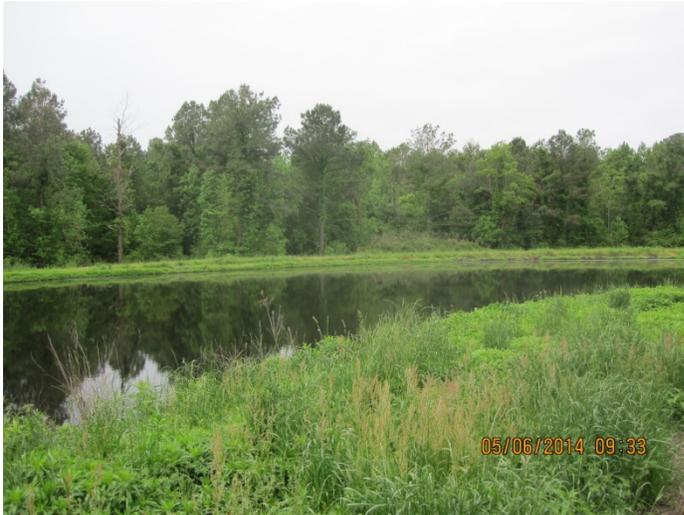
Leachate in the storm water retention pond has been observed to be at the maximum level (within one foot of the berm top) during every inspection conducted over the past year. Evidence that leachate has over washed the berm was observed during an inspection on February 26, 2014. The pump for the pond is kept in Rocky Mount rather than on site. Smith indicated a permanent pump installation is planned but the current DWQ permit does not allow construction in the pond berm. **Allowing the pond depth to remain at the maximum level for an extended period of time would seem to increase the chances of leachate over washing the berm top, especially during periods of heavy rain.**

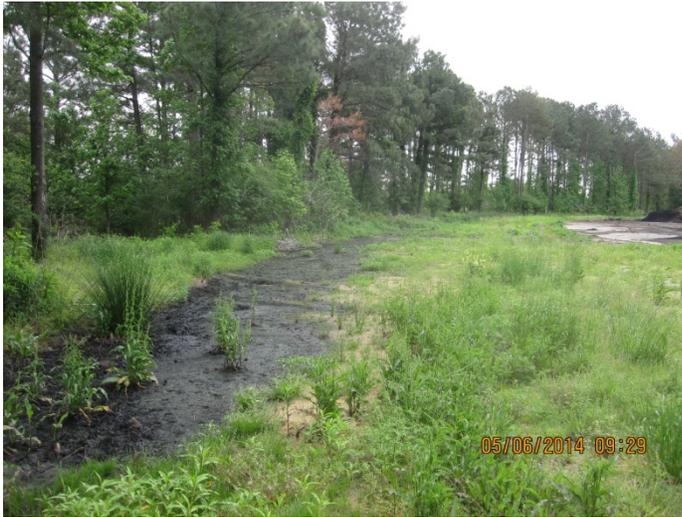
1. *See additional comments section from previous inspection reports.*
2. Storm water generated leachate (hereafter referred to as leachate) flows off the compost pad to a grassed swale on the northern side of the facility and is supposed to be conveyed to the lined storm water retention pond. **The swale is clogged with sediment and is allowing leachate to pond along the length of the swale. Leachate is flowing off the edge of the pad on the northern, eastern, and western sides of the pad on to the natural soil surface. Leachate must not come in contact with or flow over the natural soil surface. The swales must be reconfigured and constructed in such a manner that leachate flows freely to the storm water retention pond, the turning of equipment does not create ruts that will impound leachate, does not allow leachate to come into contact with natural soil surface and requires little if any maintenance. Constructing the swale of concrete and extending the concrete pad to the swale appears to be the best solution. However the Section will consider other options that will meet the same goal.**

Leachate observed ponding in the drainage swale on the northern side of the composting pad. **Permit Conditions 2:** This facility shall be operated in such a manner that erosion and runoff from the site shall be controlled. Any leachate generated at the facility and any runoff from the facility shall be managed in such a manner that ground or surface water will not be adversely affected. The facility shall be maintained to prevent the accumulation of storm water or leachate on travel areas or active composting sites.

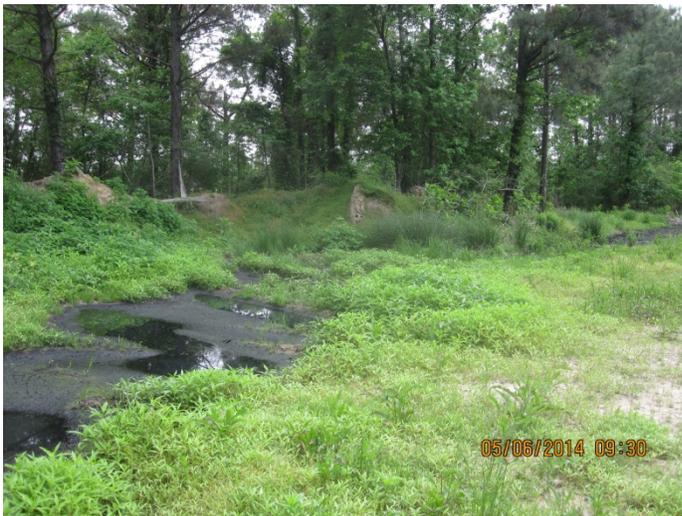
More leachate observed ponding the drainage swale on the northern side of the composting pad. This view is down slope from the previous photograph.

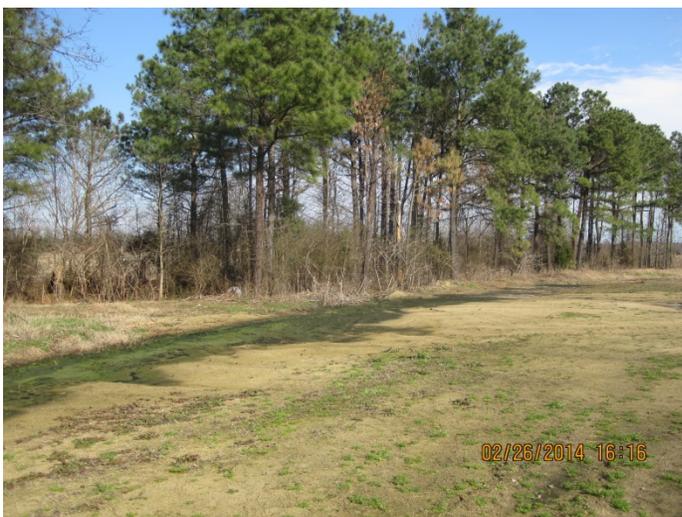
More leachate observed being ponding in the drainage swale on the northern side of the composting pad. This is further downstream from the first two photos.

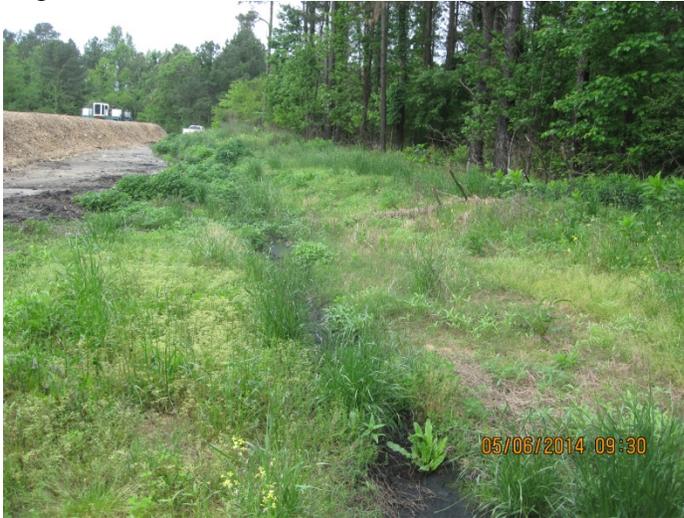
Leachate runoff observed on the western side of the composting pad. A drainage swale does not appear to have been constructed on this side of the pad. This appears to be the result of gullies being formed by leachate runoff during heavy rains.

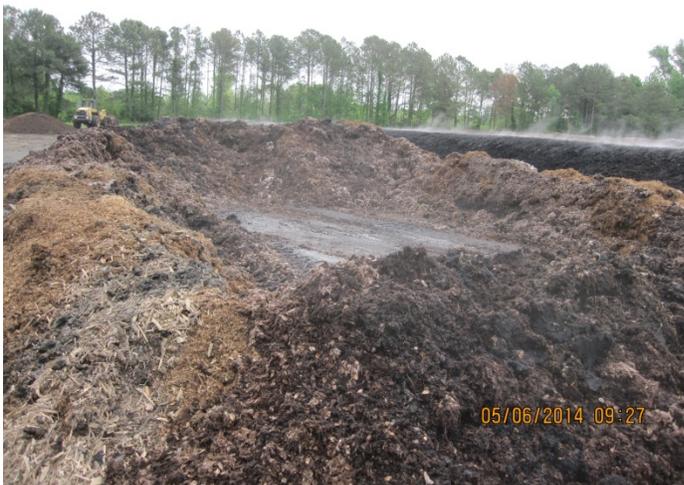
5. Incoming grease waste is being stored in an impoundment on the pad and contained by a berm constructed of compost. This is not an acceptable management practice. **The incoming liquid grease waste shall be incorporated or mixed into the active windrows in a way that prevents excess liquid from standing or pooling on the windrow or the pad.**

Incoming grease waste is being dewatered by placing in an impoundment of compost.

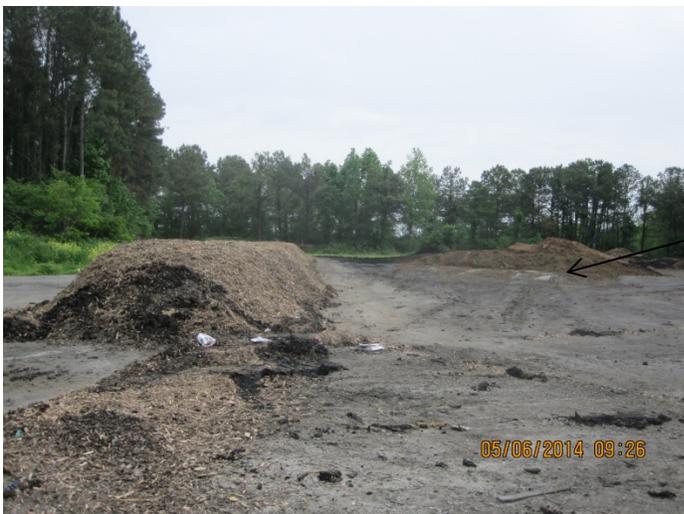
Incoming material is generally being managed better. This material is now being placed in windrows at the upper slope of the pad. Material in the background could still cause leachate to be impounded.

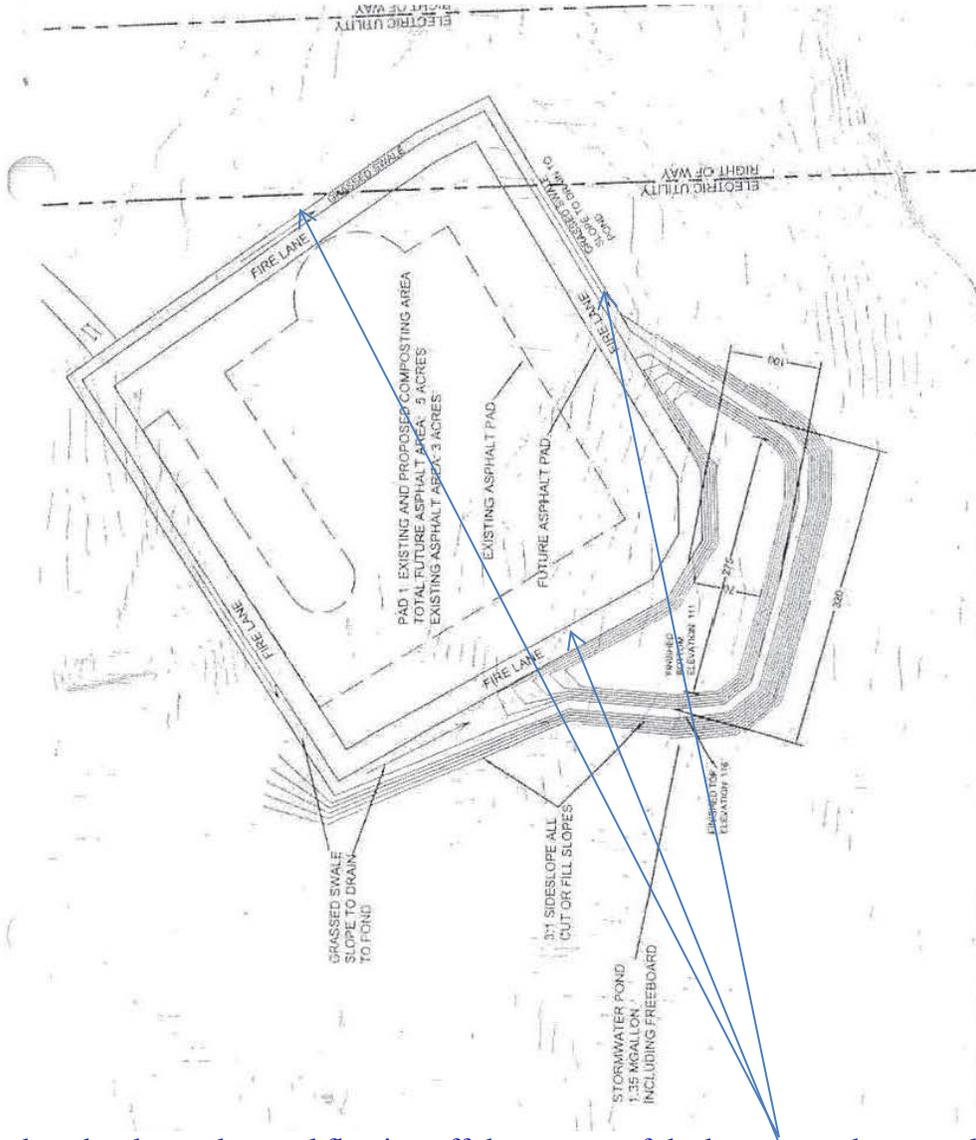
Leachate has been observed flowing off these areas of the berm onto the natural soil surface.
