FACILITY COMPLIANCE INSPECTION REPORT
Division of Waste Management
Solid Waste Section

Date of Site Inspection: April 24, 2014

Halifax County Transfer Facility
 921 Liles Road
 Halifax, NC 27839

Comprehensive Inspection

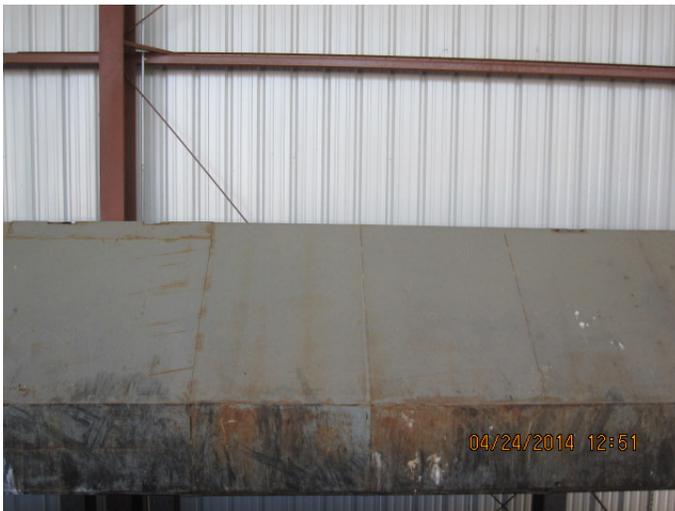
1. The facility opened on July 1, 2013. The building contractor has been informed of the problem with the tipping floor needing repair in one area.
2. The facility appears to be kept very clean inside and out. There was minimal windblown observed. Very good.

Walls are clean

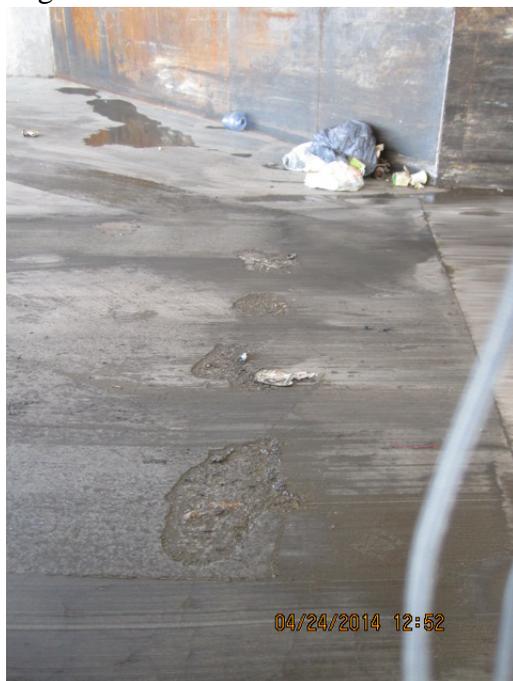
Tipping floor needing repair
