**FACILITY COMPLIANCE INSPECTION REPORT**  
**Division of Waste Management**  
**Solid Waste Section**

**Date of Site Inspection:** 7/24/2014

Evergreen Packaging Industrial Landfill  
 State Road 1550  
 Canton, NC 28716

Comprehensive Inspection; Complaint Investigation

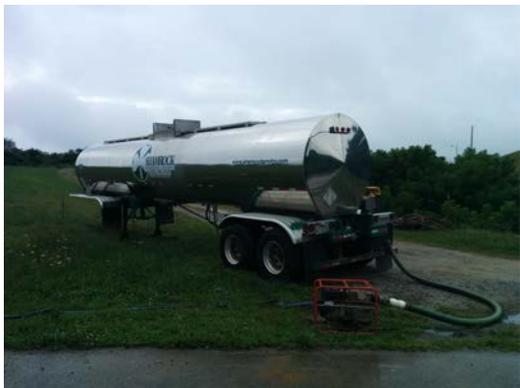
Water Tanker – 7/24/2014

3. During the site inspection no dust clouds, coated vegetation, or sediment run-off was observed at the facility. The water tanker was in place and both water trucks were operational. Due to weather patterns bringing in more rain to the region – it has been more difficult to anticipate dust events in order to get a representative inspection. However, based on 2a-e above, the site inspection, and the compliance history of the landfill, at this time no further actions/inspections are deemed warranted and the complaint investigation is considered closed.

Reduces fill turn-around time for water tankers from 60 to 30 minutes.

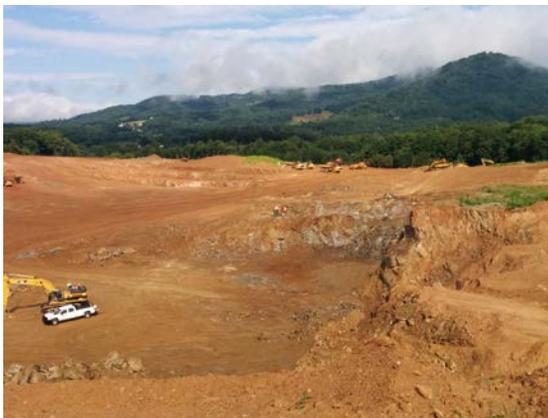
Cell 6D-North and 6-E under construction.

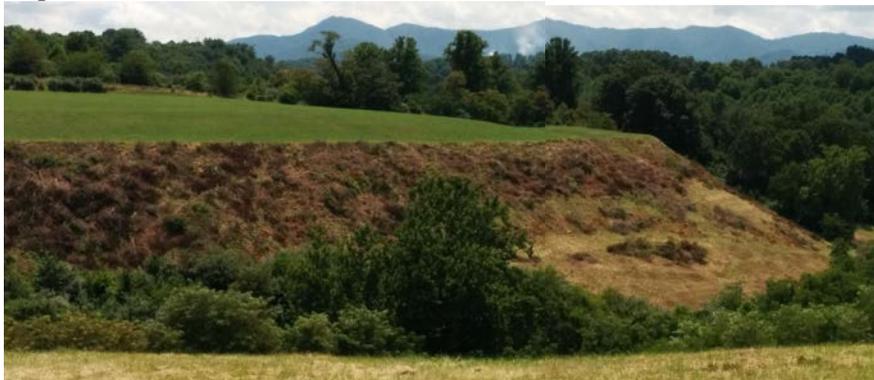
7/24/14

4. Cell H had been recently mowed. The side-slopes had been hand trimmed due to the steep incline and the vegetation generated from the moving/trimming had been left in place. It was recommended that the debris be moved off the side slope in order to prevent vegetation loss/erosion on the slope and to allow for adequate inspection.

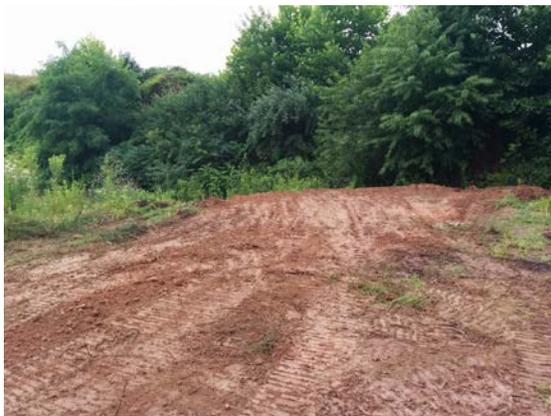
7/24/2014

5. The asbestos disposal area was inspected. The approved Operations Plan (DocID 11173, dated May 2010) states that “before the end of the day, at least 18 inches of soil will be placed over the plastic covered asbestos waste.” The area had received waste that morning and had already been adequately covered with soil.

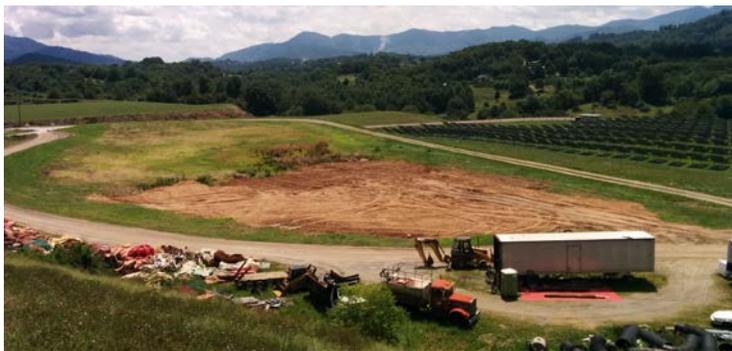
B-Upper – 7/24/2014

- e. Inspection records (quarterly self-inspections: three years available).
  - f. Landfill daily haul sheets (field records).
  - g. Landfill operator training records (SME certified training).
  - h. Operating Log for the leachate collection system
  - i. LFG (methane, H<sub>2</sub>S) records, calibration logs – no issues noted. [GP3, 4, 5, 6,7 8 and P-1, 2, 9, 10 ambient].
  - j. The current Permit and Operations Plan, along with the Environmental Monitoring Plan were available for review.
7. During the previous inspection report settlement issues were noted. C-Lower is currently staging soil for the new cell construction and will have soil left in place to address settlement. B-Upper is shown below – soil had been placed (ongoing) to address settlement and will be vegetated upon completion.
