# ABF Environmental

ABF Project Number: ABF-14-1547

RE: May 2015 Quarterly Inspection Report  
Old Fort Landfill, Old Fort Township, McDowell County, North Carolina  
Permit# 56-03

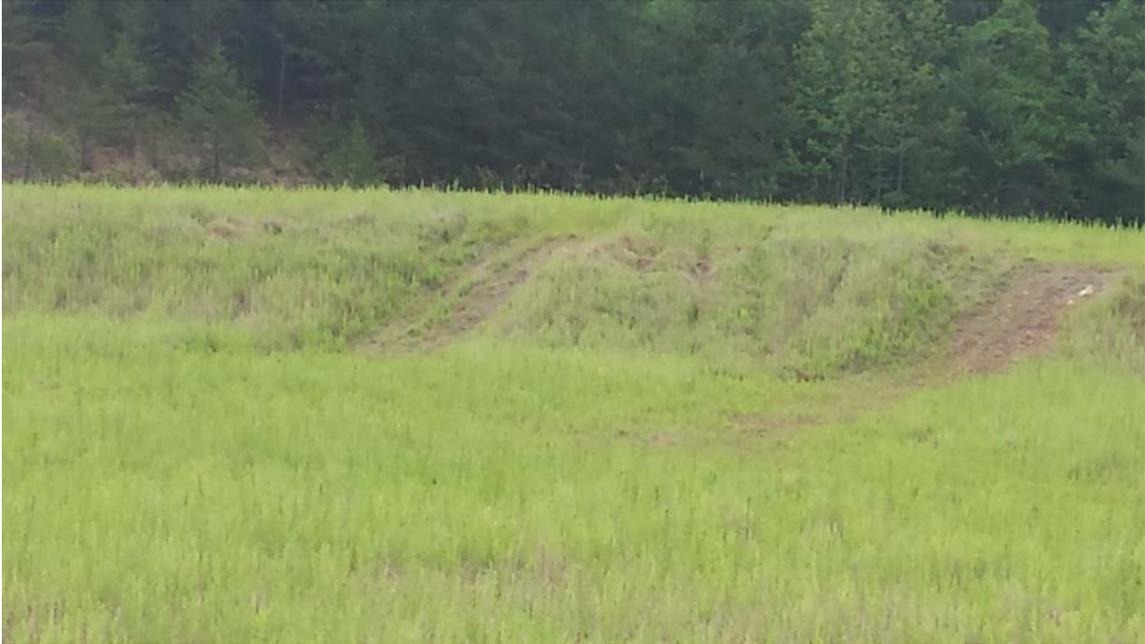
**Corrective Action:** Very light erosion between Phase I  
and Phase II near center. Repairs not needed  
yet but will likely make repairs in fall

The erosion from initial ATV use after capping,  
but ATVs not using site now.

Photo A – Light cap erosion between Phase I and Phase II looking south

As indicated above, the only immediate remedial tasks are to make light surface repairs and revegetate a small area between Phase 2 and Phase 3 Caps, and complete a mowing event. This will be completed in the fall of 2015. The repairs to the Phase I Cap and tree removal from the surface of Phase I Cap will be completed in the spring of 2016. Refer to the attached Figures for the location of the pertinent landfill features along with the May 2015 Landfill Inspection Record included in the Tables. In addition, refer to Appendix A for the photographic record of the inspection. If you have any questions or comments, please do not hesitate to contact us at (248) 219-9228.

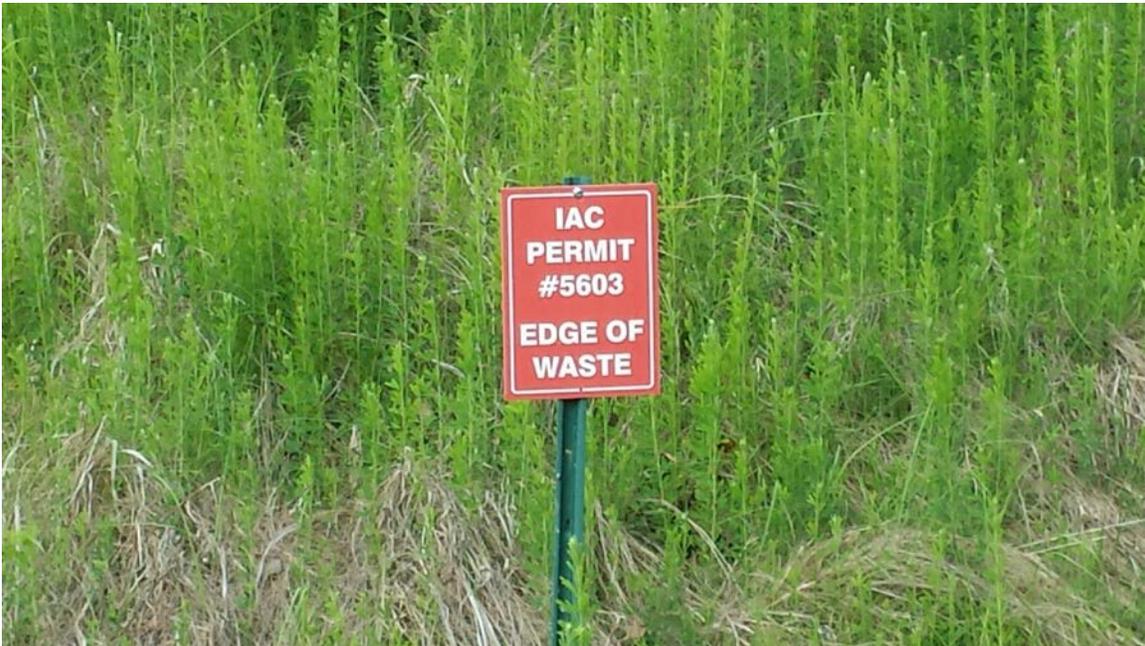
- All Detention Basins were found to be in good shape.
- All Permanent Diversions were found to be in good shape.
- All Outlet Stabilization Structures were found to be in good shape.
- All Inlet Protection Structures were found to be in good shape.
- All Rock Dams were found to be in good shape.
- All Edge of Waste signs are present.

Photo B – Typical Edge-Of-Waste signage around landfill

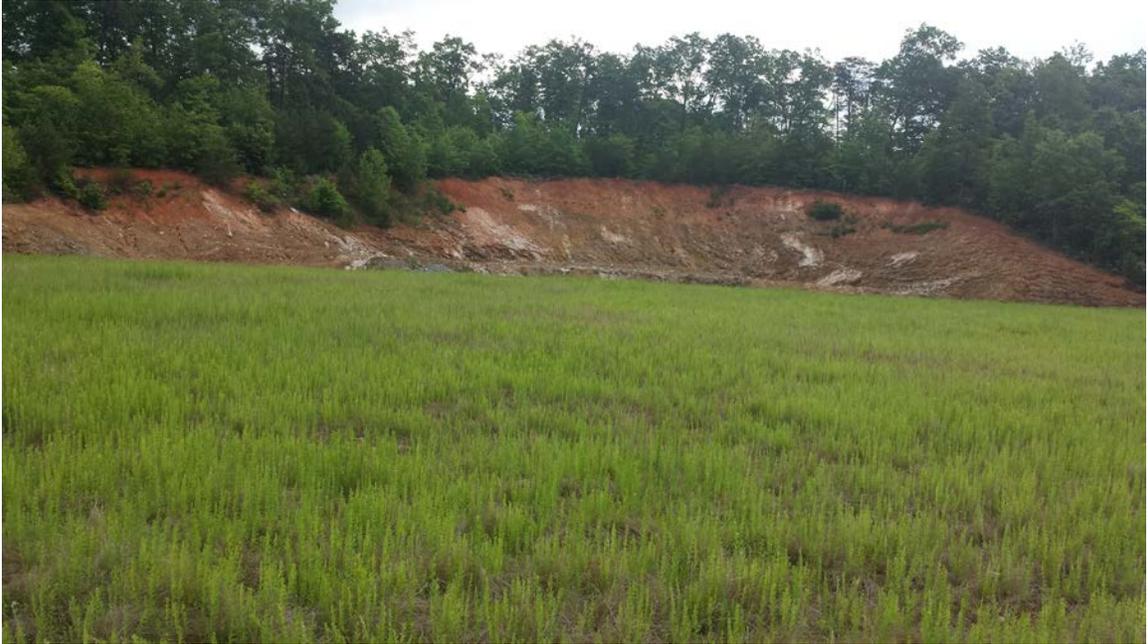
Photo C – Cap looking northeast towards embankment

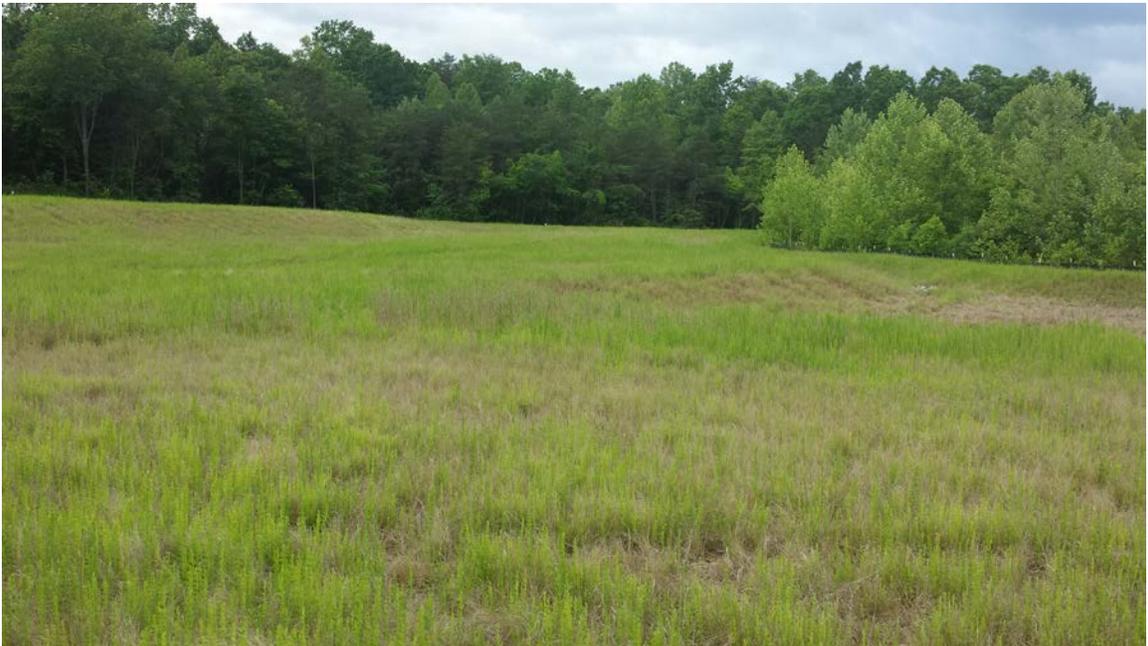
Photo D – General view of cap looking southwest
