FACILITY COMPLIANCE INSPECTION REPORT
Division of Waste Management
Solid Waste Section

Date of Site Inspection: May 19, 2014 Date of Last Inspection: December 27, 2009

Home Gallery site
 401,411,421,431S Wesleyan Blvd
 Rocky Mount, North Carolina

Inspection of closed CCB fill site

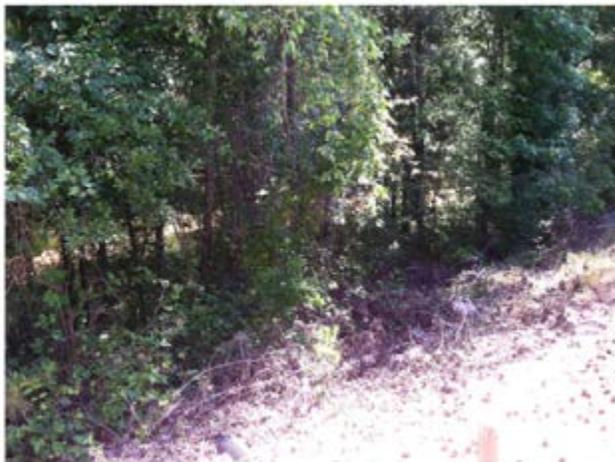
View of the eastern slope

6. No uncovered ash was observed but the slopes of the fill area were thick with vegetation and the area below the fill was a swamp so complete survey was not possible.
