June 10, 2015

Re: Marshall Steam Station Industrial Landfill Structural Fill
Structural Fill Permit No. CCB0072
Marshall Steam Station
Terrell, North Carolina

| Subject | Marshall Station Industrial Landfill/Structural Fill Evaluation of Possible Slope Nonconformity – Issue MAR-128 | | |

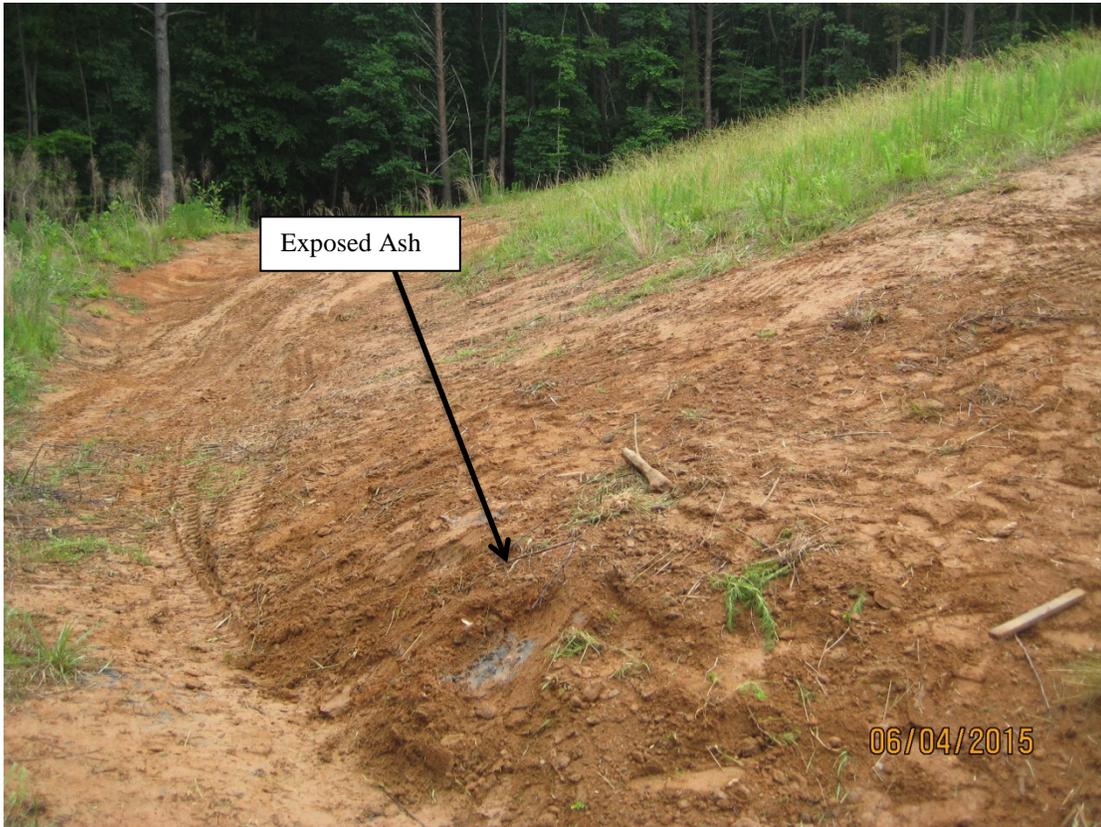
Figure 2 – View of Bulge Area at toe of slope looking generally northwest

As part of routine vegetation maintenance, Duke Energy staff encountered a small area of exposed ash and soft cover soil near the toe of slope of the covered Structural Fill immediately downslope of a downdrain pipe inlet. The project location is shown on Figure 1.

At the time of our visual inspection, the area was generally cleared of vegetation. Probing of the surface indicated localized soft areas at the toe and on the approximately 3H:1V slope leading to the basin. Vegetation was removed from the basin and no standing water was observed, but we understand that standing water was routinely observed near the outlet pipe until the recent maintenance completed on June 3, 2015.

The area in question is shown on the photograph, Figure 2 below and is less than 25-ft in width as measured perpendicular to the embankment slope. Ash is exposed in localized spots in a very small area (less than 5 square feet) near the toe of the slope in an apparent slope irregularity shown on Figure 2. No evidence of previous washing or erosion is evident. No cracking, sloughing or other evidence of slope failure was observed.

3. *Conduct an investigation of the area* – a proposed investigation is outlined below.
 - a. Advance hand augers on the crest, surface and toe of slope in the area in question to identify areas where the required 18-inches of soil cover is not in place. A minimum recommended investigation area is the slope starting at the existing downdrain pipe and moving north/west along the perimeter until adequate cover is confirmed.

- b. Excavate test pits to visually examine the condition of the cover soil and ash. Test pits should be excavated using a mini-excavator with a 12 or 16-inch bucket to minimize disturbance. Test pits should be located at the toe of the slope in the slope irregularity area, mid slope and at the crest of the slope. If conditions permit, test pits within the vicinity of the pipe inlet are recommended. In all test pits, excavate through the soil cover and into the ash 2 to 3-ft. Estimate the relative degree of compaction and note the presence of water, condition of the excavation walls, etc.

4. *Monitor the slope area* – Once the investigation is completed, monitor the slope area as follows:
 - a. Visually inspect to note changes in conditions three times per week and after any significant rain event (>0.025-inches). Observe the downdrain pipe inlet to note the presence and approximate depth of standing water.

- b. Install stakes at an established interval at the crest, midpoint, toe and downstream of the toe. Monitor the stakes using survey methods weekly and report movement of stakes, if any. Monitor slope stakes for two months or as directed by Duke staff.
