Re: Marshall Steam Station Industrial Landfill Structural Fill
Structural Fill Permit No. CCB0072
Marshall Steam Station
Terrell, North Carolina 28682

Attached you will find the Construction Quality Assurance Repair Report for the slope non-conformity. This repair was overseen by and report prepared by AECOM under the direction of Duke Energy.

Subject Marshall Station Industrial Landfill/Structural Fill
FINAL Report of Repair of Nonconforming Areas– Issue MAR-128

This Technical Memorandum addresses the repairs to the slope non-conformity at the southwest corner of the future Industrial Landfill at Marshall Station – Issue MAR-128. At the request of Duke Energy, AECOM investigated the area with hand augers and test pits in June 2015 and submitted a report with recommendations to Duke Energy dated July 16, 2015. Recommendation included:

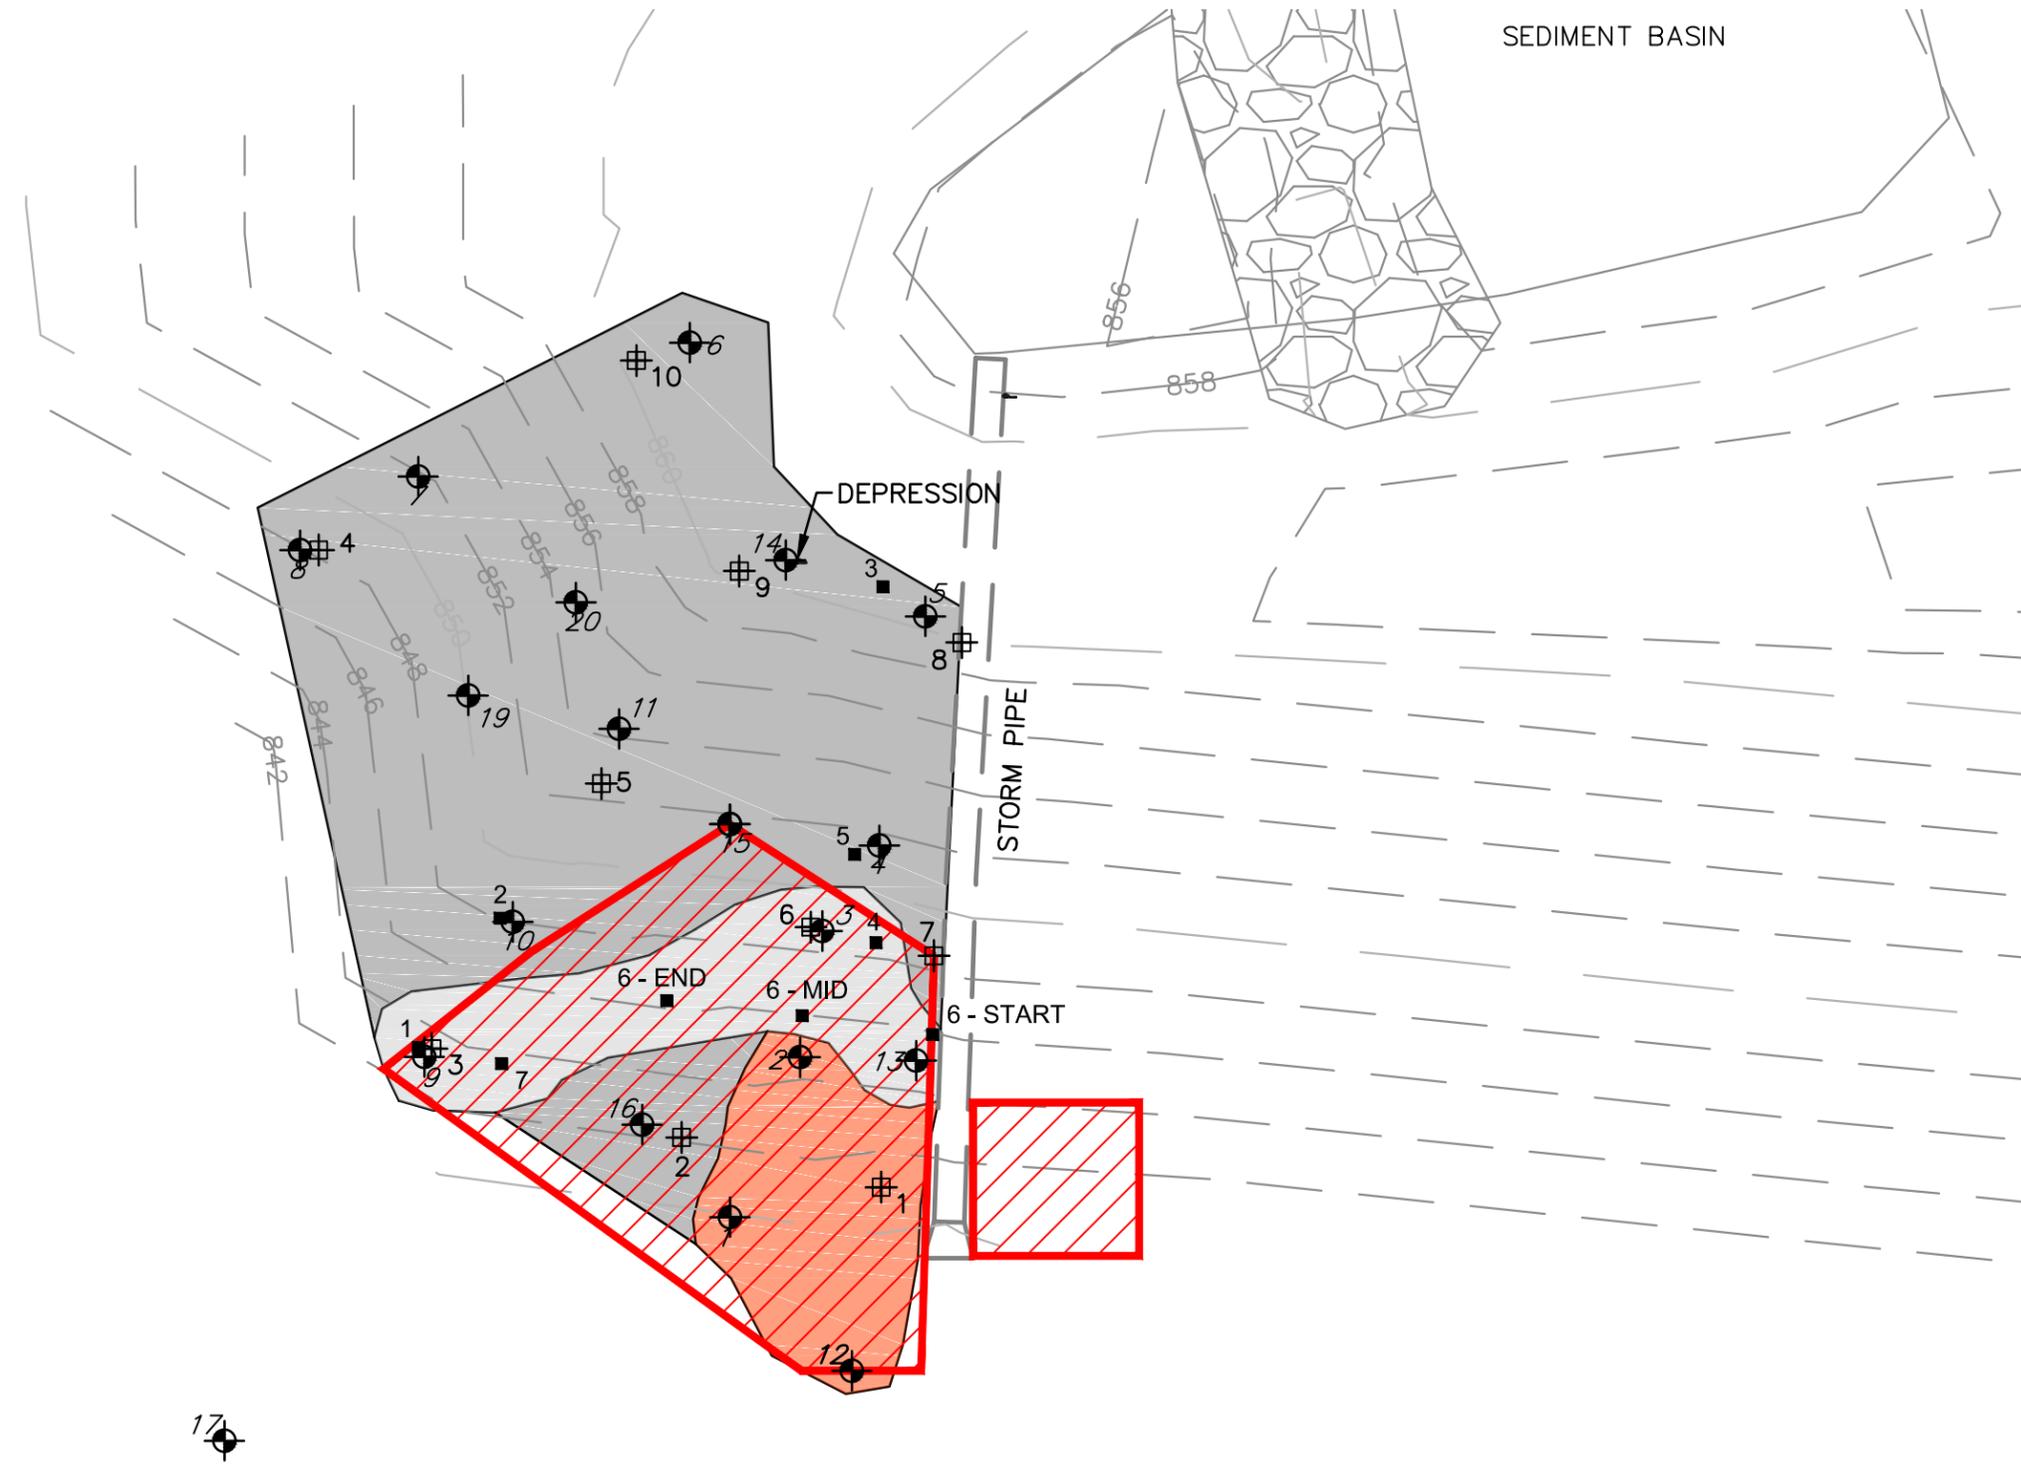
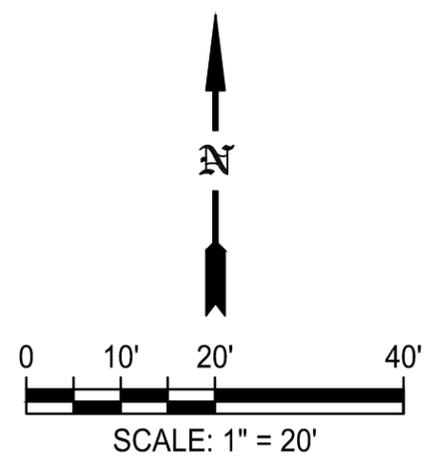
AECOM				
MARSHALL STEAM STATION				
DUKE ENERGY				
MARSHALL INDUSTRIAL LANDFILL				
APPROXIMATE LIMITS OF EXCAVATION				
DRAWN BY: SS	CHECKED BY: JAB	PROJECT No: 60441887	DATE: 10/5/2015	FIGURE No: 2

The lateral and vertical extents of the soft/saturated ash were established based upon visual observation by the AECOM representative and the Earnhardt Superintendent. The soft/wet areas were limited in size and generally agree with the areas identified by AECOM during the June 2015 investigation (see Daily Activity and Observation Reports, Attachment 2).

Approximately 26 loads of wet or soft ash were removed and hauled to the FGD Landfill on August 17 and 18, 2015. The approximate limits of the excavation on the slope due to the presence of soft or wet ash are provided in the Daily Activity and Observation Reports, Attachment 2, and duplicated on Figure 2. Once it was confirmed visually that the soft/ash was removed, Earnhardt graded the area in preparation for placement of cover soil. As can be seen on Figures 3 and 4, ash was excavated in the area west of the down pipe from the toe of slope to near the crest.

Once the exposed subgrade in the excavation area was graded and prepared, Earnhardt hauled silty fine sand soil to the work area and spread the soil in nominal 8 to 10-inch thick lifts. Each lift was spread using a dozer (see Figure 5) and compacted using a CAT 563 penetrating foot compactor. Earnhardt contracted with ESP Associates to perform in-place density measurements. Compaction was performed until testing indicated that the lift conformed to project criteria (minimum 95% maximum Standard dry density, ASTM D-698

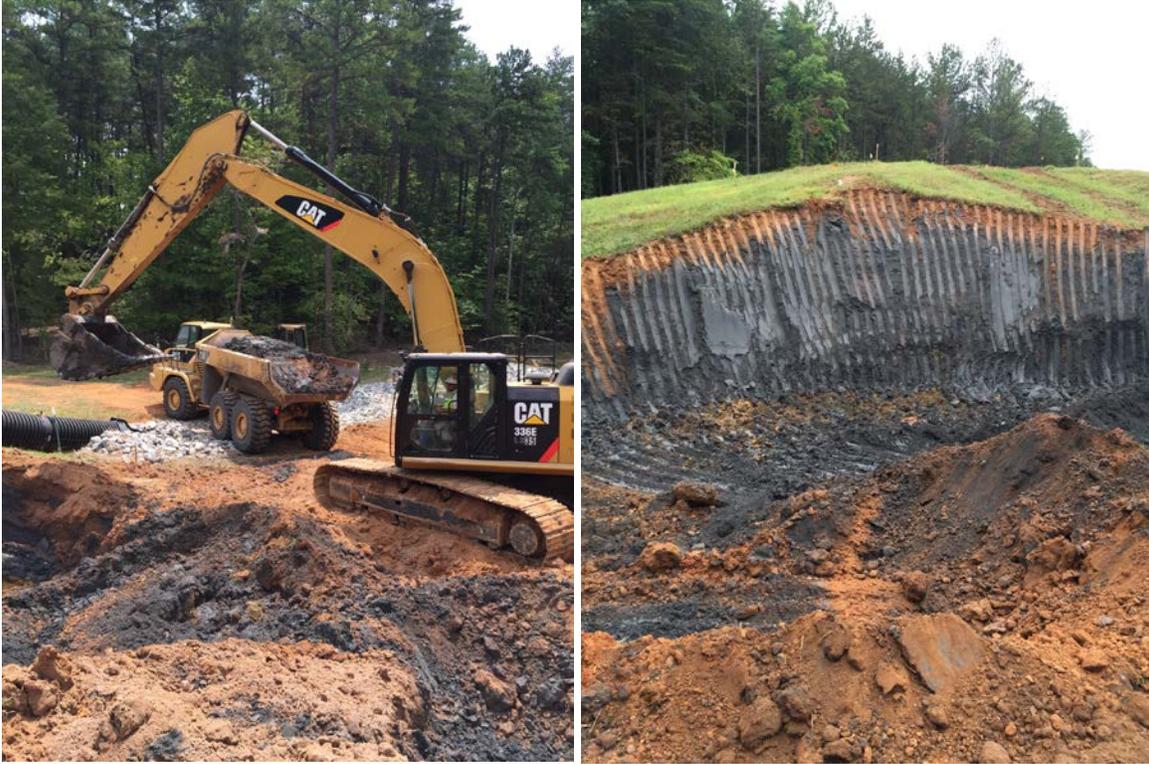
Figure 3 (left) – Removal and loading of ash west of down drain near toe of slope. Figure 4 (right) - Northern limits of slope excavation, including all of wet ash encountered. Note thickness of cover soil near crest of slope is less than project minimum.

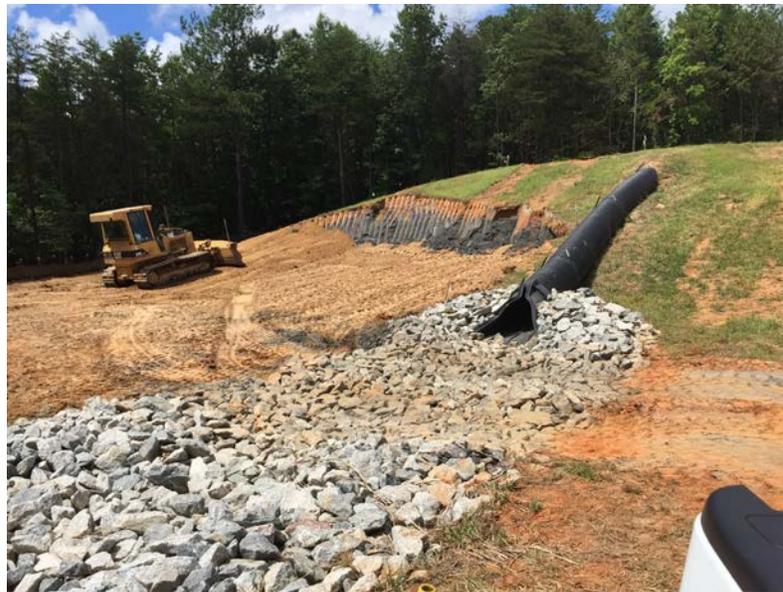
Figure 5 – Placement and spreading of soil cover on south slope of repair area.

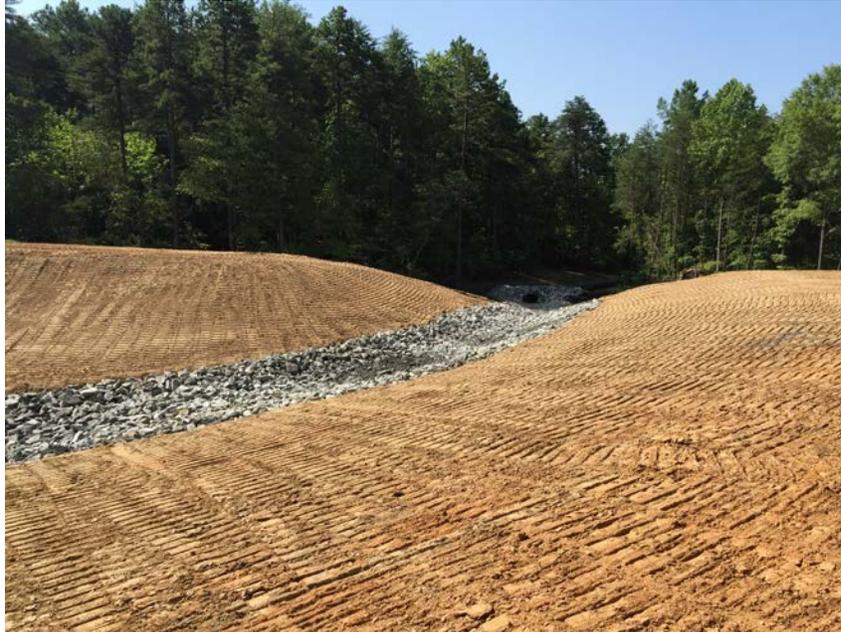
The former basin area was graded to meet adjacent grades to prevent ponding of surface water runoff. A nominally 10-ft wide swale was graded to connect the existing swale draining the western perimeter of the structural fill. The swale was constructed on the southern slope to replace the down drain and was extended downstream to the existing rip rap lined swale leading to the Ash Basin. The adjacent Industrial Landfill areas were graded to drain to the swale. A photo of the swale at the crest of the slope showing the re-grading of the crest of the slope is shown on Figure 6.

Figure 6 – View of finished swale at top of slope looking generally south. Existing pipe to the Ash Basin is visible in the background.

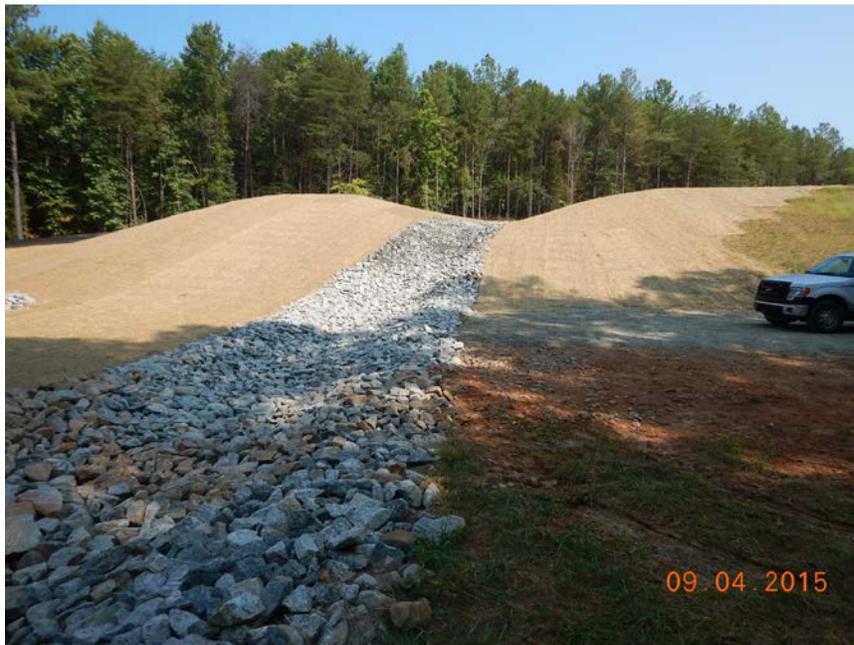
Figure 7 – View of completed rip rap lined swale and seeded areas looking north (Photo provided by Duke Energy)

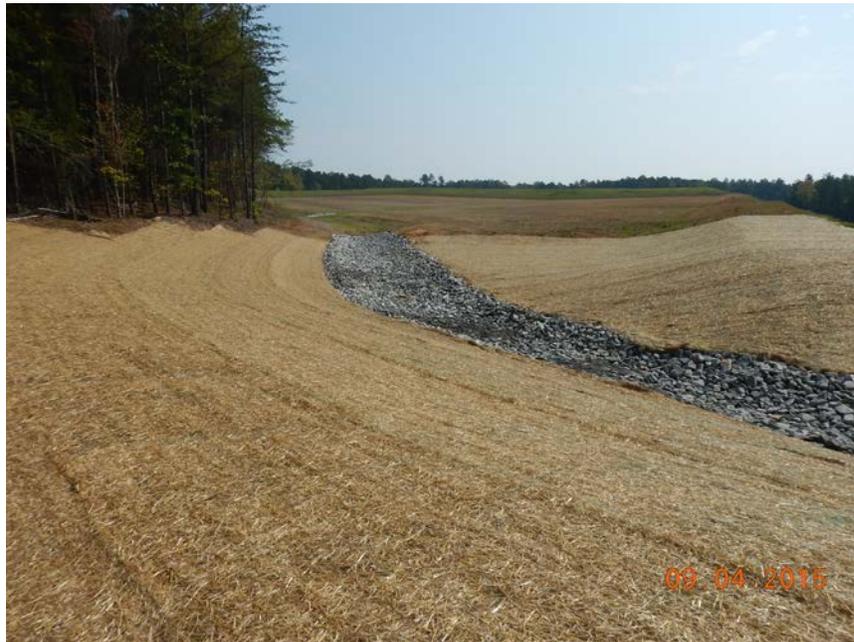
Figure 8 – View of completed rip rap lined swale and seeded areas looking north (Photo provided by Duke Energy)

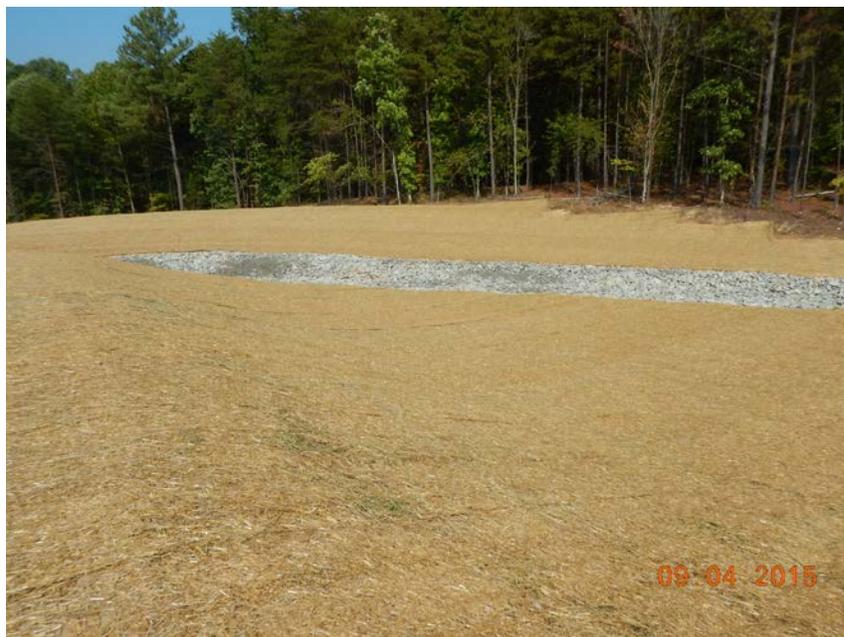
Figure 9 – View of completed rip rap lined swale and seeded areas looking west (Photo provided by Duke Energy)

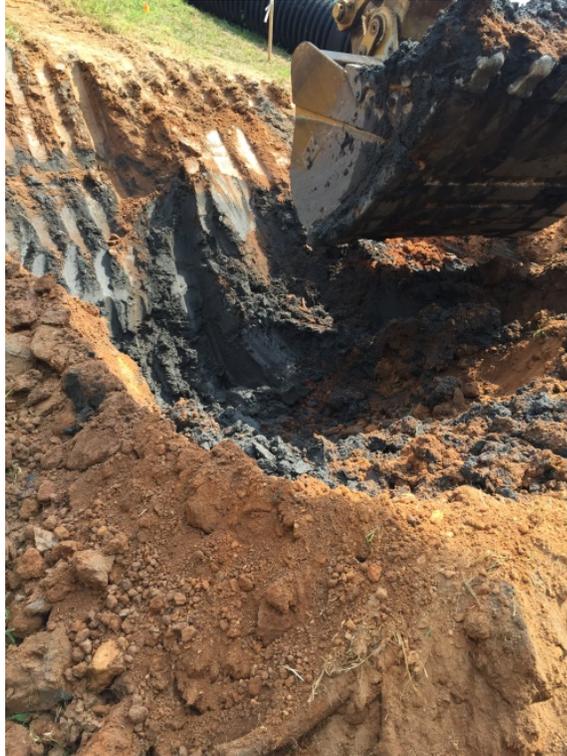
Photo 2 – Continue excavating to locate grade for ash removal. 8/17/15

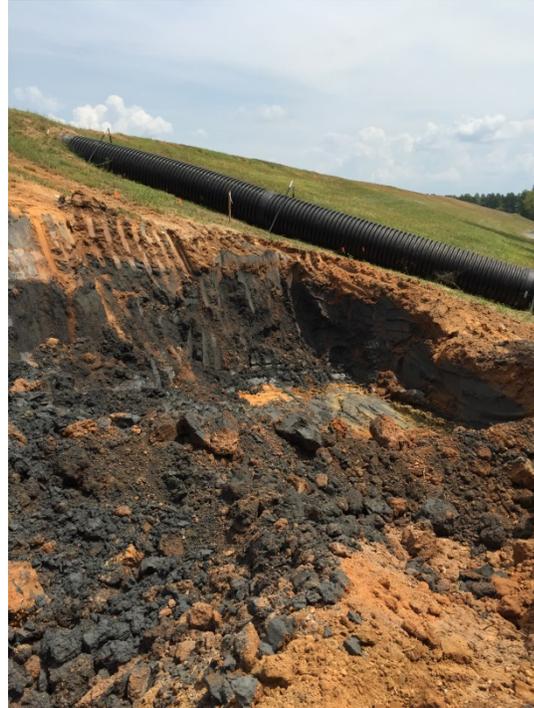
Photo 4 – Excavating moving to the west to establish western extents of soft ash. 8/17/15

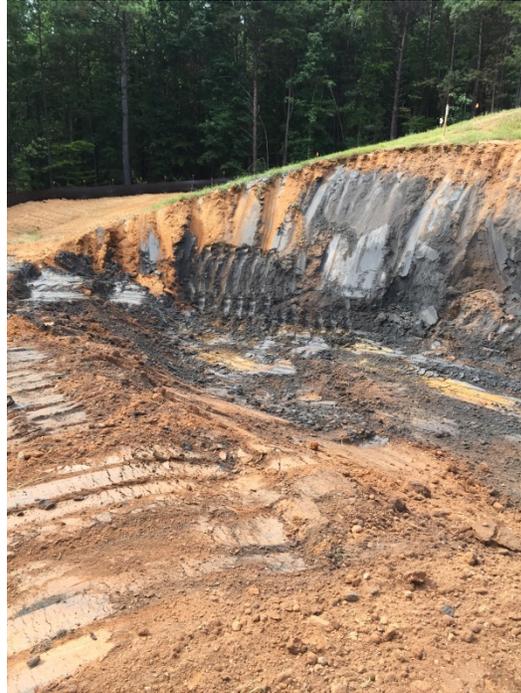
Photo 6 – Extent of excavation west of down pipe prior to preparation for placement of compacted fill looking north. 8/18/15

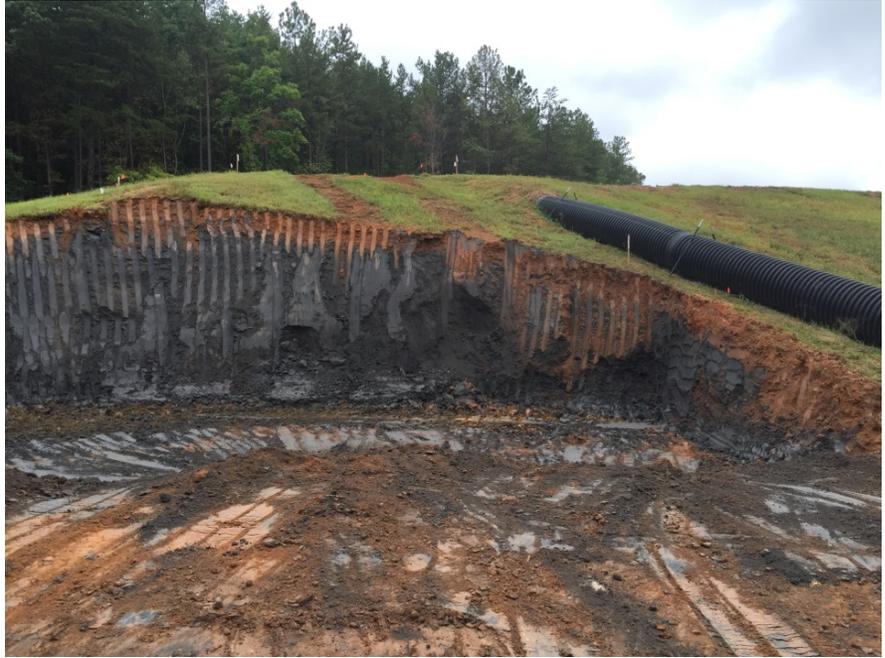
Photo 8 – Eastern end of excavation west of down pipe ready for placement of compacted fill. 8/18/15

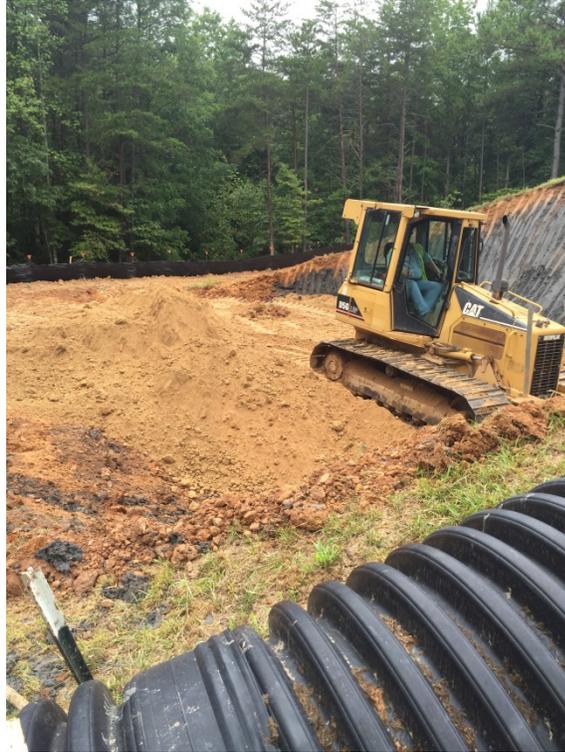
Photo 10 – Compaction of initial lift of backfill in area west of down pipe. 8/18/15.

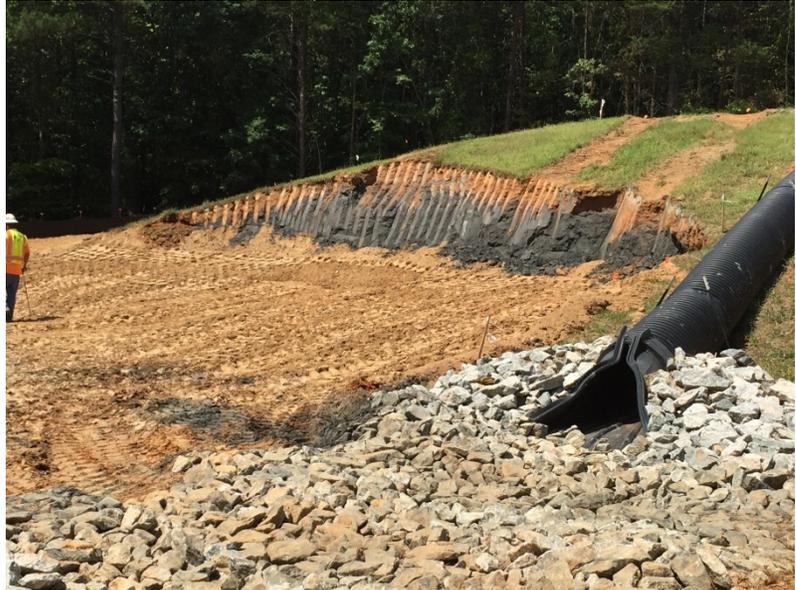
Photo 12 – Compacting additional lift. 8/18/15

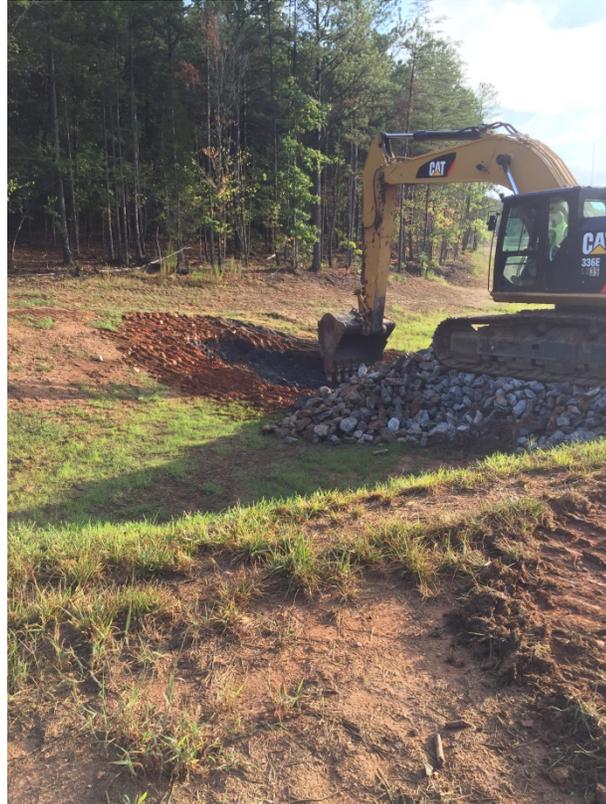
Photo 14 – Compaction testing final lift on main excavation. 8/19/15

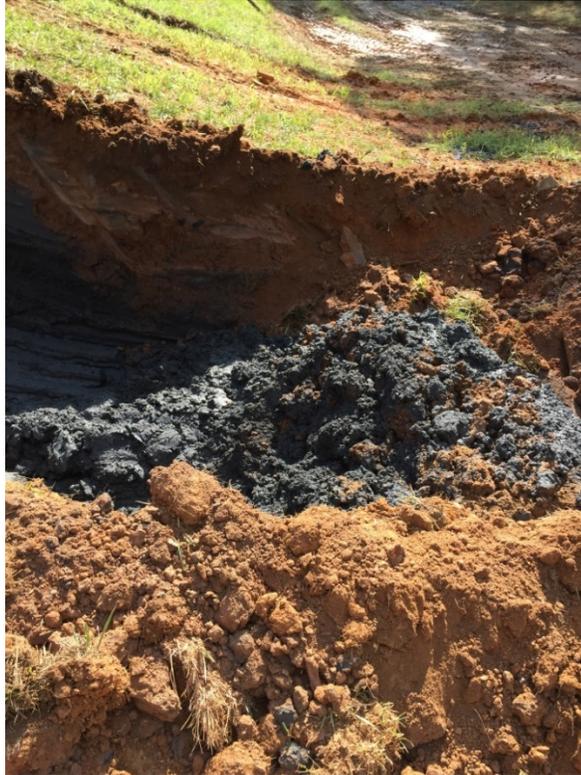
Photo 16 – Final excavation beneath and to the east of down pipe. 8/19/15.

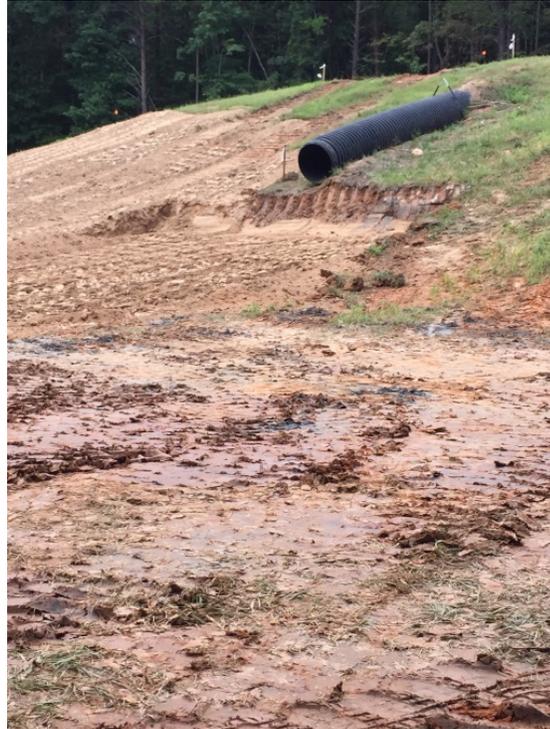
Photo 18 – Finish grading of compacted backfill located east of basin down pipe location. Section of pipe remains to provide temporary drainage. 8/19/15

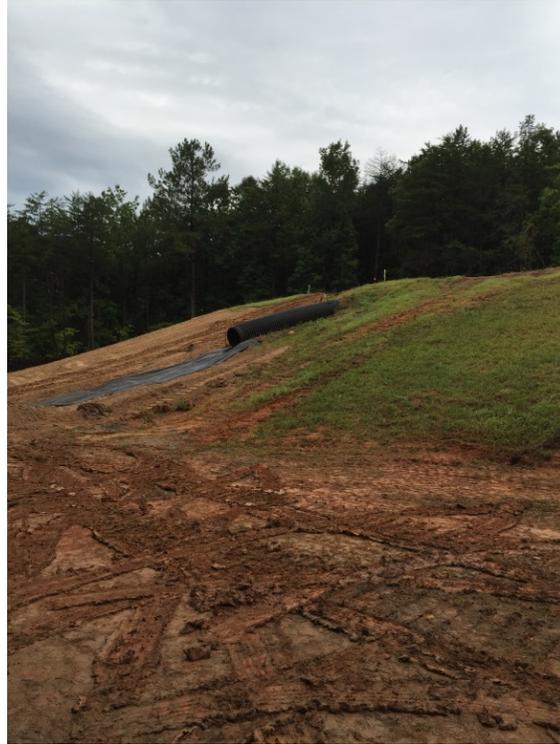
Photo 20 – Excavating crest of slope for removal of remainder of down pipe and grading for rip rap swale. 8/21/15

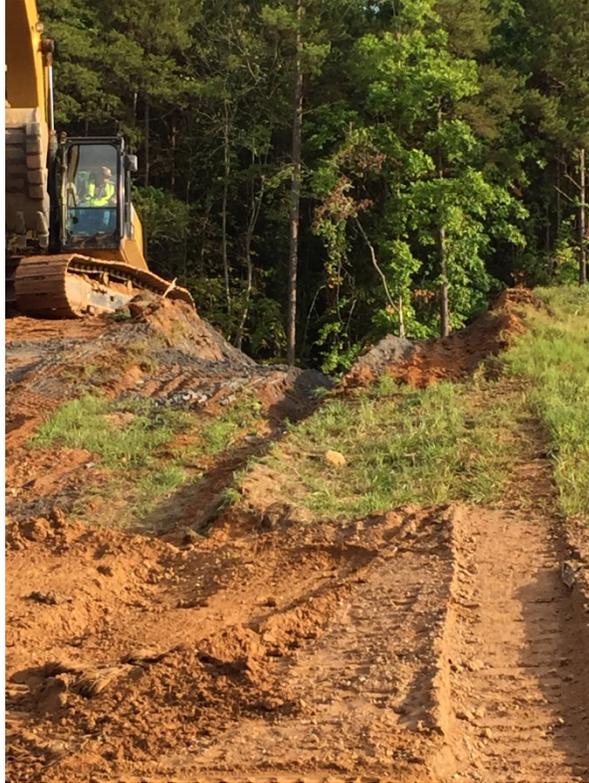
Photo 22 – Excavating drainage swale on top of slope looking southwest. Slopes approximately 1-ft of fall every 10'. 8/21/15

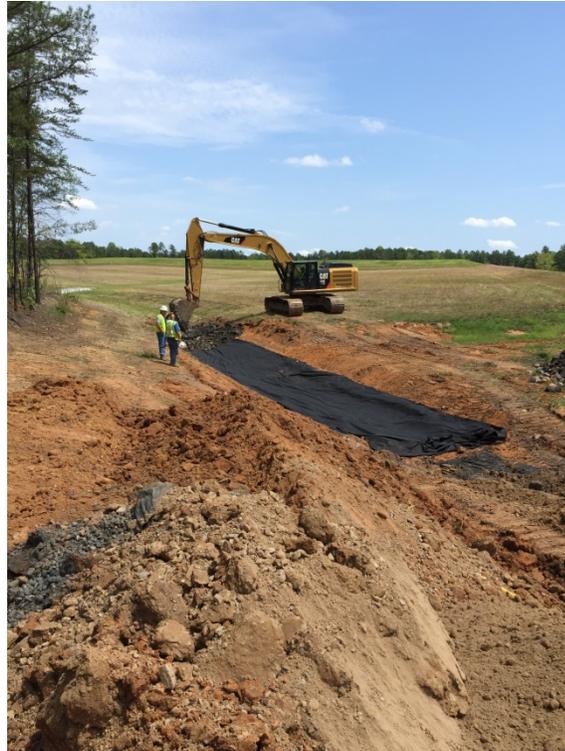
Photo 24 – New rip rap lined drainage swale looking southwest. 8/21/15

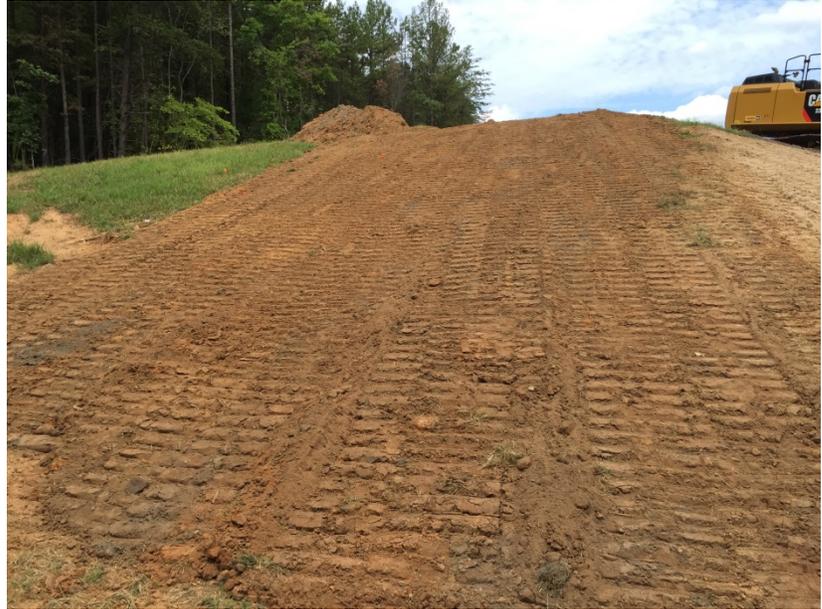
Photo 26 – Excavating crest of slope for new drainage swale. 8/22/15

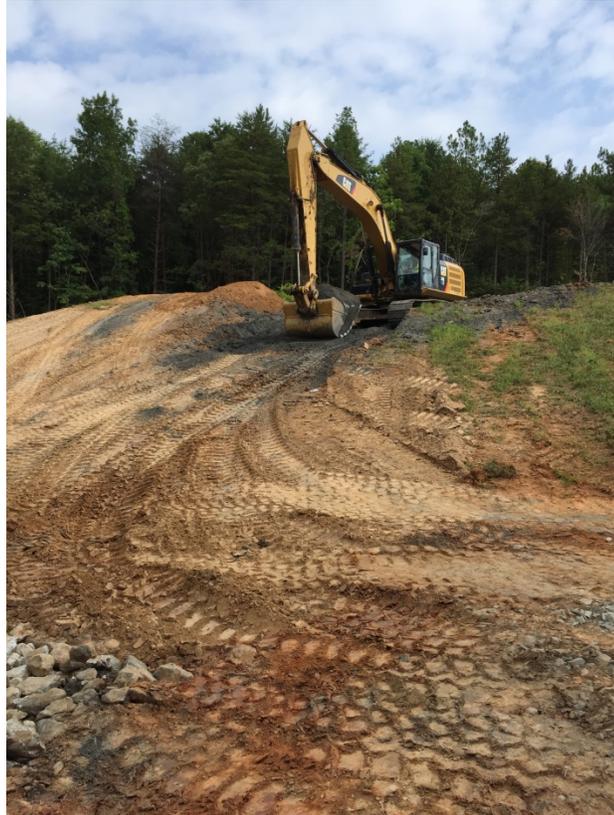
Photo 28 – Placement of soil cover over swale in former basin area to provide minimum required cover. 8/22/15

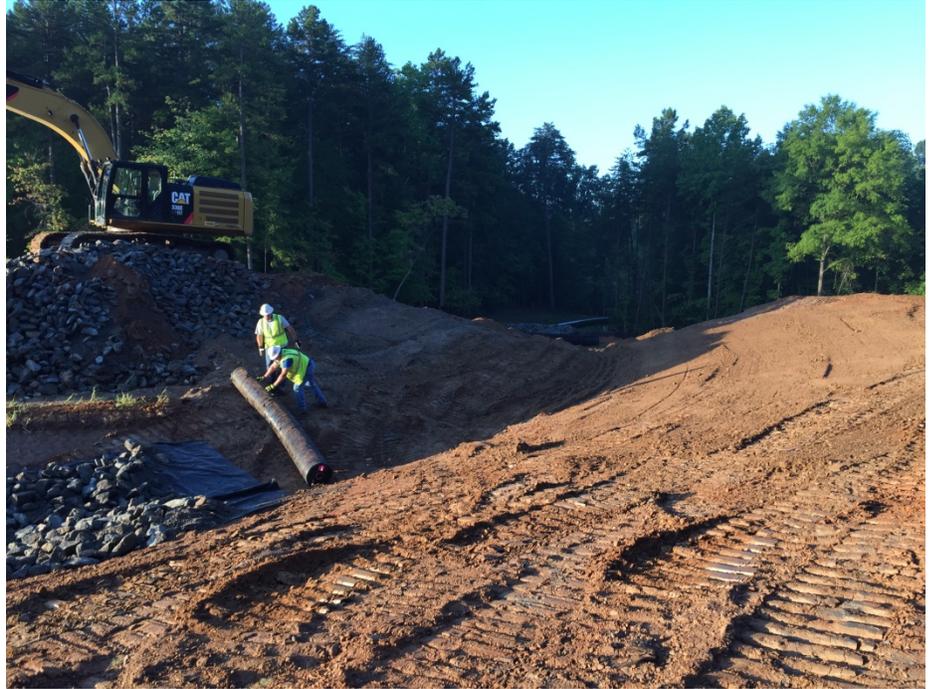
Photo 30 – Excavating of swale on main slope. 8/21/15

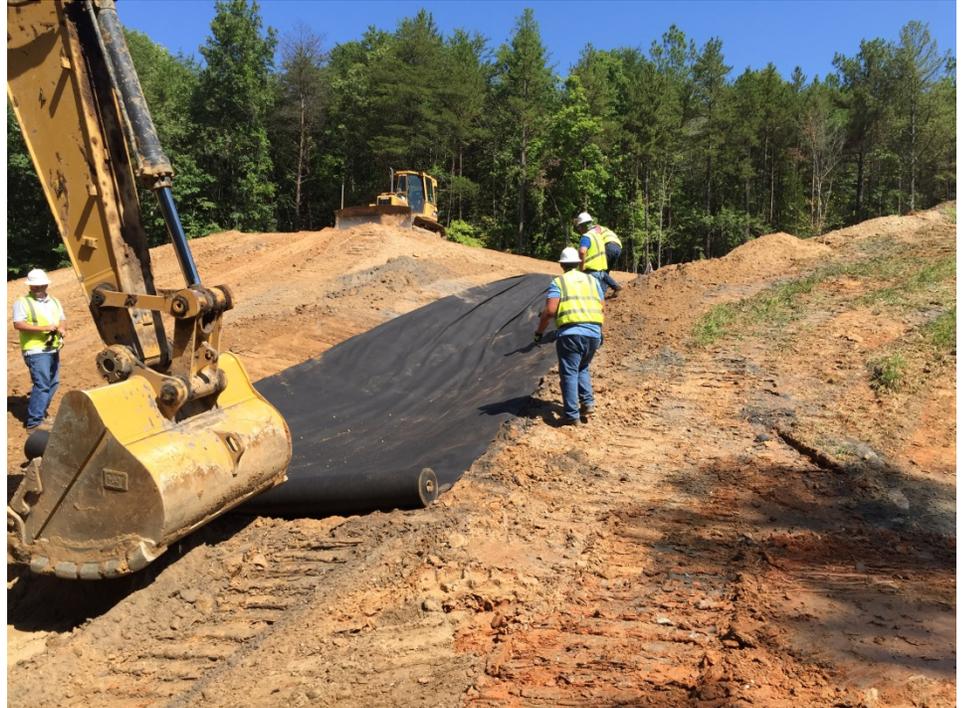
Photo 32 – Compacting swale subgrade at toe of slope to address ground movement. 8/24/15

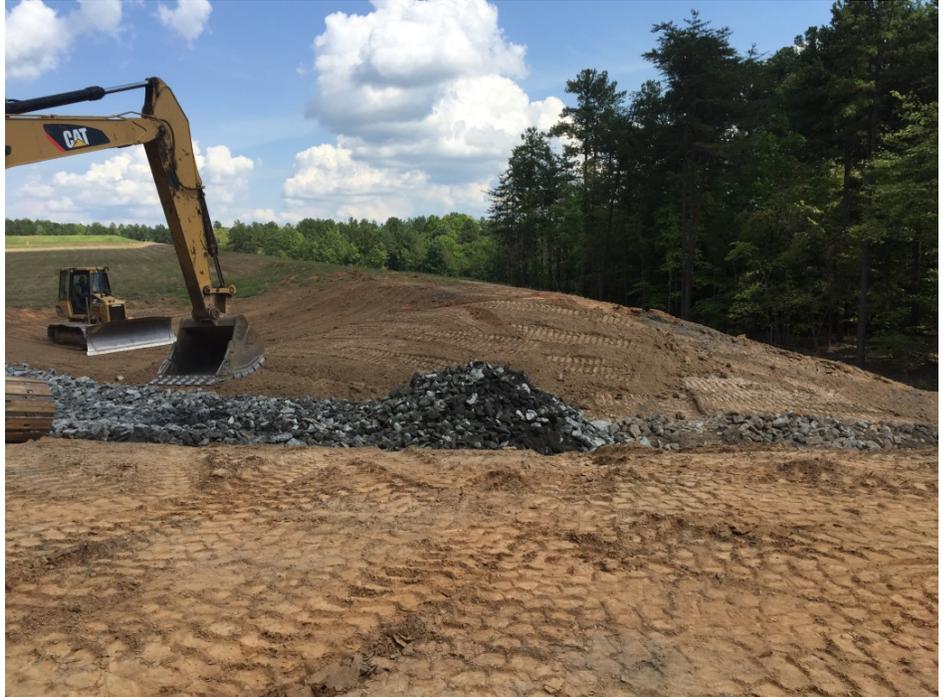
Photo 34 – Checking final slope and cover for swale northeast of crest. 8/24/15

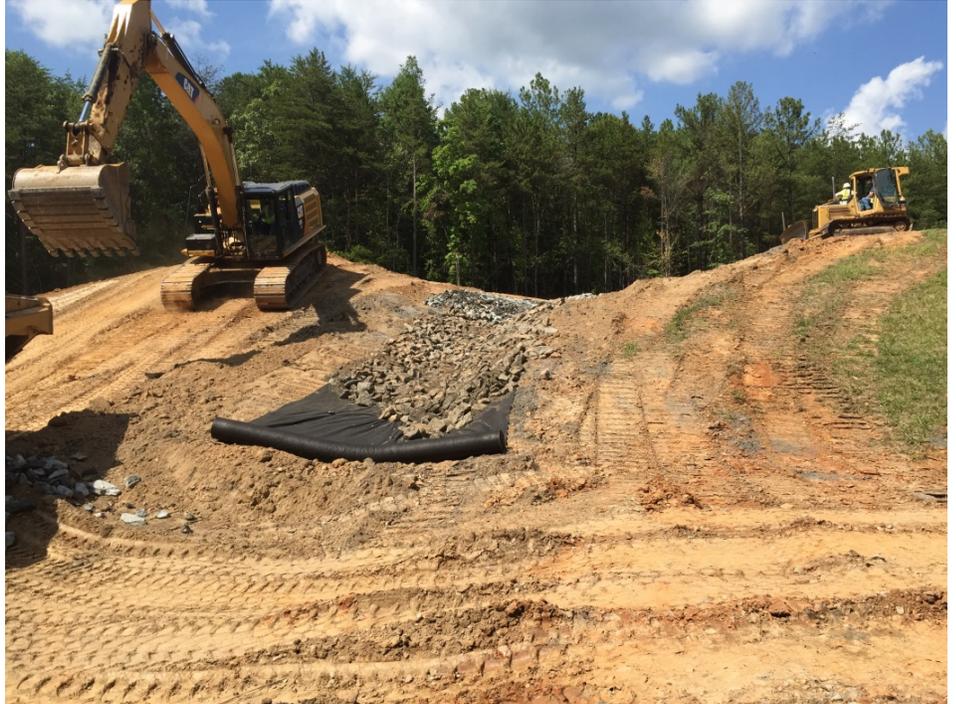
Photo 36 – Final grading on east side of new swale. 8/25/15

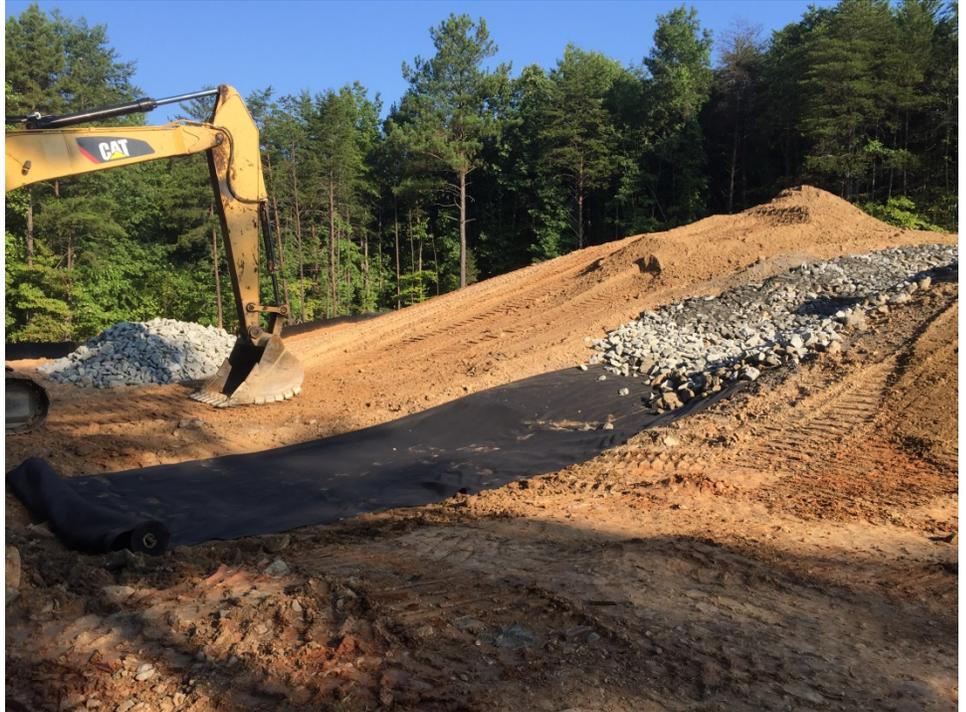
Photo 38 – Finishing rip rap and transitioning of new swale (foreground) to existing swale (background). Looking generally south. 8/25/15

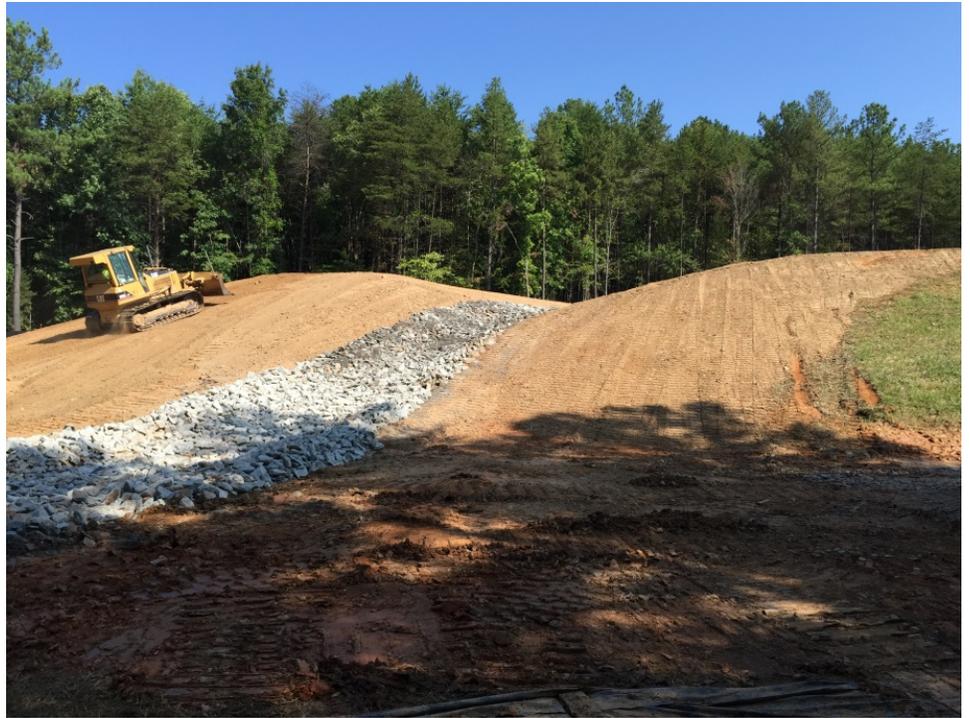
Photo 40 – Completed swale looking southwest prior to seeding. 8/25/15

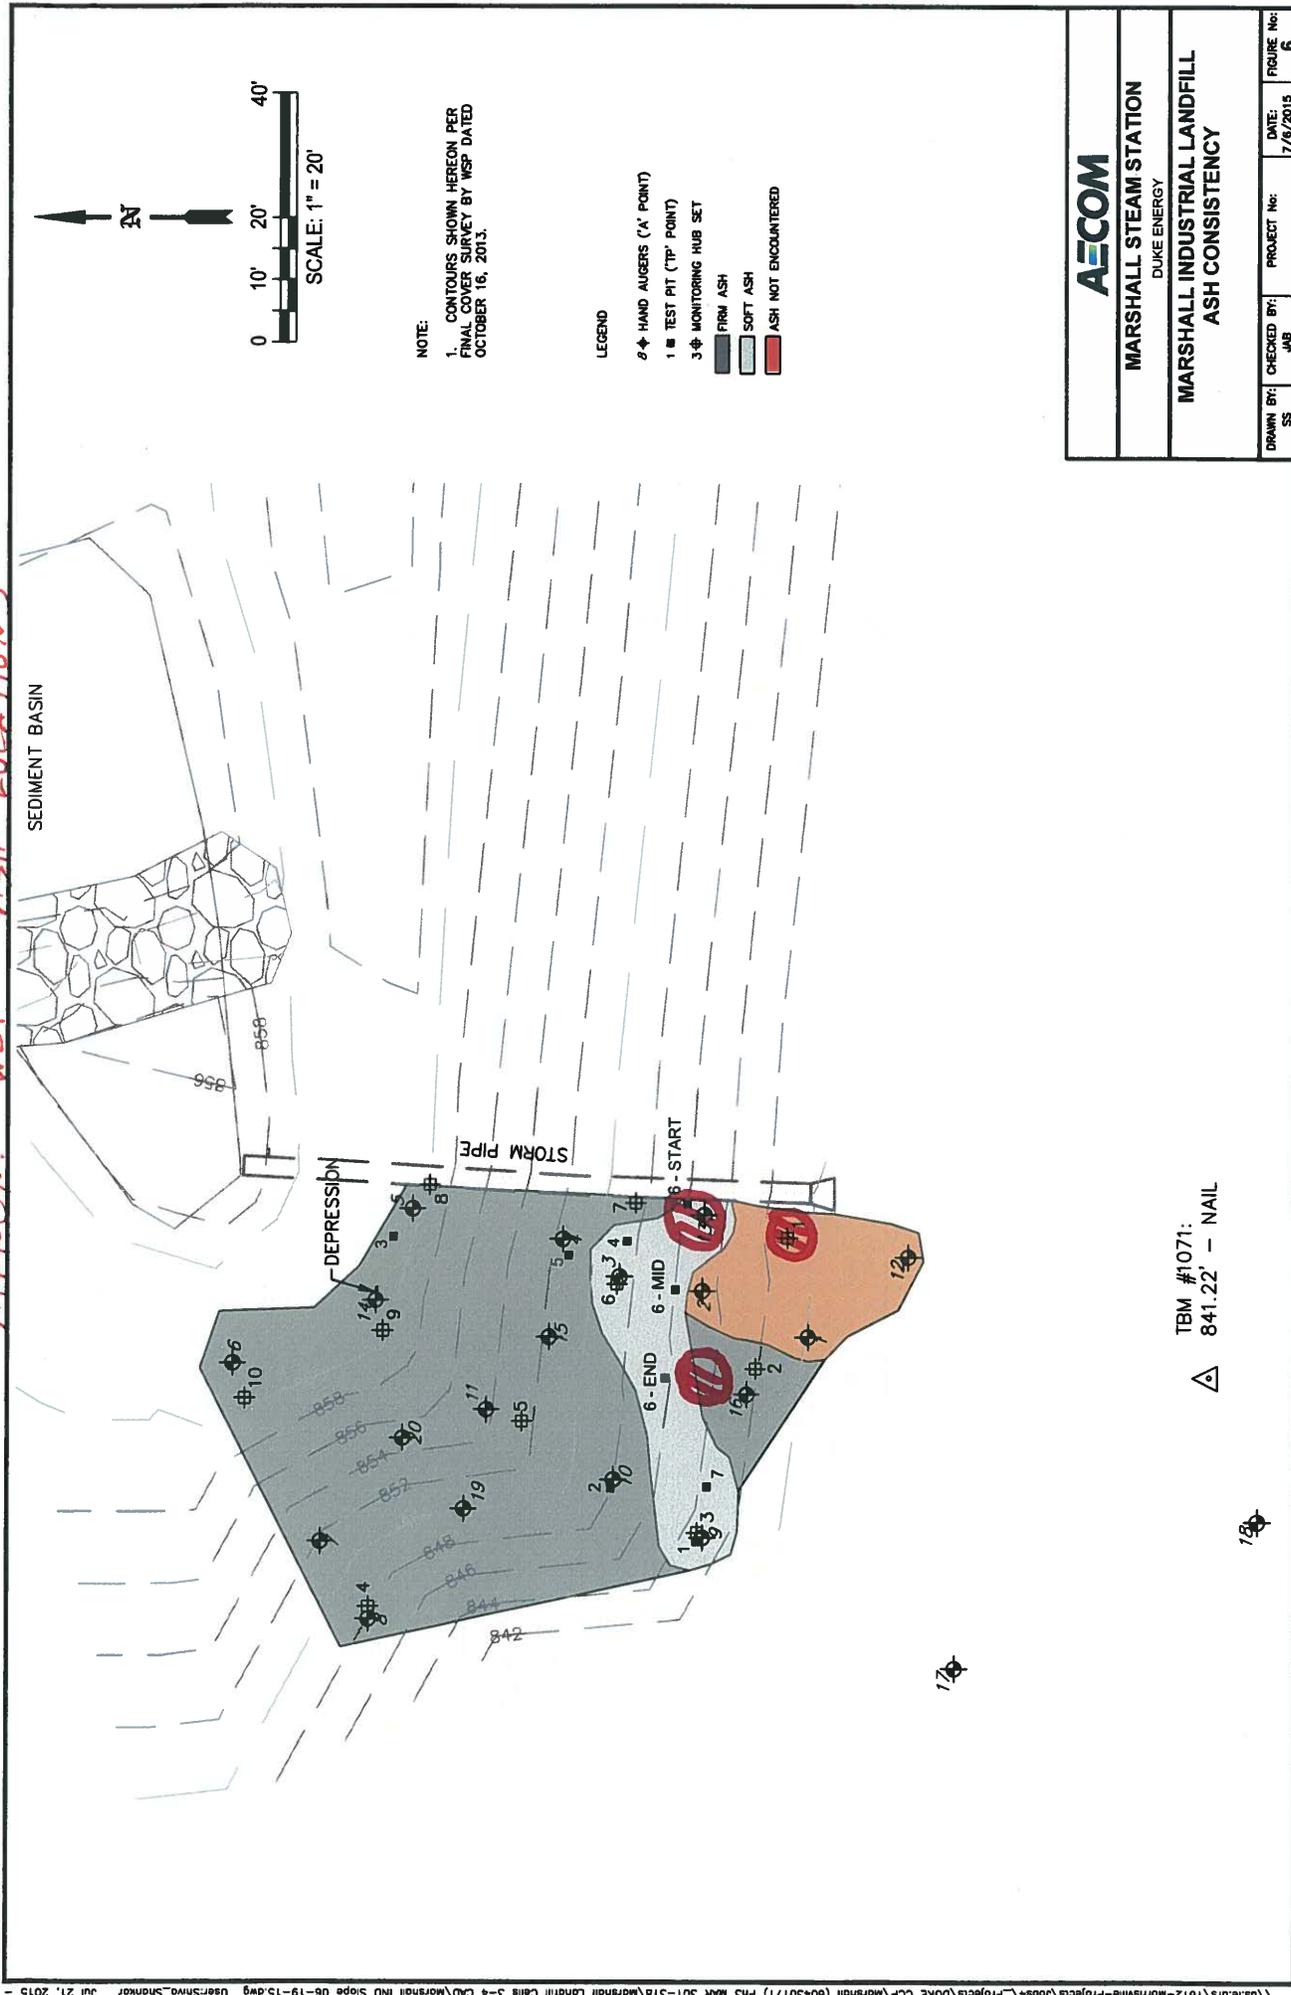
APPROX. "WET" ASH LOCATIONS
