FACILITY COMPLIANCE INSPECTION REPORT
Division of Waste Management
Solid Waste Section

Date of Site Inspection: December 12, 2014

Inert Disposal - Stump Dump LCID Landfill
 1017 Center Grove Church Road
 Moncure, NC 27559

Comprehensive Inspection (to ensure that the notified land clearing and inert debris (LCID) landfill is in compliance with 15A North Carolina Administrative Code (NCAC) 13B .0563, .0564, and .0566)

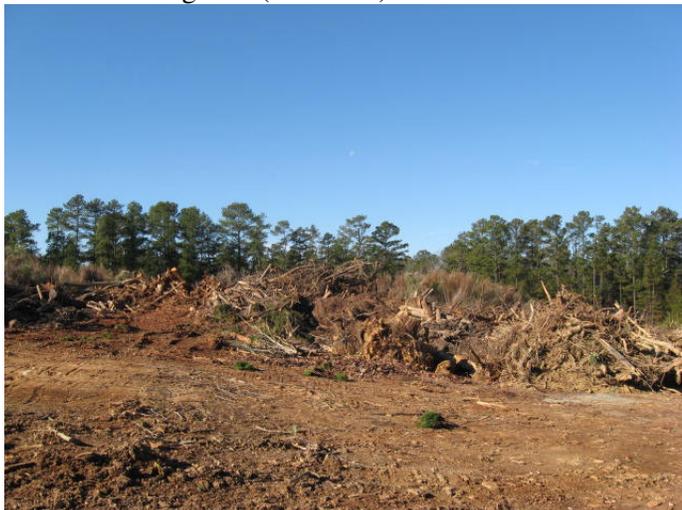
LCD at working face (rear view)

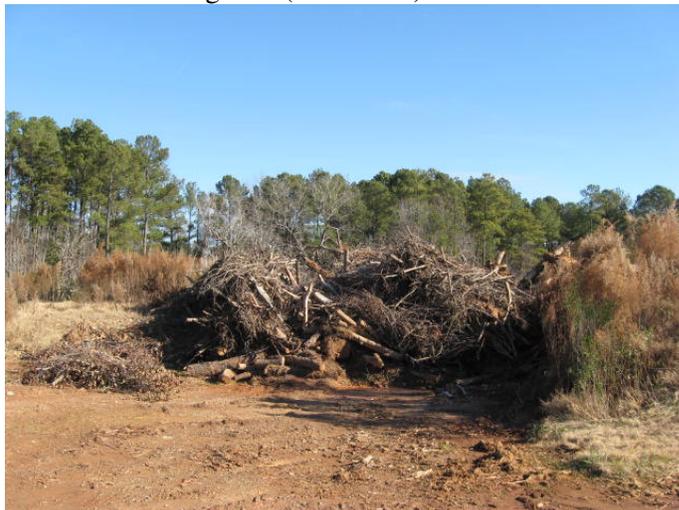
LCD at working face (front view)

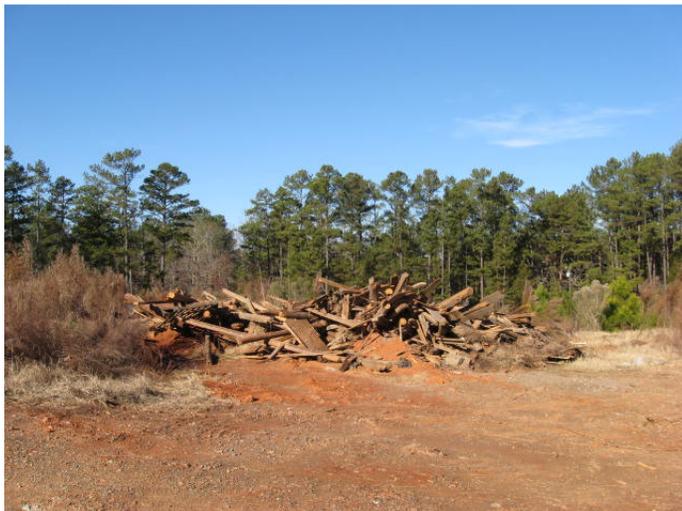
On December 12, 2014, SWS conducted an inspection of the Inert Disposal - Stump Dump LCID Landfill. A load of demolition debris was off-loaded at the LCID landfill adjacent to the working face. Mr. Candelori stated that the demolition debris is from a tobacco barn.

9. During the inspection demolition debris was observed at the LCID landfill. See "Observed Violations" for remediation requirement.
10. Per 15A NCAC 13B .0566(4), "Adequate soil cover shall be applied monthly, or when the active area reaches one acre in size, whichever occurs first."

Demolition debris – to be removed

By December 31, 2014, the facility shall remove the demolition debris and bring it to a disposal facility permitted to accept the waste. Disposal receipts shall be provided to SWS. Material from the demolition debris that can be reused or recycled may be segregated and stored for future use or brought to an end user. All demolition debris to be reused or recycled shall be free of additional material (nails, wires, metal, tar paper, etc.). Signed documentation of where the material went and how it will be used shall be provided to the SWS. This is a onetime option granted for the removal of the demolition debris from the landfill.

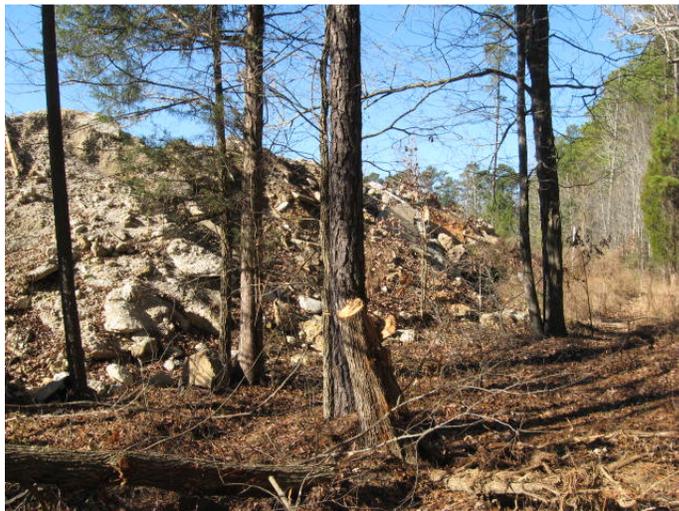
On December 12, 2014, SWS conducted an inspection of the Inert Disposal - Stump Dump LCID Landfill. Solid waste along a portion of the left side and left rear external side slopes was not adequately covered with soil. Solid waste at the working face was not covered with soil. Mr. Candelori acknowledged that most of the solid waste in question has not been adequately covered with soil monthly. He stated that he will rework the external side slopes to ensure solid waste is adequately covered with soil and cover the solid waste at the working face.

7. During the inspection solid waste along a portion of the left side and left rear external side slopes was not adequately covered with soil. Solid waste at the working face was not adequately covered with soil monthly. See "Observed Violations" for remediation requirement.

Material to be covered with soil - left side external side slope

By January 30, 2015, the facility shall rework and adequately cover with soil the solid waste along the left side and left rear external side slopes and cover with soil solid waste at the working face that has not been covered monthly.

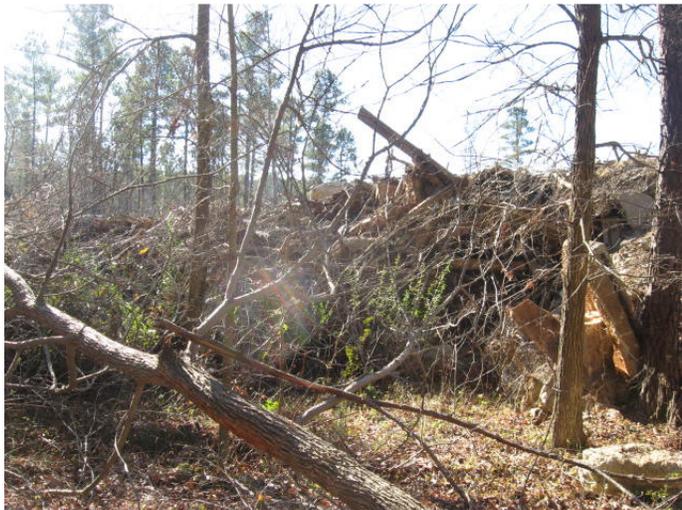
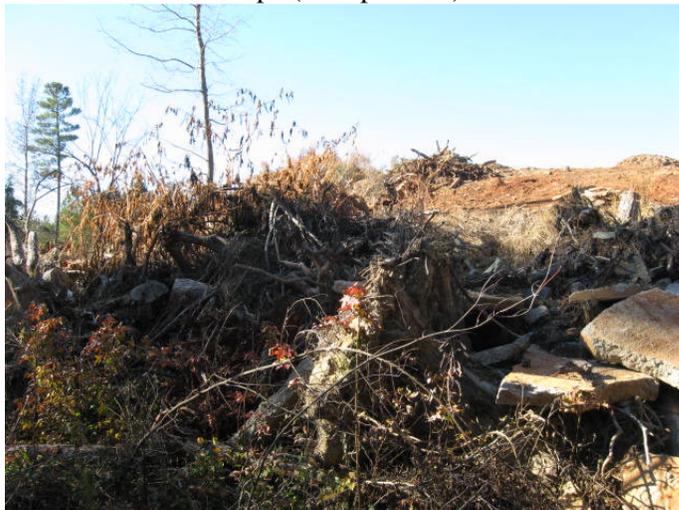
Material to be covered with soil - left rear external side slope (both pictures)
