FACILITY COMPLIANCE INSPECTION REPORT
Division of Waste Management
Solid Waste Section

Date of Inspection: 17 February 2016

Carteret County MSW Landfill
 Landfill Road
 Newport, NC

1602-20160217INSP
Page 2 of 4

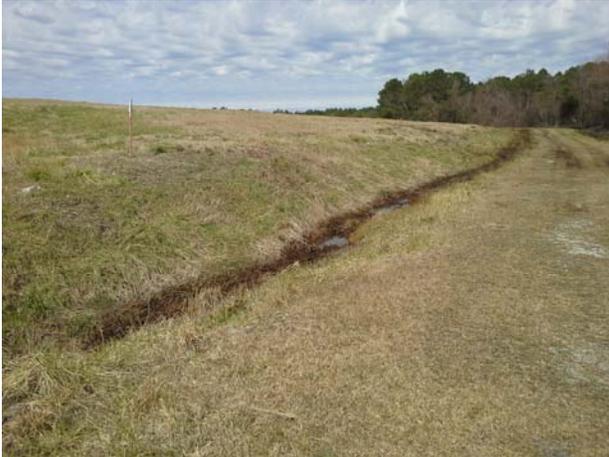
- 1) This Facility is a closed Municipal Solid Waste (MSW) Landfill.
- 2) The Facility access road is of all-weather construction and is being well maintained at this time.
- 3) The site is secured by a locked gate at the Facility entrance. The gate was closed and locked upon my arrival and the Facility was secured from unauthorized access during this Facility Compliance Site Inspection.
- 4) No attendant was on-site during this Facility Compliance Inspection.
- 5) The perimeter surface water drainage ditch is being maintained clear of brush and woody vegetation providing for positive drainage of surface waters from the Facility.

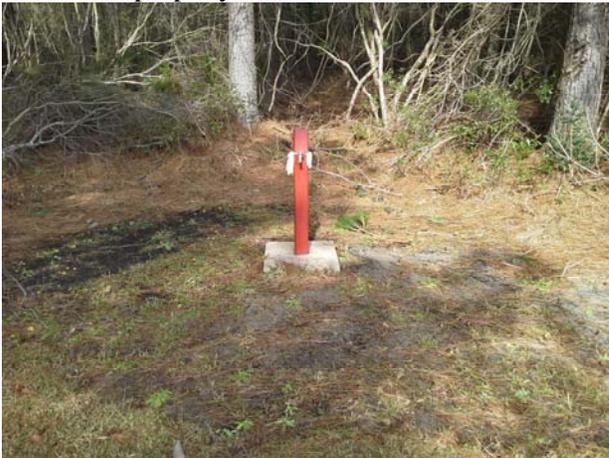
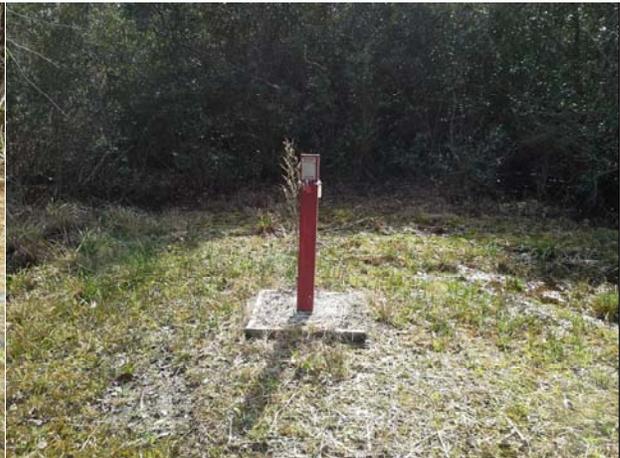
- 6) An all-weather perimeter road is maintained around the landfill for access to the Facility monitoring wells and to perform Facility maintenance and inspections.
- 7) The Facility groundwater monitoring wells were reviewed during this Facility Compliance Inspection. All the wells were properly labeled, secured with locks, and had well maintained access.

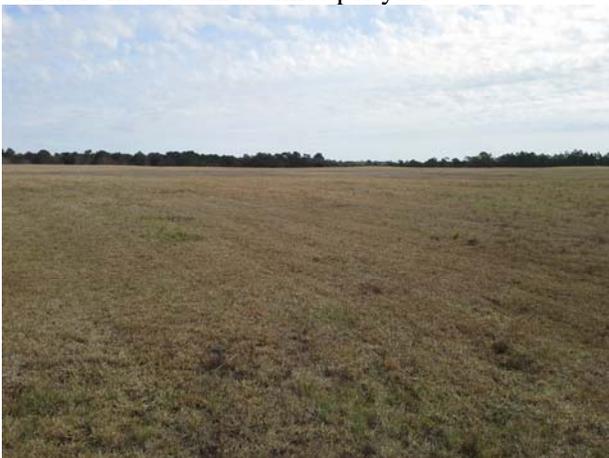
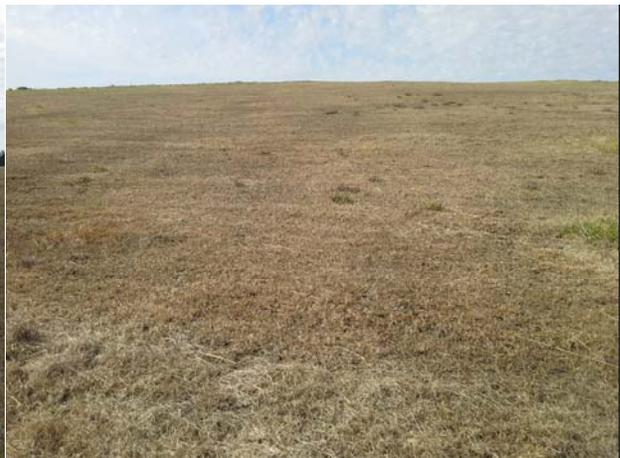
- 8) Soil has been stockpiled adjacent to the landfill access road for use in repair and maintenance of the landfill cap system.
- 9) Highly visible edge-of-waste markers have been installed and are being maintained throughout the Facility as required.
- 10) Overall, the landfill has a well-established and well maintained cover crop of native warm season grasses which is mowed three times per year.

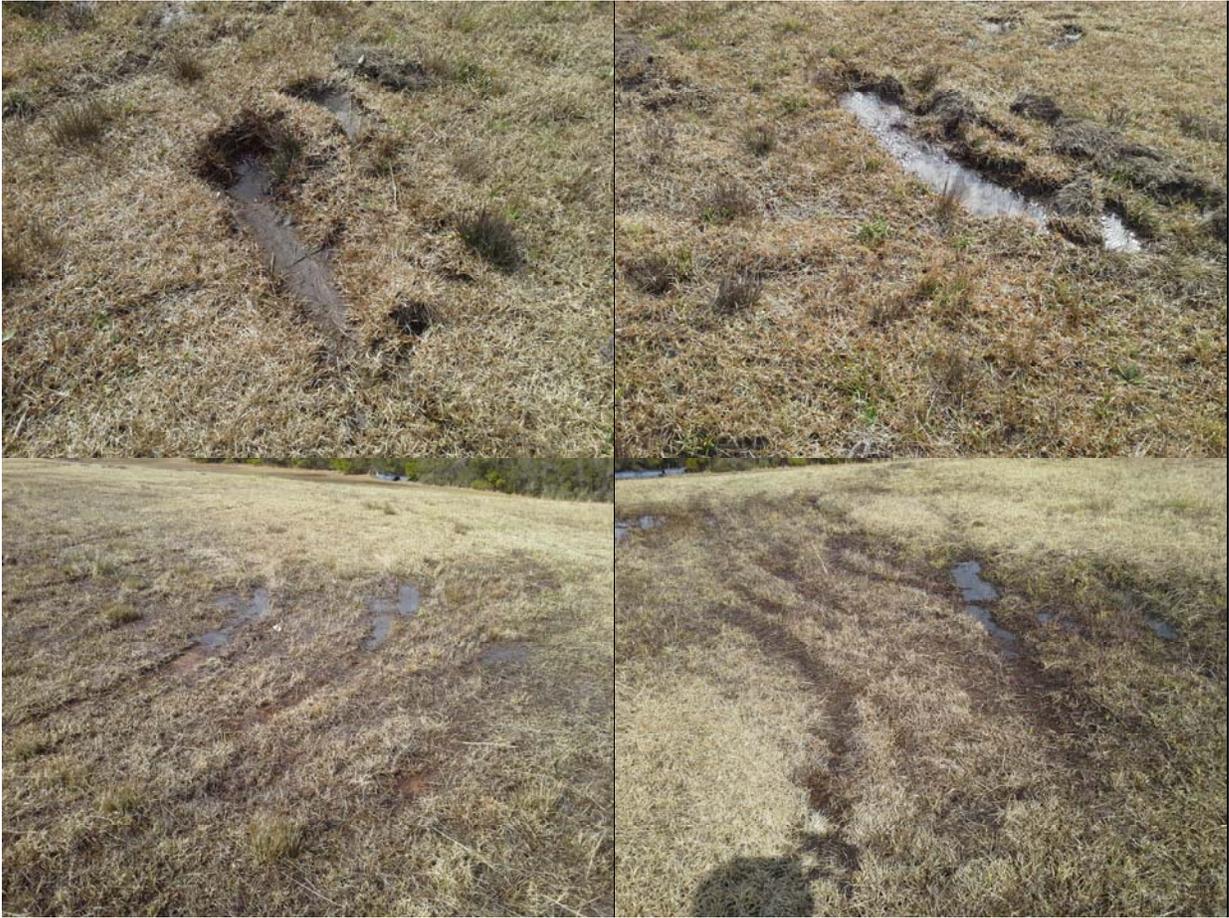
- 11) The landfill sideslopes are being maintained clear of trees and other woody vegetation.
- 12) Some damage to the cover crop from maintenance equipment was observed on the top lift of the landfill.

*Please repair these areas by grading, seeding, and mulching as soon as possible.

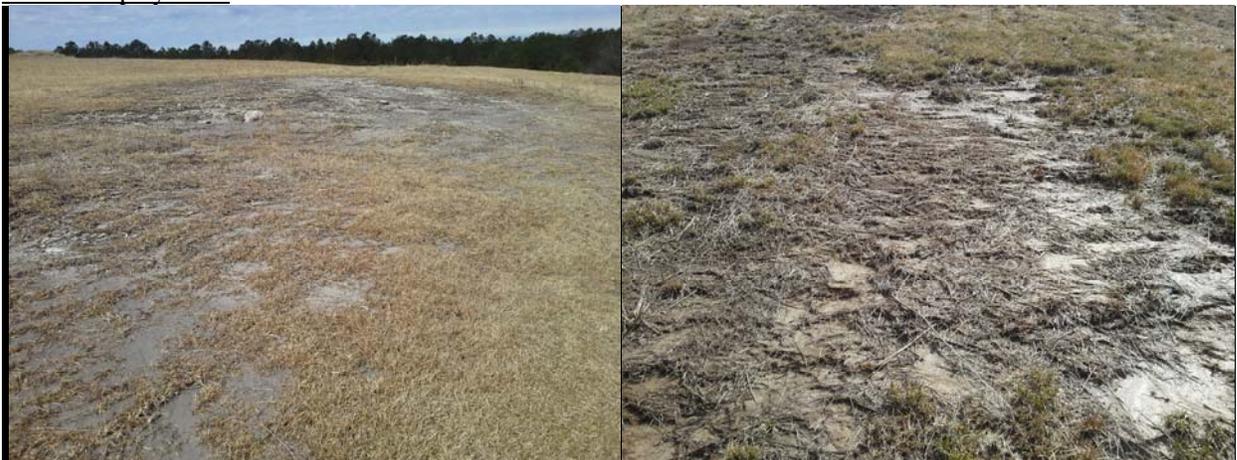
- 13) Several areas of sparse cover crop were noted in various places around the top lift of the landfill. *Please repair these areas by seeding and mulching to establish a cover crop suitable to prevent erosion of your landfill cap system.

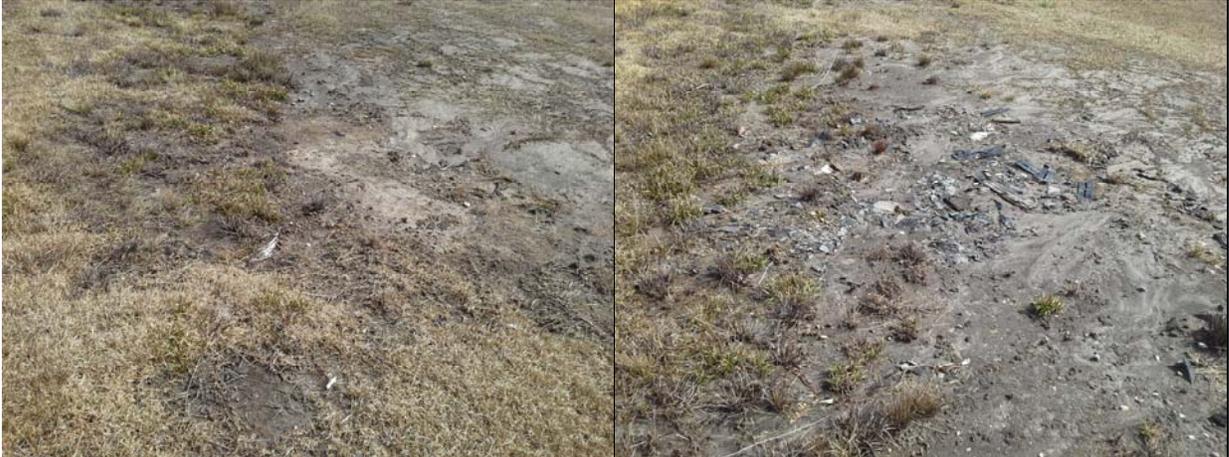
- 14) Areas of erosion were noted on the southeastern and northwestern landfill sideslopes. *Please work to repair these eroded areas by grading, seeding, and mulching as necessary to establish a groundcover suitable to prevent erosion of your landfill cap system. All repaired areas should be graded at a slope not greater than 3:1.

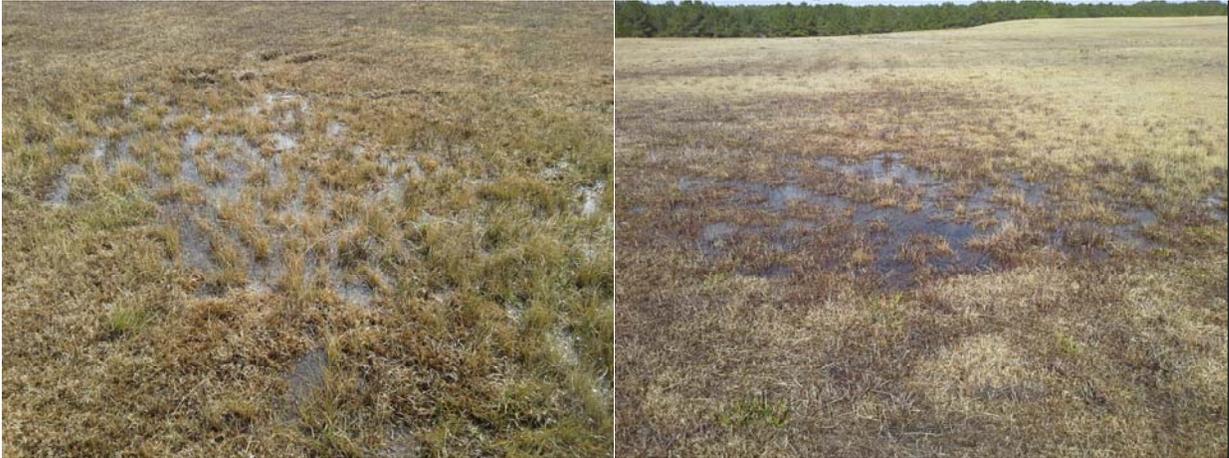
- 15) Areas of differential settlement were observed around the top lift of the landfill. Some of these areas were observed as retaining surface waters. *To prevent the ponding of surface waters on the landfill, please fill and grade these areas at a slope not greater than 3:1. All filled and graded areas should be seeded and mulched to establish a groundcover suitable to prevent erosion of your landfill cap system.
