FACILITY COMPLIANCE INSPECTION REPORT
Division of Waste Management
Solid Waste Section

Date of Site Inspection: July 27, 2015

Old Coca Cola Plant
 Hwy 158
 Weldon, NC 27890

CCB fill site, no permit required

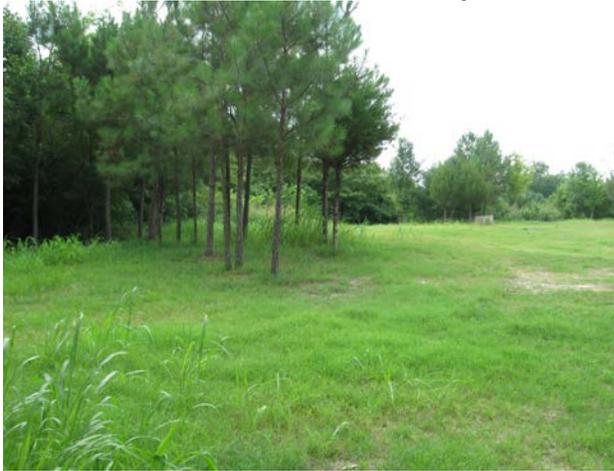
Looking towards river

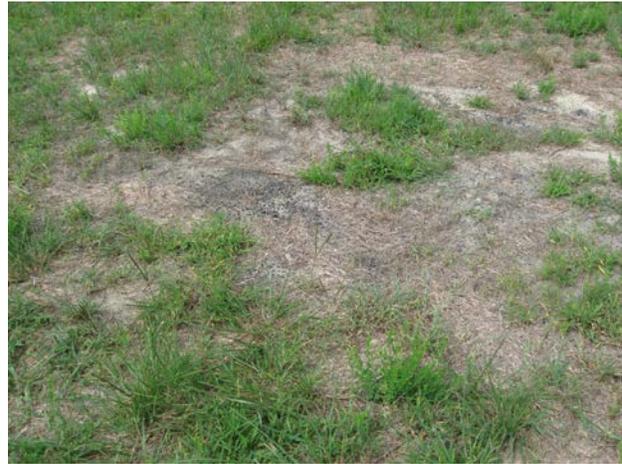
1. The exact extent of the actual coal ash fill area is not known. The site appears to have a good ground cover established. There are many trees established closer to the river. There are a few small areas running approximately 40 feet, parallel to the road and towards the bridge, where **12 inches of soil and an additional 6 inches of soil capable of growing ground cover needs to be added, as it appears that coal ash is exposed. This work must be done within 30 days of receipt of this report.**

Exposed ash towards road

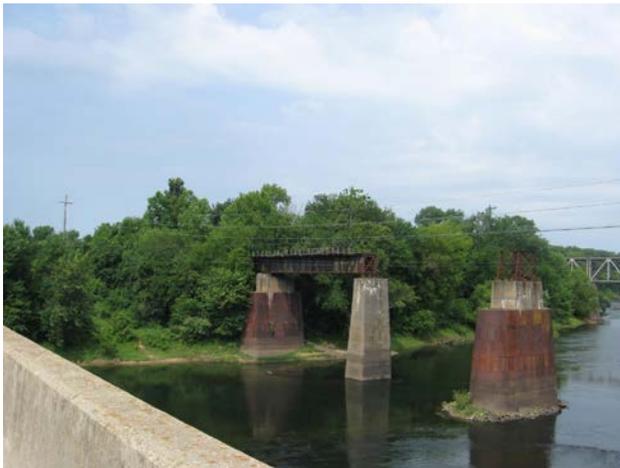
Looking across river to site
