FACILITY COMPLIANCE INSPECTION REPORT
Division of Waste Management
Solid Waste Section

Date of Inspection: 17 February 2016 Date of Last Inspection: 21 July 2015

Rouse's Septic Tank Service LCID
Gloria Dawn Road
Morehead City, NC 28557

N0084-20160217INSP

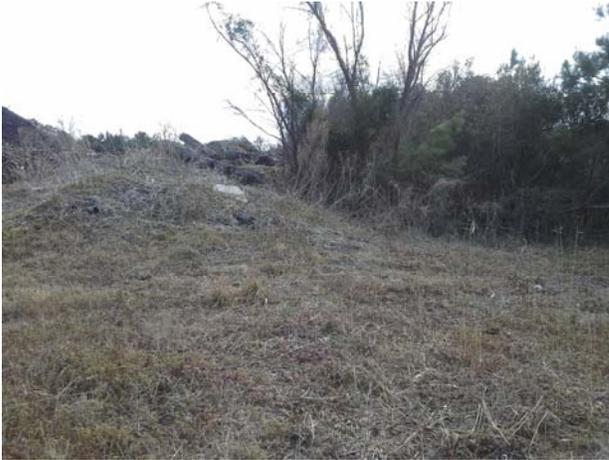
- 9) Overall, the landfill has been covered with native warm season grasses and/or a natural coppice-type cover.
 - 10) The area around the toe of the landfill is inaccessible in several areas. *Please mow and remove any brush, trees, and other woody vegetation growing in the access around the toe of the landfill for proper inspection and maintenance of the landfill cap.

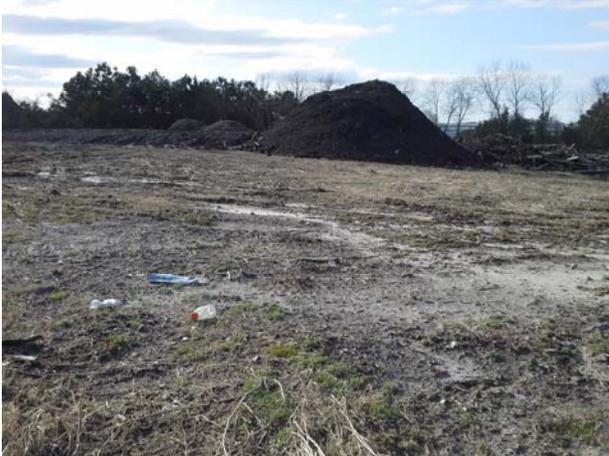
- 11) Soil has been stockpiled at the working face for use in cover and maintenance operations.

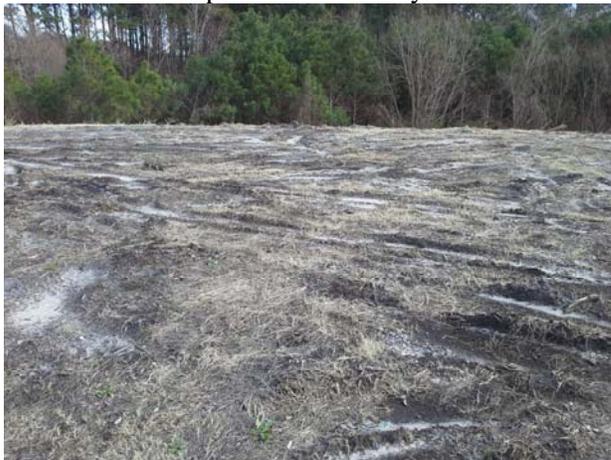
- 12) The landfill working face is less than one acre and is being maintained in a compact and manageable size. Portions of the top lift have recently been covered and graded.

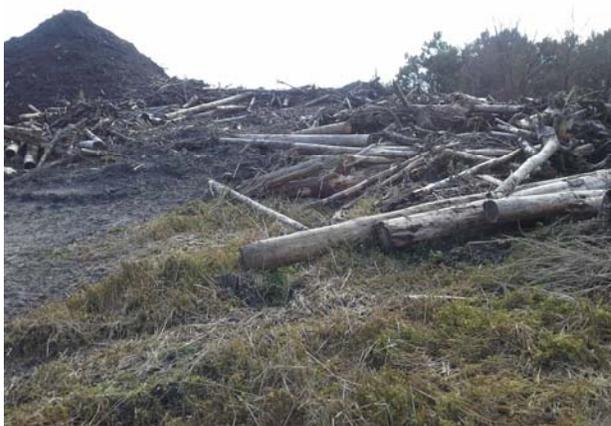
- 13) The waste type being disposed is LCID waste only; no unacceptable waste streams were observed during this Facility Compliance Inspection. *Please ensure that all waste is compacted, covered and graded monthly or when the active working area reaches one acre in size, whichever occurs first.

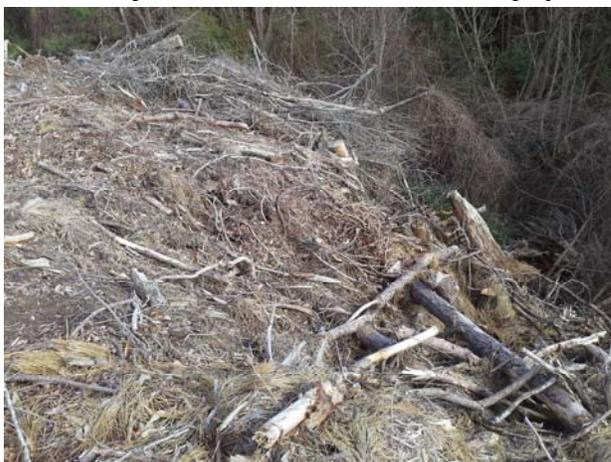
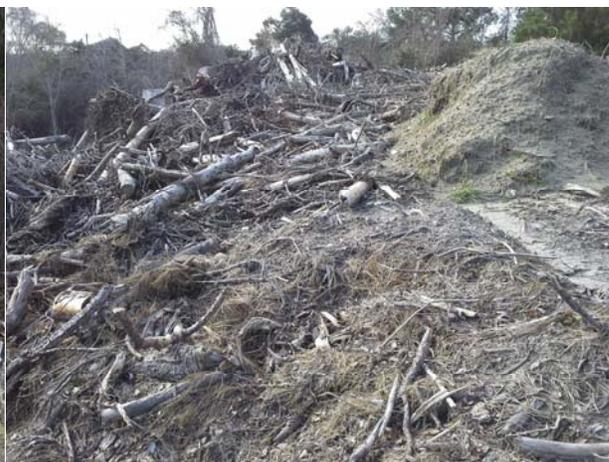
- 14) The outside slopes have not been compacted and covered as required. *Please ensure that all outside slopes are covered and graded at a slope not greater than 3:1, and are seeded and mulched to establish a groundcover suitable to prevent erosion of the landfill cap system.
