**HAZARDOUS WASTE SECTION - COMPLIANCE BRANCH
FILE TRANSMITTAL & DATA ENTRY FORM**

Facility Name: Wise Recycling

File Description/Comments: Self-Disclosure to UST & Hazardous Waste Sections, DWM, DEQ

Re: Wise Recycling LLC, Clayton, NC — Voluntary Self-Disclosure
under DENR's Self-Disclosure Policy

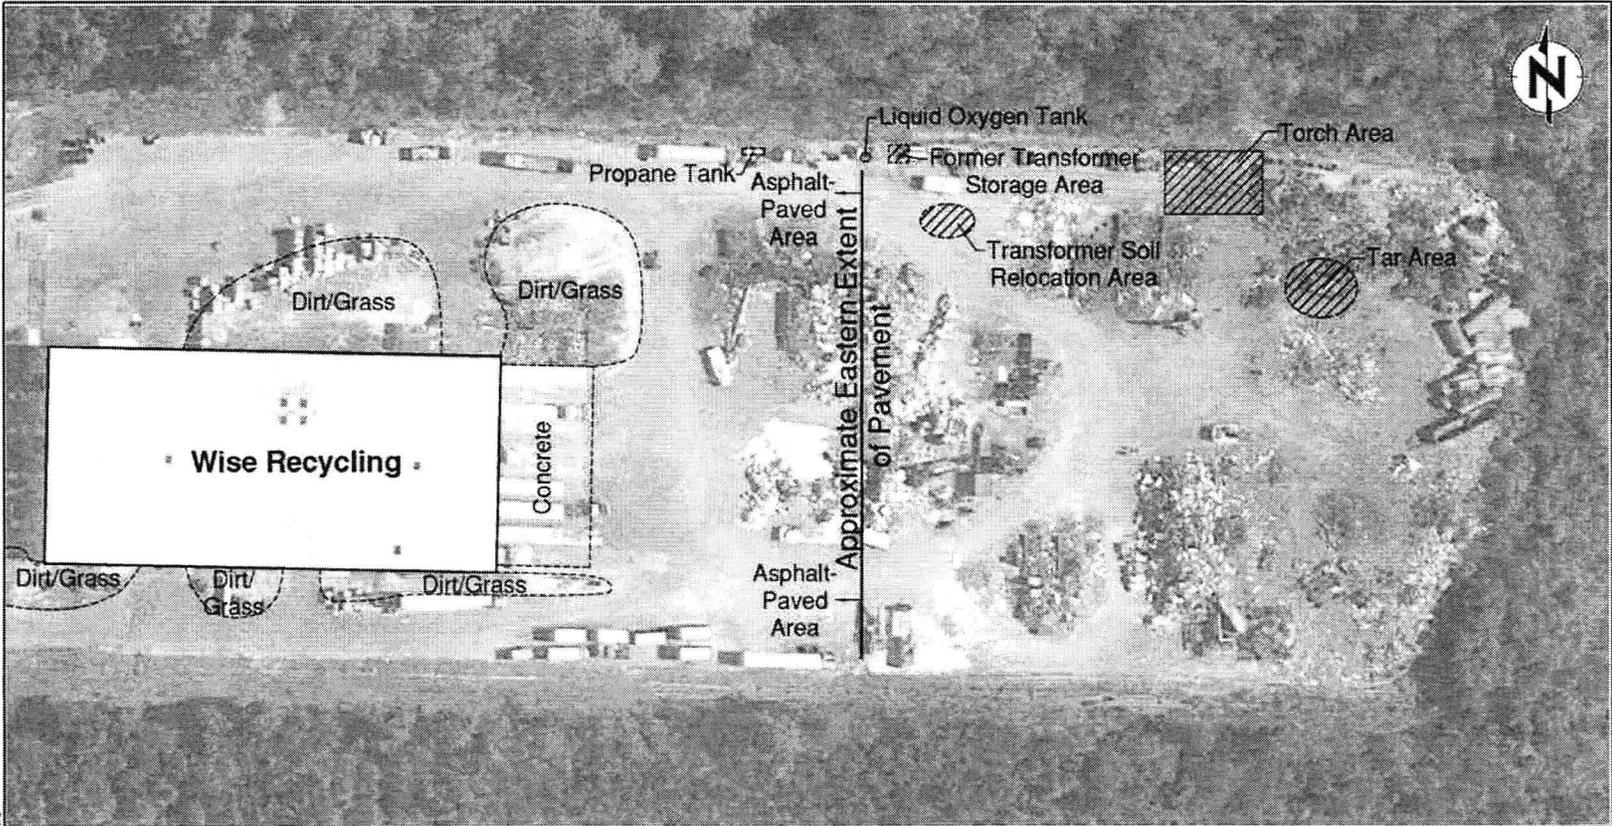
Figure
1

Site Layout
Wise Recycling
 Clayton, North Carolina

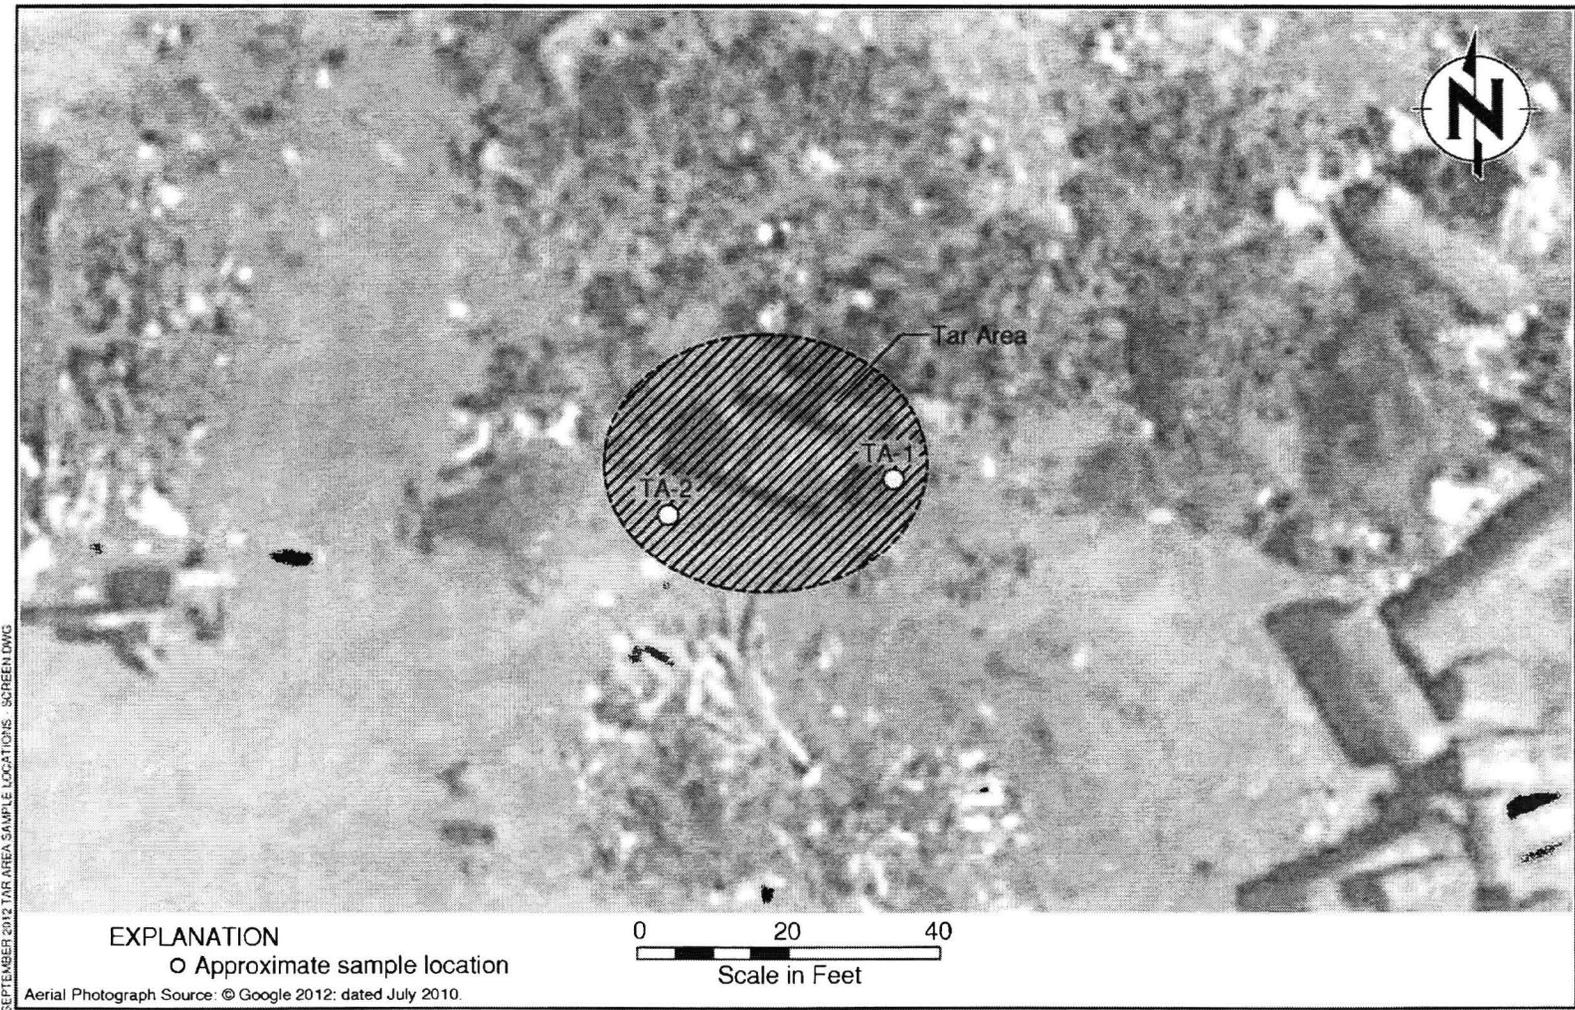
Figure
2

In addition, during the self-audit Wise learned that material appearing to be road tar (or similar material) reportedly had leaked or spilled from a single tank truck or trailer. The tar is believed to have been contained at a single location near the back of the scrap yard.

During the self-audit, the presence of the tar was confirmed visually, initially in August 2012, and again during a September 2012 site inspection and targeted soil sampling event. The results of analysis of those samples confirm that the material is, or is similar to, road tar. A summary of those results and depictions of the sampling locations are attached hereto as **Attachment A**.

September 2012 Tar Area Sample Locations
 Wise Recycling
 Clayton, North Carolina

In follow-up to the self-audit, all incoming junk vehicles are now checked to ensure that all fluids have been removed, and, if fluids are found, they will be handled properly. And, as discussed at the November 19, 2012 meeting, Wise intends to arrange for the removal and proper disposition of the above-referenced tar at an appropriate offsite facility, and to evaluate and address any soil impacts in accordance with applicable USEPA and DENR guidance. ENVIRON has been retained to perform this work.

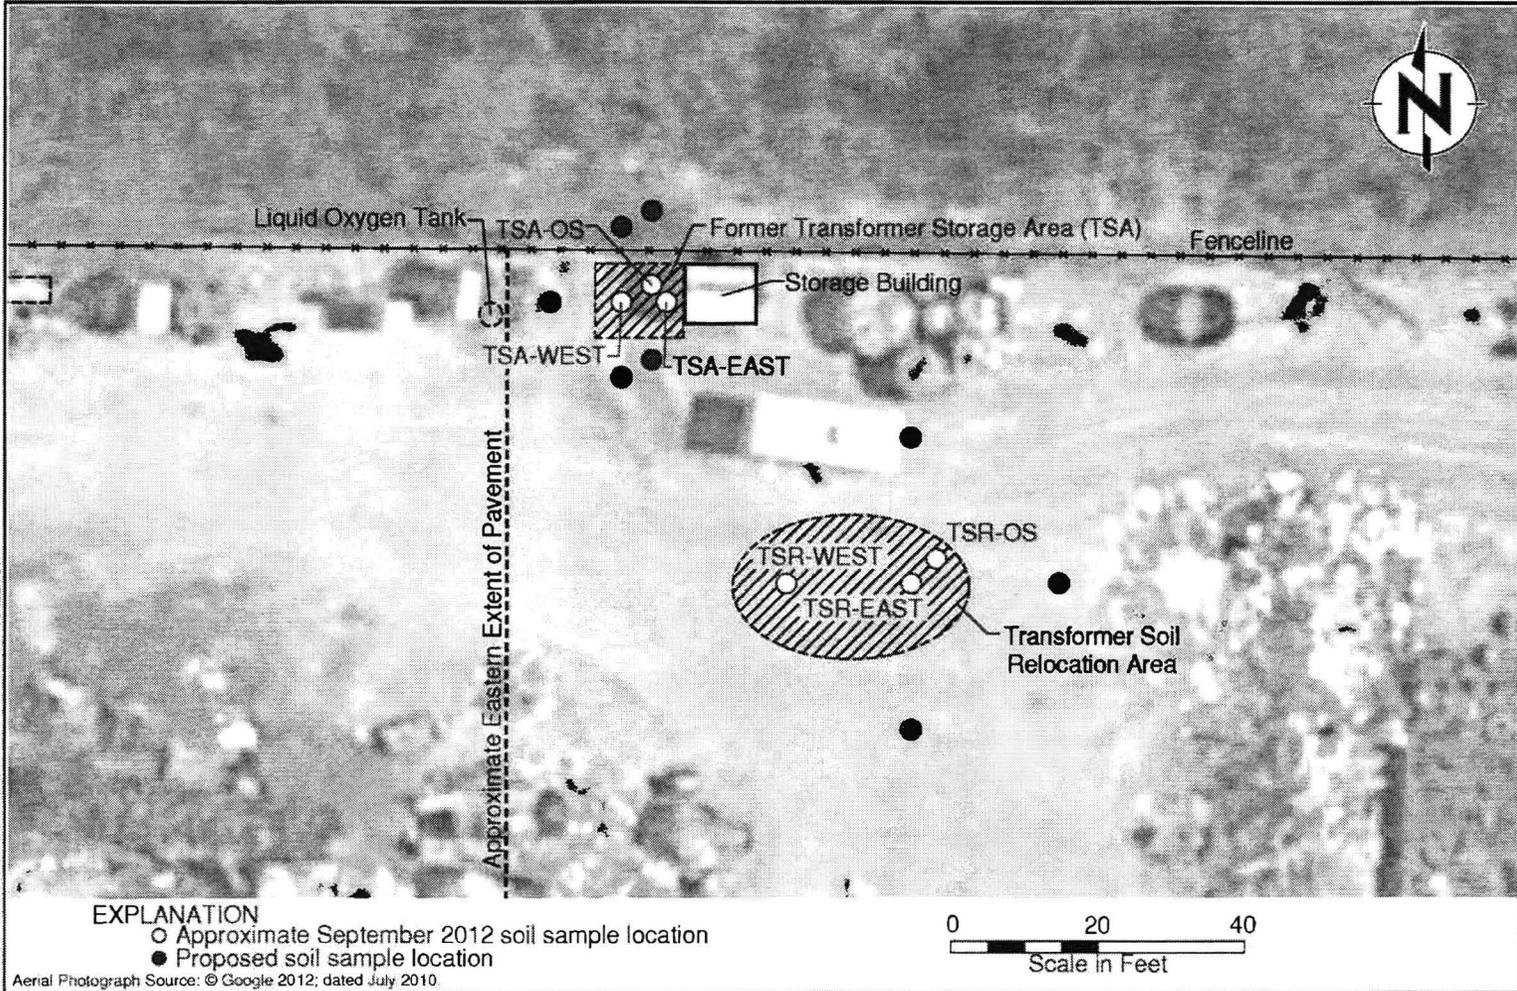
Figure
3

Wise also received information that a transformer that appeared to contain fluid was present for several months at the site and was reportedly observed to be leaking at the top of the unit. The age, origin, and polychlorinated biphenyl (PCB) content, if any, of the transformer are not known. The transformer, which was staged in the northern portion of the scrap yard, was removed from the site earlier this year. Soil from the area where the transformer was situated reportedly was subsequently moved to an interior area of the yard.

As part of the self-audit, soils were sampled in the former transformer storage area and the soil relocation area (in September 2012). The test results indicate the presence of PCBs at low concentrations (up to 3.79 milligrams per kilogram [mg/kg]). Based on the low concentrations of PCBs observed in the soil samples, it is unlikely that the transformer contained PCB oils. A summary of those results and depictions of the sampling locations are attached hereto as **Attachment A**.

September 2012 Transformer Area Sample Locations
 Wise Recycling
 Clayton, North Carolina

As discussed at the November 19, 2012 meeting, Wise intends to evaluate and address any soil impacts in the former transformer staging area and soil relocation area, in accordance with applicable USEPA and DENR guidance. ENVIRON has been retained to perform this work. In the short term, as part of such work, soil located in the former transformer storage area and the soil relocation area has been roped-off/isolated to prevent disturbance by vehicular traffic and prevent worker contact.
