MEMORANDUM

Re: Semi-Annual RCRA Post-Closure Inspection
Former Ashland Distribution Company Facility
2802 Patterson Street,
Greensboro, North Carolina
Facility ID # NCD 024 599 011

ATTACHMENT 1
PHOTOGRAPHIC LOG
FORMER ASHLAND INC. DISTRIBUTION FACILITY
2802 PATTERSON STREET
GREENSBORO, NORTH CAROLINA
FACILITY ID # NCD 024 599 011

ATTACHMENT 2
Post-Closure Inspection Checklist
Former Underground Hazardous Waste Tank
Ashland Chemical, Inc
Greensboro, North Carolina

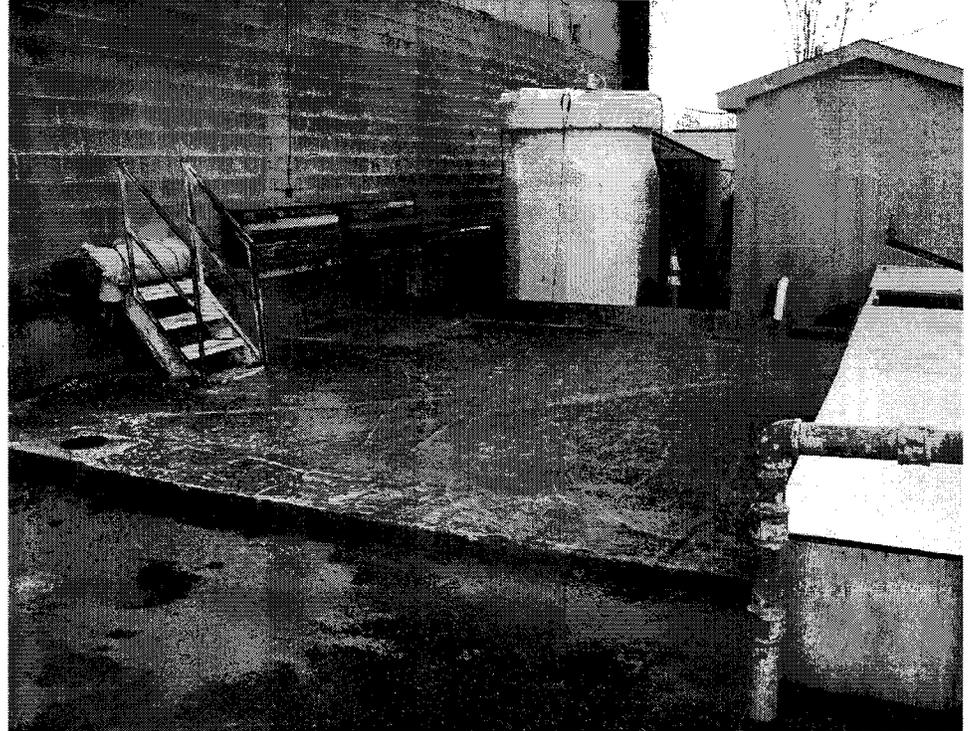
- The facility is enclosed by a fence and the access gate located off Patterson Street was secured by a chain and padlock upon arrival. The cap was in good condition with no observable damage or cracks.
- No standing water was observed on the cap.
- No materials are currently stored on the cap.

Photo 1:
East view of RCRA
pad.

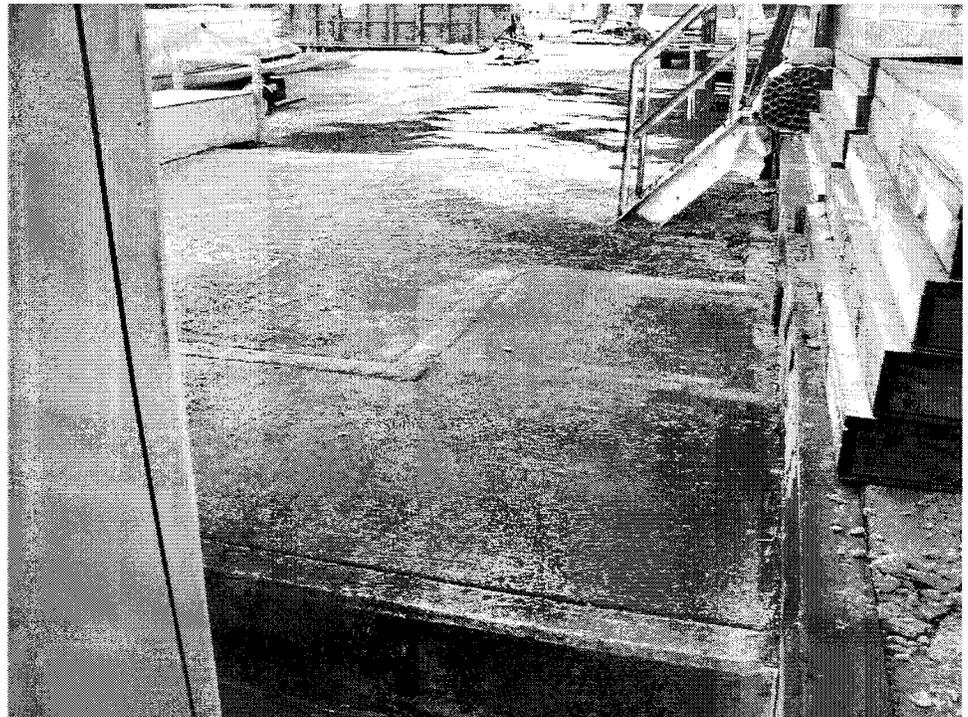
Photo 2:
West view of RCRA
pad.
