Hazardous Waste Section
File Room Document Transmittal Sheet

MEMORANDUM

Re: 2013 Annual RCRA Post-Closure Inspection
Former Ashland Distribution Company Facility
1415 South Bloodworth Street
Raleigh, North Carolina
Facility ID # NCD 088 560 032

ATTACHMENT 1
PHOTOGRAPHIC LOG
FORMER ASHLAND DISTRIBUTION COMPANY FACILITY
1415 SOUTH BLOODWORTH STREET
RALEIGH, NORTH CAROLINA
FACILITY ID # NCD 088 560 032

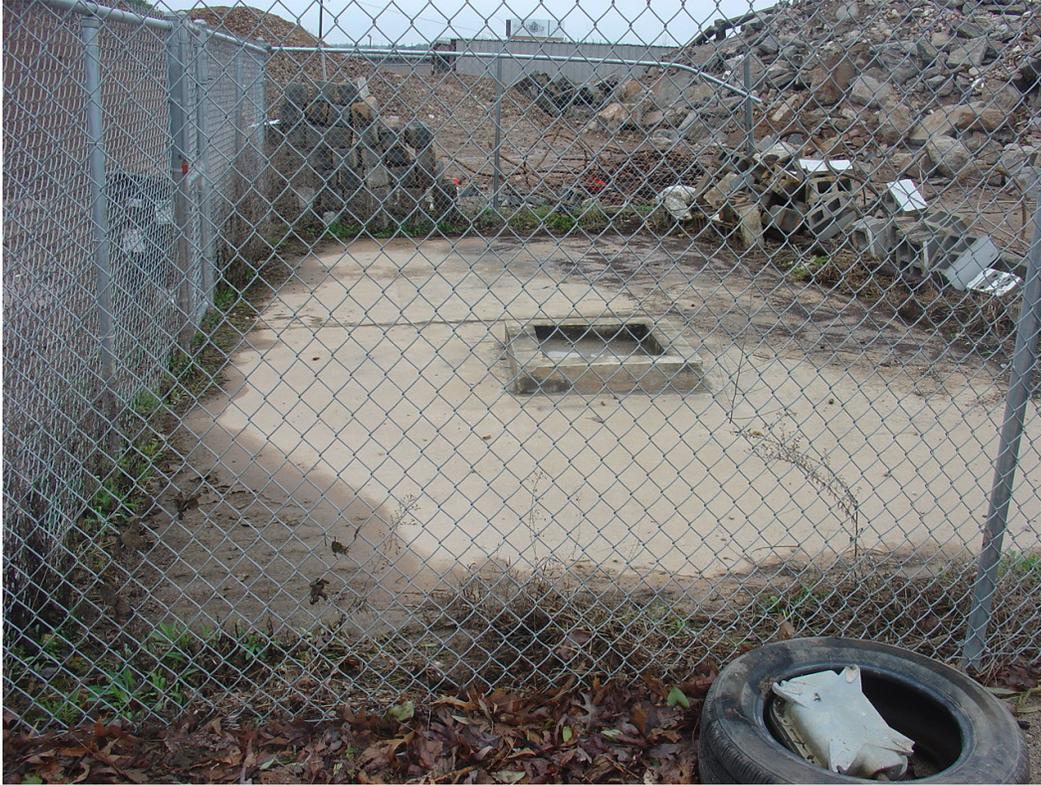
Photo 1. View of RCRA cap, facing south.

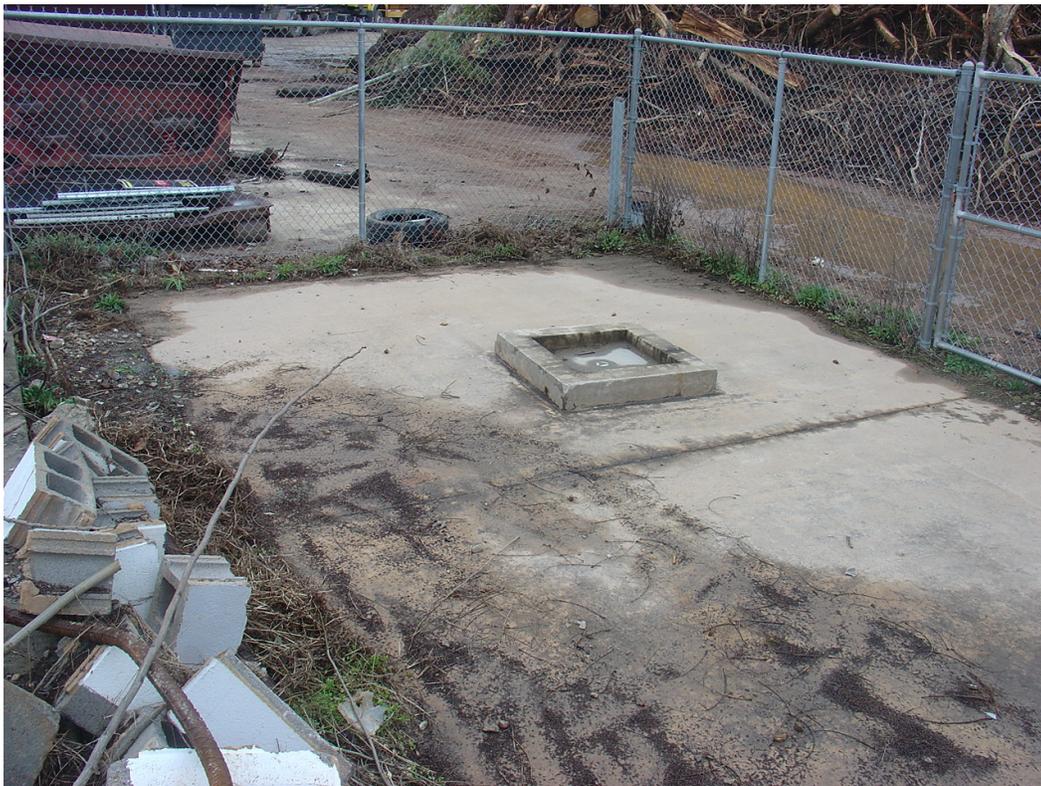
Photo 2. View of RCRA cap, facing north.
