Asbestos Survey Former Precision Dynamics Facility

1033 Carter Avenue
Charlotte, North Carolina

H&H Job No. CHP-013
December 12, 2013

RE: Asbestos Survey
Former Precision Dynamics Property
1033 Carter Avenue
Charlotte, North Carolina
H&H Job No. CHP-012

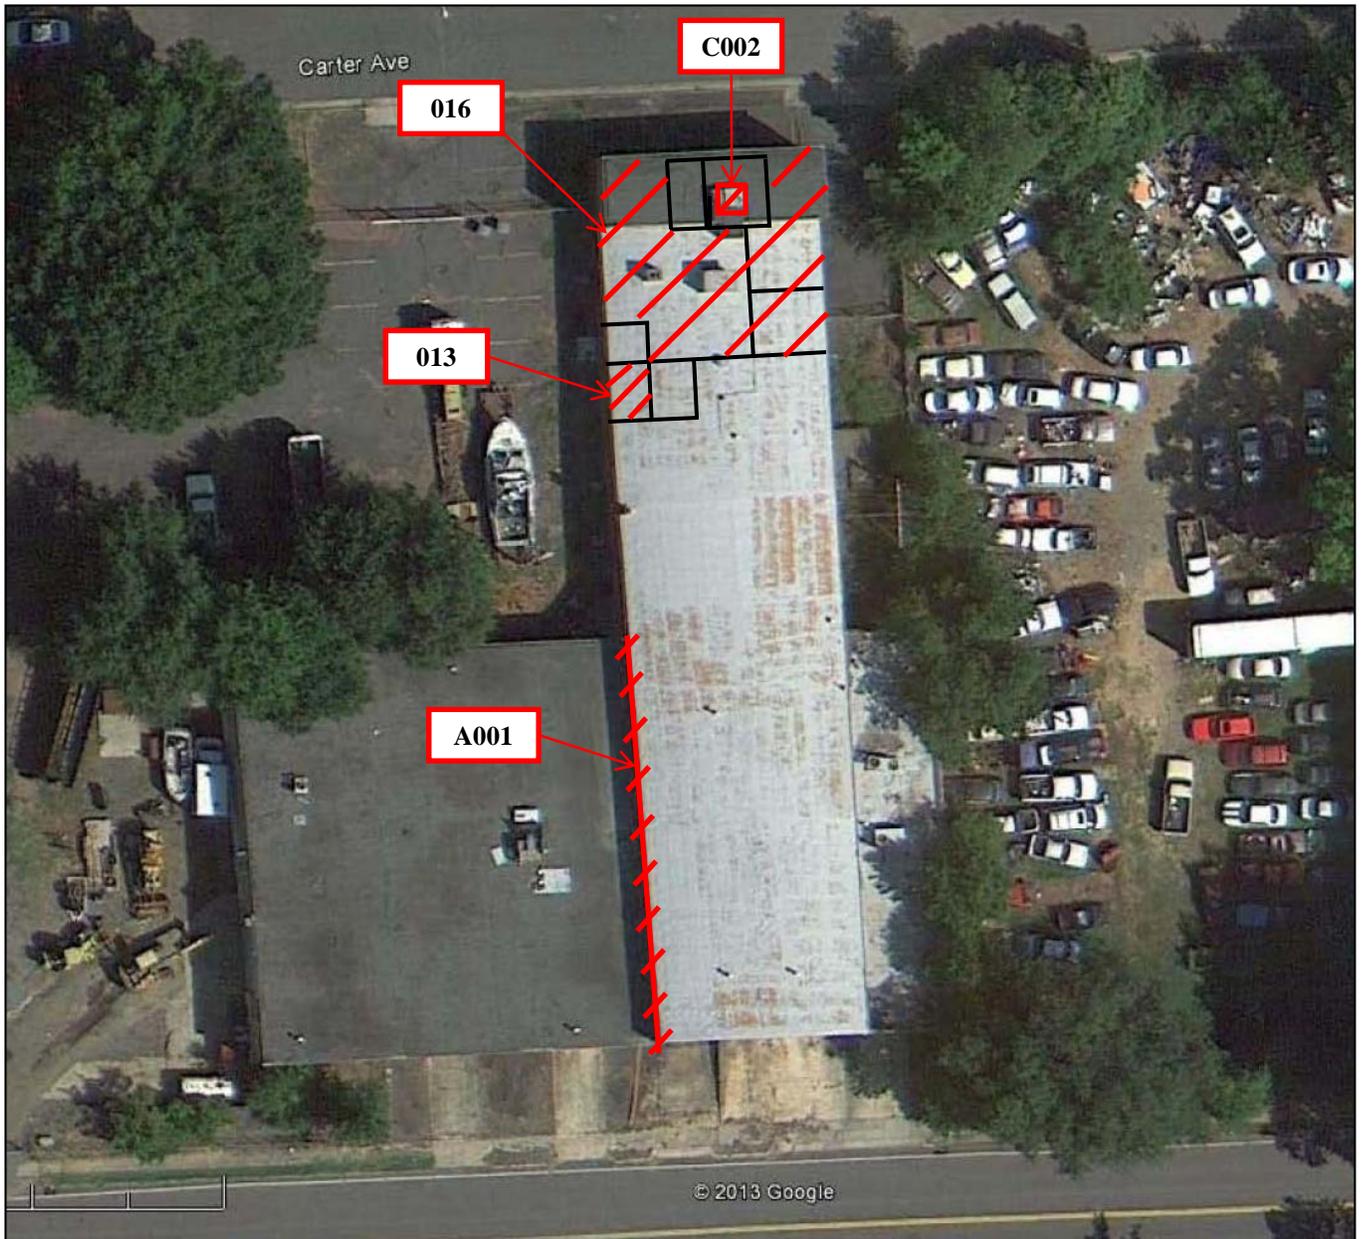
SITE MAP WITH ASBESTOS DETECTIONS

013 Positive Sample for Asbestos

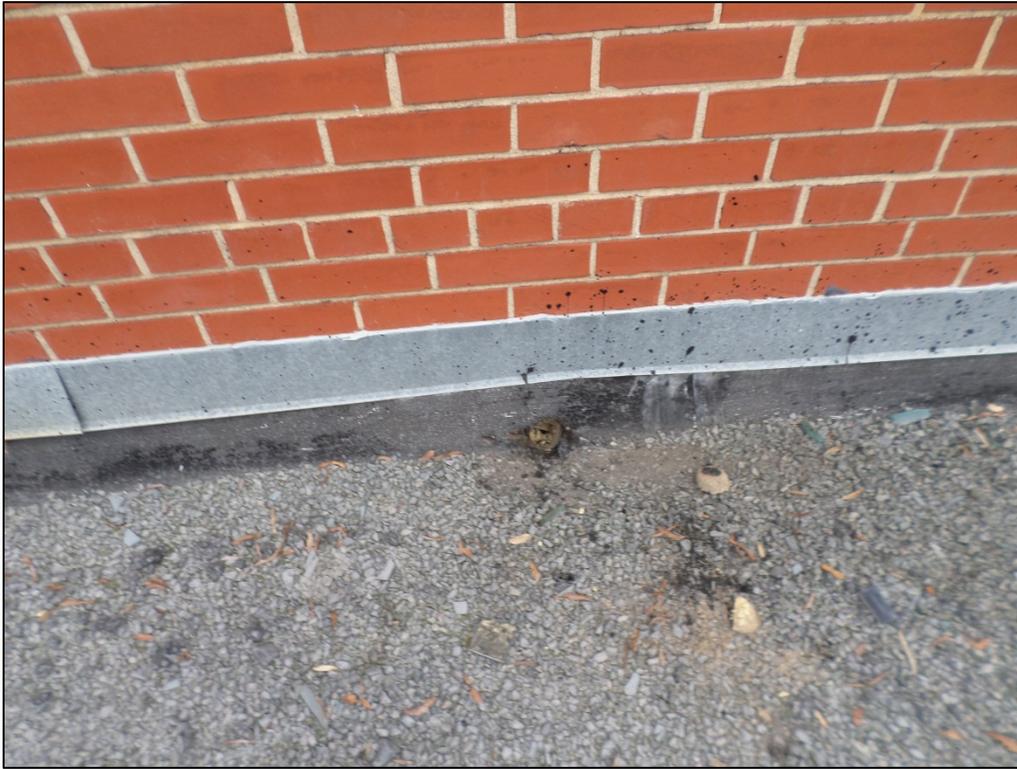
H&H identified the roof systems detections (samples A001 and C002) and the black mastic below the floor tiles (sample 016) as Category I non-friable ACMs. These materials are also identified under the AHERA Assessment Category “asbestos containing building material (ACBM) with potential for damage.” The EPA classifies resilient flooring, asphaltic roofing products, packings, and gaskets as non-friable Category I materials under the National Emission Standards for Hazardous Air Pollutants (NESHAP) regulations. Removal of non-friable Category 1 materials is not required prior to demolition, as long as routine demolition activities are conducted. However, the landfill that receives the demolition debris should be notified and be permitted to accept non-friable Category 1 ACM. Landfills often charge a premium for debris containing asbestos. Therefore, removal of the asbestos-containing flashing and black mastic from other demolition materials should be considered.

Photograph 1: Flashing (A001) on Roof System A along wall with Roof System B

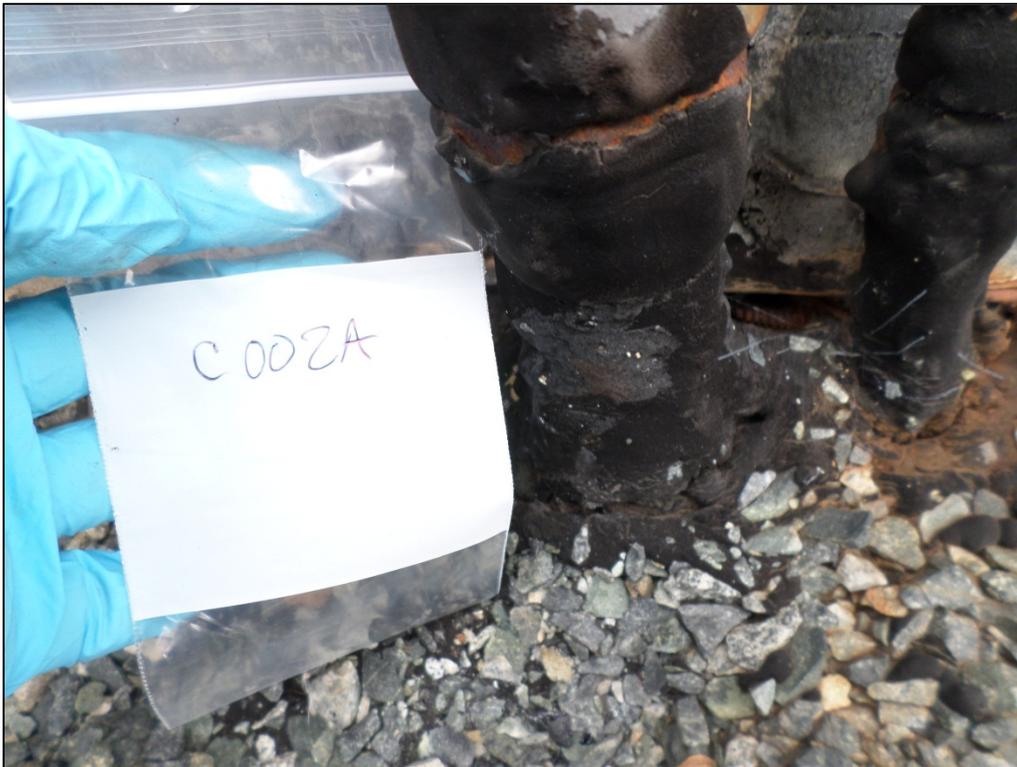
Photograph 2: Black mastic (C002) on HVAC unit on roof system C

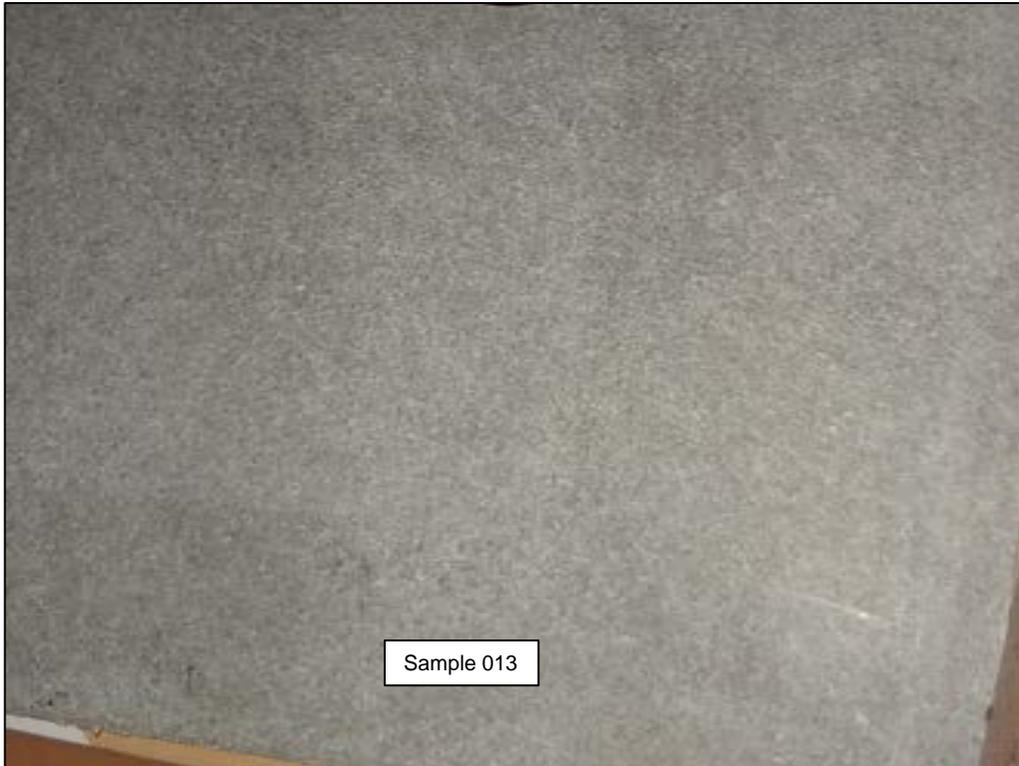
H&H identified the non-friable asbestos containing tansite board (sample 013) under the AHERA Assessment Category 2 which is any other non-friable ACBM not listed in Category 1. The transite board was also identified by H&H as “ACBM with potential for damage.” Because

the amount of transite is less than the NESHAP amount of regulated material (160 sq ft), the transite does not have to be removed prior to renovation or demolition, as long as routine demolition activities are conducted.

Photograph 3: Transite board (013) used as ceiling in the heater room on the mid-level

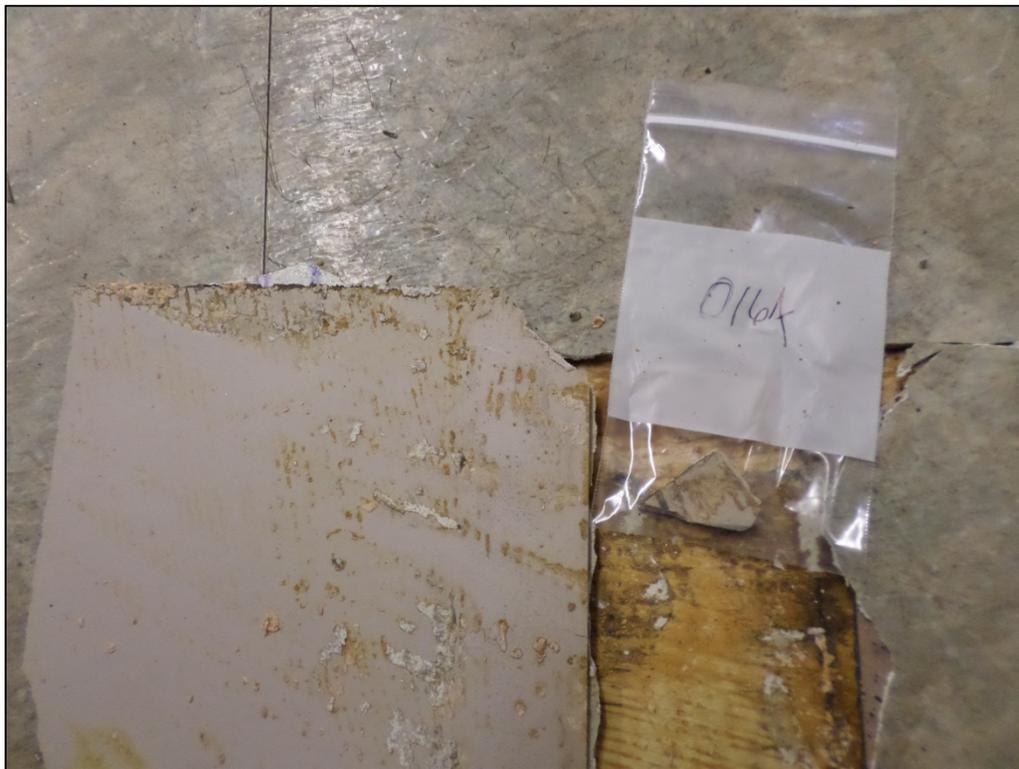
Photograph 4: Black mastic below the non-detect Pink floor tiles which are seen in some of the main office area and are also found below a layer of non-detect Grey swirl floor tiles in other parts of the main office area
