RCRA INSPECTION REPORT (Revised)

1. **Facility Information:** Aircraft Painting & Interiors, LLC
3680 Airport Loop Road
Salisbury, NC 28147
NCR 000 143 867

4. **Date of Inspection:** April 10, 2007

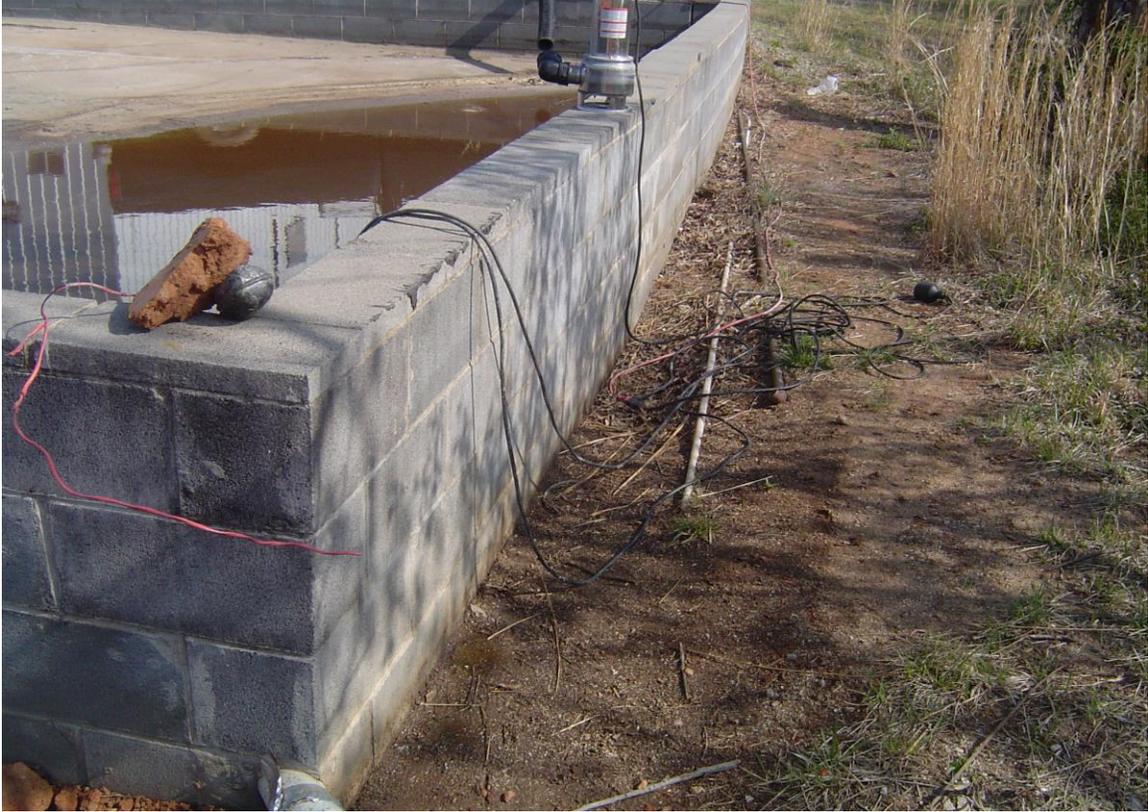
The wastewater evaporative process may constitute as hazardous waste disposal and treatment and the facility does not have a hazardous waste permit (see deficiency section). The facility had approximately (8) 55-gallon containers of hazardous waste on site. This amount exceeds 2,200 pounds, so therefore the facility is subject to small quantity generator regulations located at 40 CFR Part 262. The facility has failed to properly notify as a small quantity generator (see deficiency section). The facility has stored, treated and disposed of hazardous waste without obtaining a hazardous waste permit (see deficiency section). The facility would typically operate as a conditionally exempt generator. Based on the properties of methylene chloride, soil contamination may have occurred from the stripper material leaching through the concrete hangar floor, concrete underground tank and ancillary equipment, and through the sloped concrete evaporative pad (see deficiency section).

Picture shows the evaporation pad behind the facility.

On April 12, 2007 I spoke with Mr. Ken Silverman by phone. I explained that the facility must immediately cease the discharge of potential listed hazardous waste from the facility. I instructed Mr. Silverman to cover the concrete pad and cover the inside shop drain. I also explained that any water accumulating in the concrete pad must be containerized.

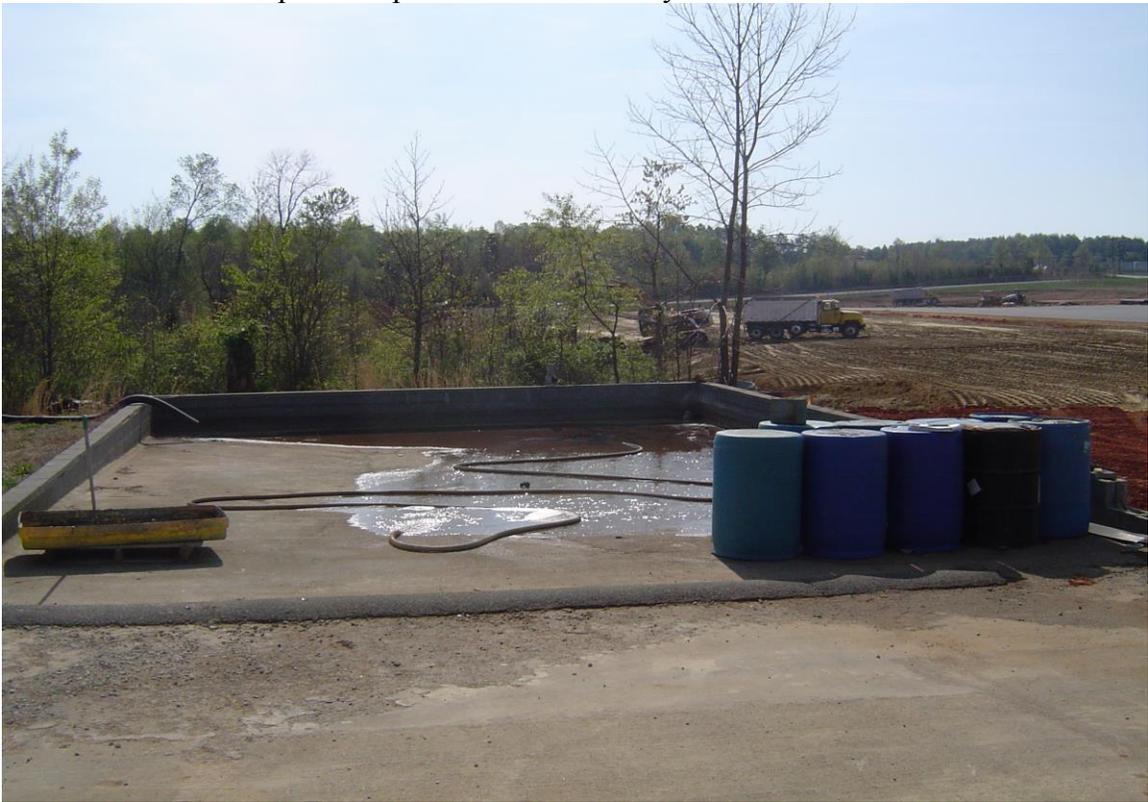
Picture shows the evaporation pad from the front.

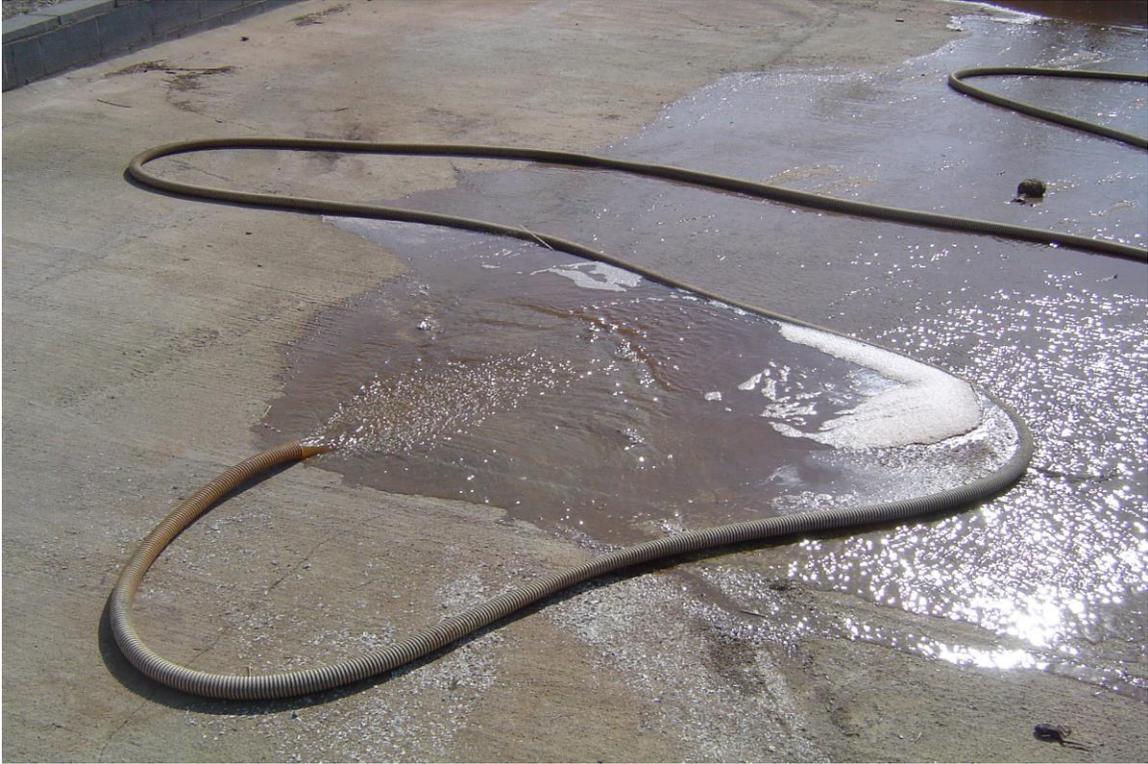
Picture shows wastewater being circulated over the evaporation pad.

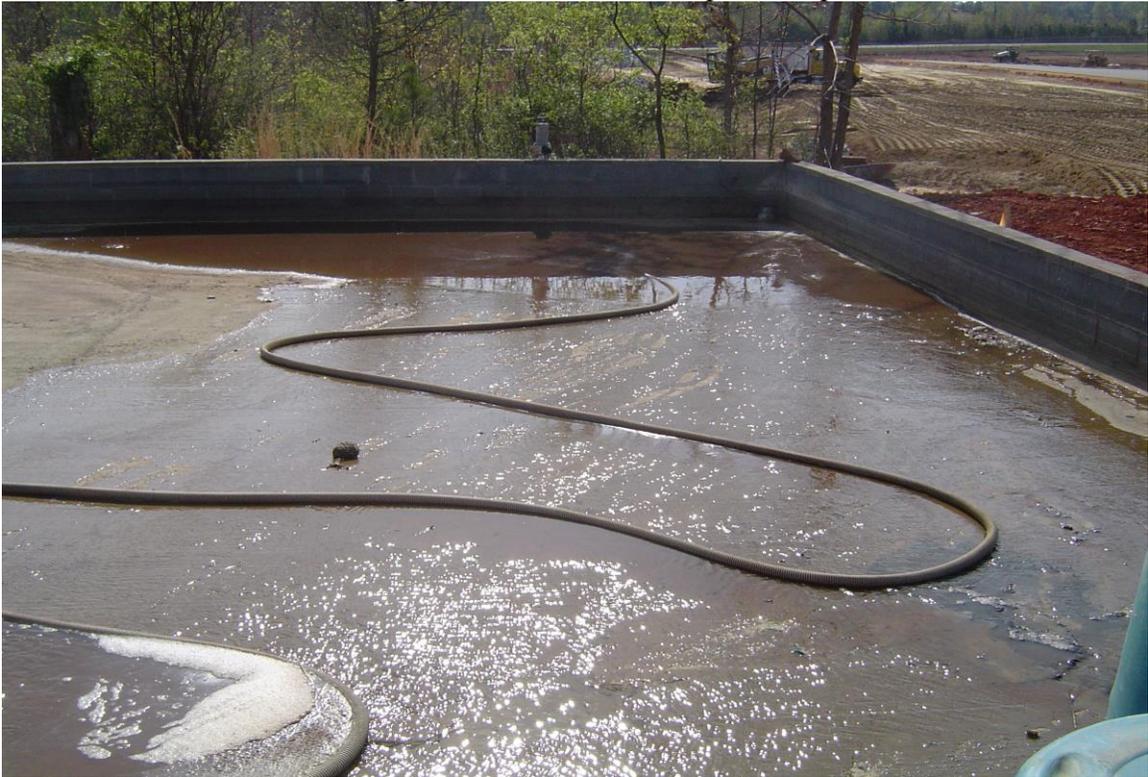
Picture shows wastewater being circulated over the evaporation pad.

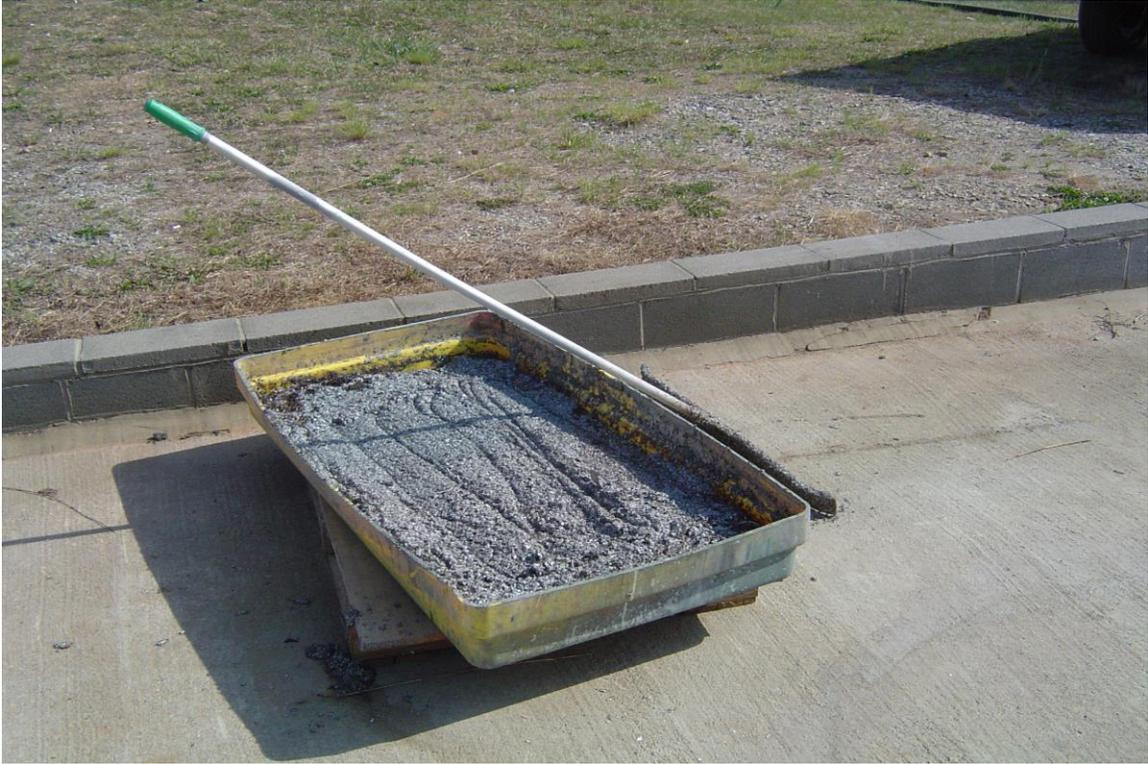
- **40 CFR 262.34 (d)(4) referenced at 40 CFR 262.34 (a)(2)** - Aircraft Painting & Interiors, LLC is in violation of this regulation in that there were (9) 55-gallon hazardous waste containers, located in the facility's Central Storage Area, and one metal pan holding hazardous waste paint chips/stripper, located at the Evaporation Pad Area, and the containers were not labeled with the date that accumulation began.

- **40 CFR 262.34 (d)(4) referenced at 40 CFR 262.34 (a)(3)** - Aircraft Painting & Interiors, LLC is in violation of this regulation in that there were (9) 55-gallon hazardous waste containers, located in the facility's Central Storage Area, and one metal pan holding hazardous waste paint chips/stripper, located at the Evaporation Pad Area, and the containers were not labeled with the words "Hazardous Waste".

Picture shows paint chip sludge collected off of the evaporation pad.

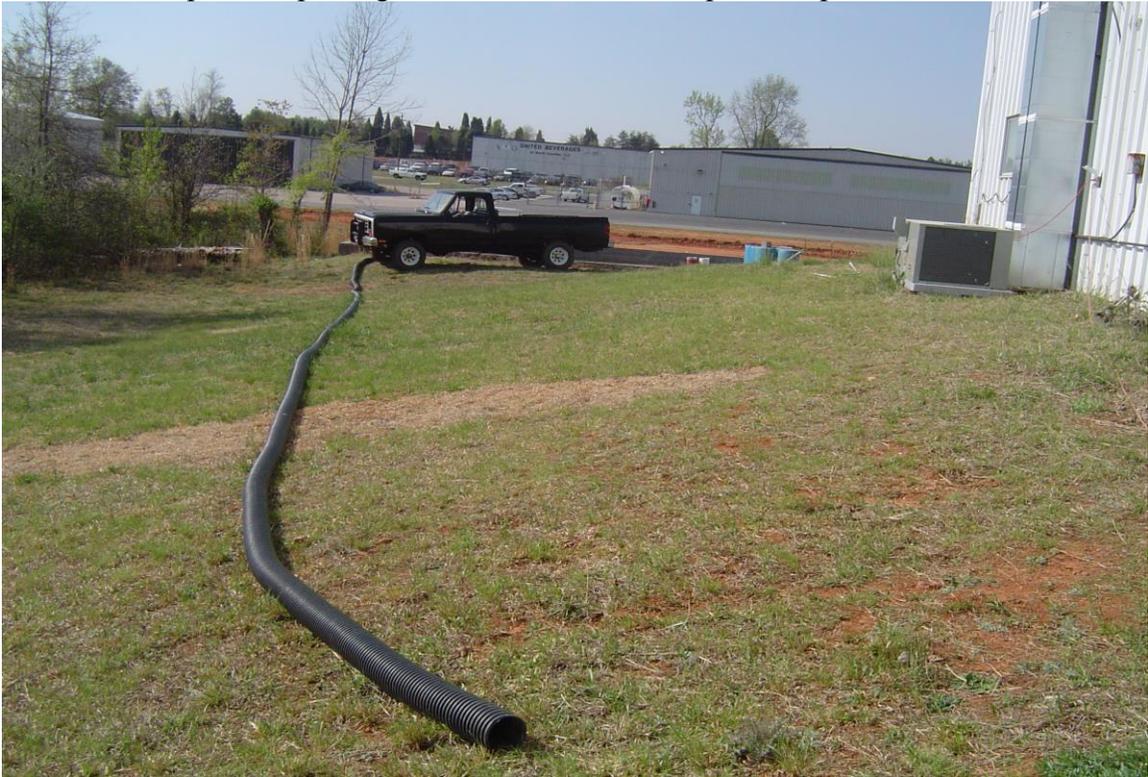
Picture shows the flexible plastic tubing used to transport waste water from under ground tank to evaporation pad.

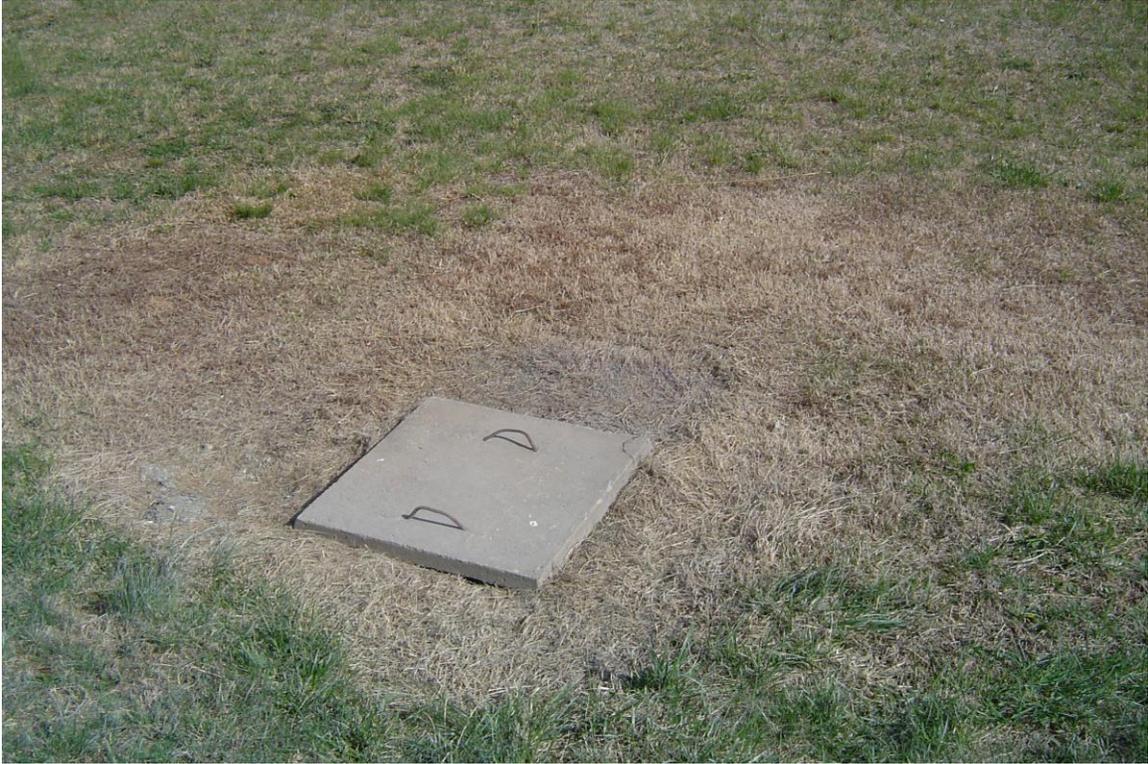
Picture shows the top of the underground tank. Water is pumped to the tank from the inside of the hangar.

On October 18, 2007 I visited Aircraft Painting to observe soil excavation and soil sampling. Mr. Silverman contracted Geological Resources, Inc (GRI) to excavate soil around the underground tank and to collect post-excavation samples as well as RCRA metal background samples. GRI removed approximately 17.5 tons of soil and the underground tank. GRI collected 5 samples, to be analyzed for volatile organics and RCRA metals, from the tank area. GRI also collected 5 background samples from around the facility. The excavated pit was backfilled with clean soil as requested by Mr. Silverman. During the excavation a 4" PVC pipe was found leading from the former tank to an unknown location. The outfall location from the piping was not known and will be investigated. Training records for the two GRI employees was obtained from GRI.

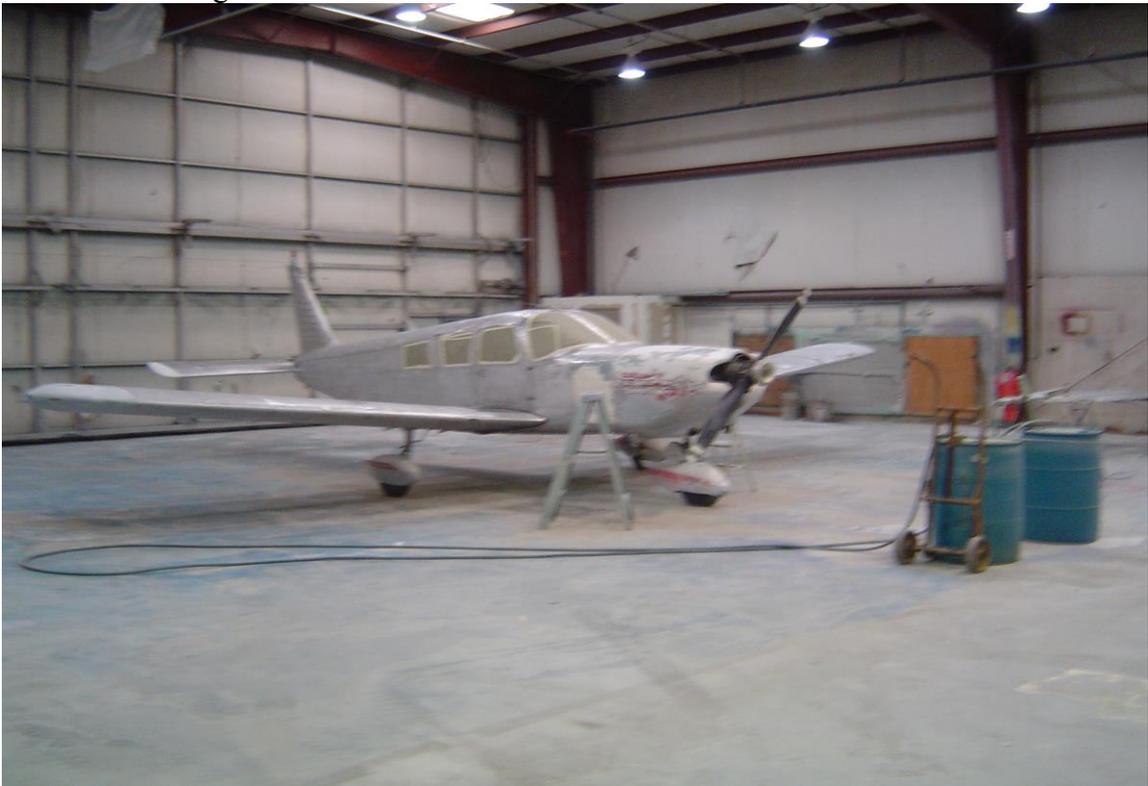
Picture shows the inside of the hangar where paint stripping is conducted.

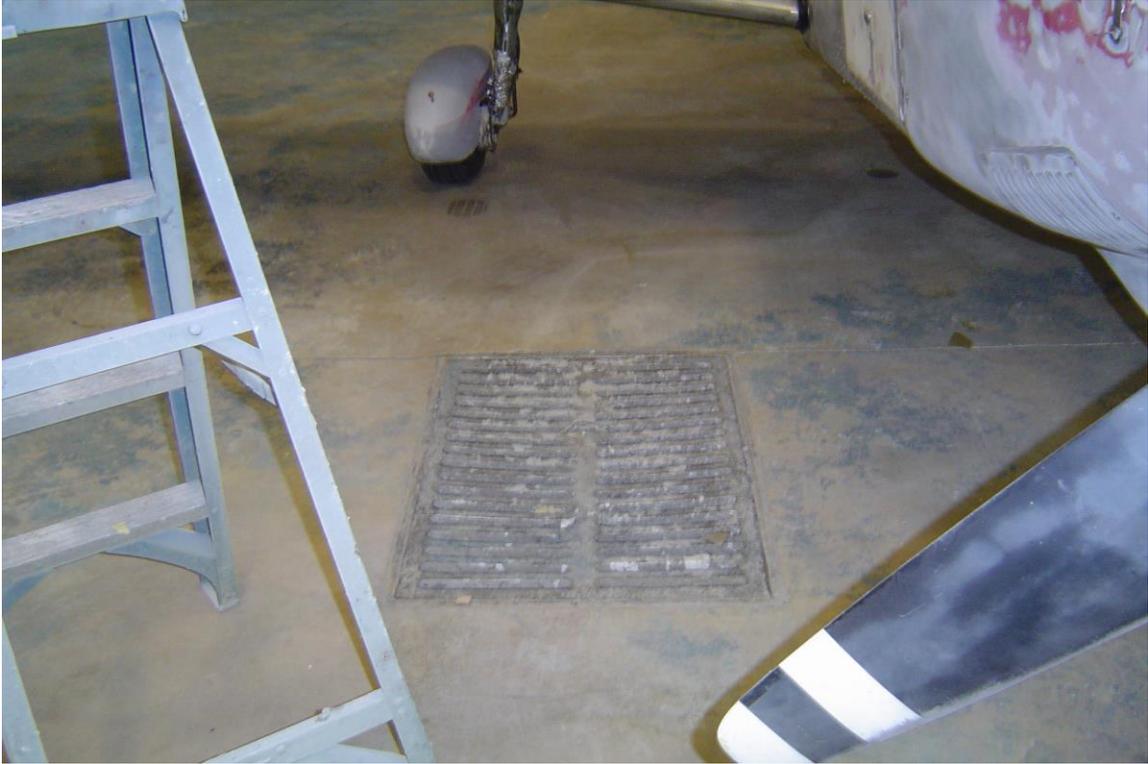
Picture shows the hangar floor drain. Wastewater from paint stripping is washed into the drain and then piped to the underground tank.

On April 24, 2007 I spoke with Mr. Ken Silverman by phone. Mr. Silverman explained that he had covered and diverted rainwater away from the concrete pad and that the facility was no longer using methylene chloride as a paint stripper. They are now using a biodegradable stripper. Mr. Silverman also stated that he is working on the NOV issued and the shop floor drain has been sealed. Mr. Silverman submitted an email with this information as well.

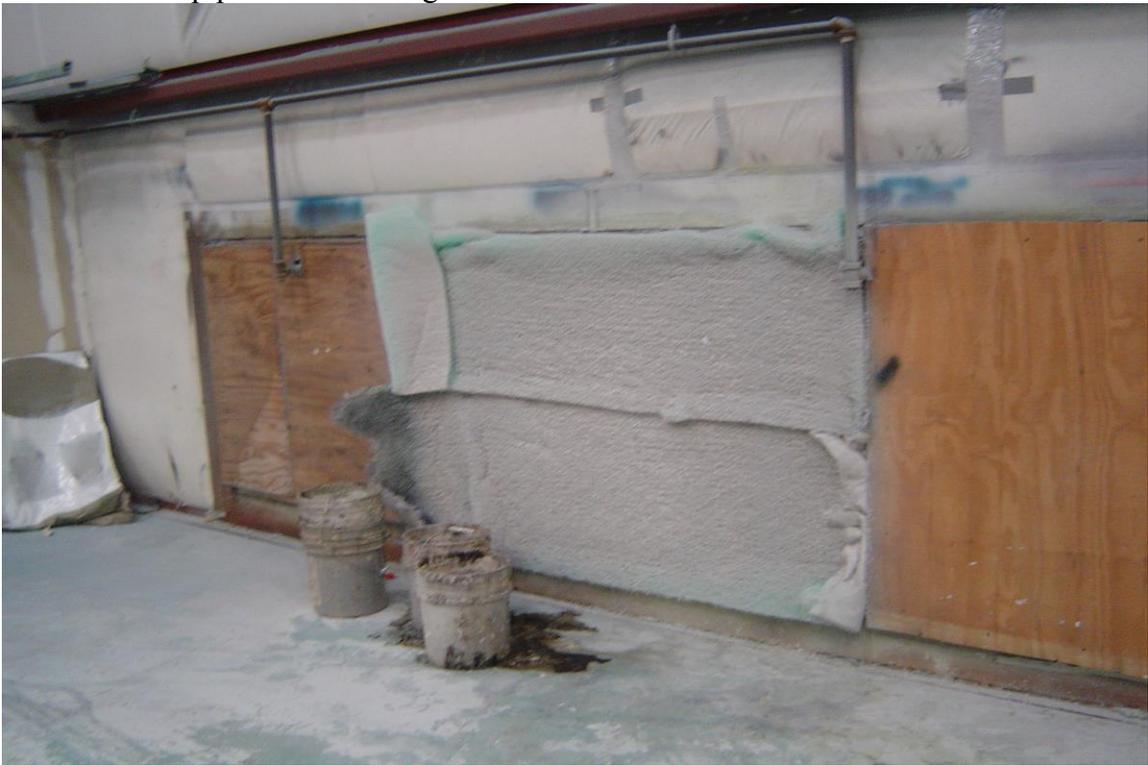
1. Hangar Floor Area - There were (3) 5-gallon containers of waste paint chips/stripper located inside the hangar area. The (3) 5-gallon containers of waste paint chips/stripper were observed to be leaking onto the hangar concrete floor at the time of the inspection. Mr. Silverman stated that the containers are designed to leak to promote evaporation. The containers were not properly closed or labeled (see deficiency section).
2. Painting Room Area - There was one (1) 55-gallon container of waste paint thinner located in this area. The container's funnel was not closed and the container was not properly labeled at the time of the inspection. There were spills of hazardous waste on the outside of the funnel (see deficiency section).

- **40 CFR 262.34 (c)(1)** - Aircraft Painting & Interiors, LLC is in violation of this regulation in that the facility failed to place hazardous waste into containers. Spills of hazardous waste were noted on the outside of (3) 5-gallon containers of hazardous waste paint chips/stripper located in the Hangar Area. Spills were noted on the ground under the containers as well. Spills were also noted on the outside of the funnel on the 55-gallon container of hazardous waste paint thinner located in the Paint Room Area.

- **40 CFR 262.34 (c)(1)(i) referenced at 40 CFR 265.173 (a)** – Aircraft Painting & Interiors, LLC is in violation of this regulation in that (3) 5-gallon containers of hazardous waste paint chips/stripper, located at the Hangar Area, and (1) 55-gallon container of hazardous waste paint thinner, located at the Paint Room Area, were not properly closed at the time of the inspection.

- **40 CFR 262.34 (c)(1)(ii)** – Aircraft Painting & Interiors, LLC is in violation of this regulation in that (3) 5-gallon containers of hazardous waste paint chips/stripper, located at the Hangar Area, and (1) 55-gallon container of hazardous waste paint thinner, located at the Paint Room Area, were not properly labeled at the time of the inspection.

Picture shows three 5-gallon containers with waste paint chips/stripper/water collected from the hangar floor and floor drain.

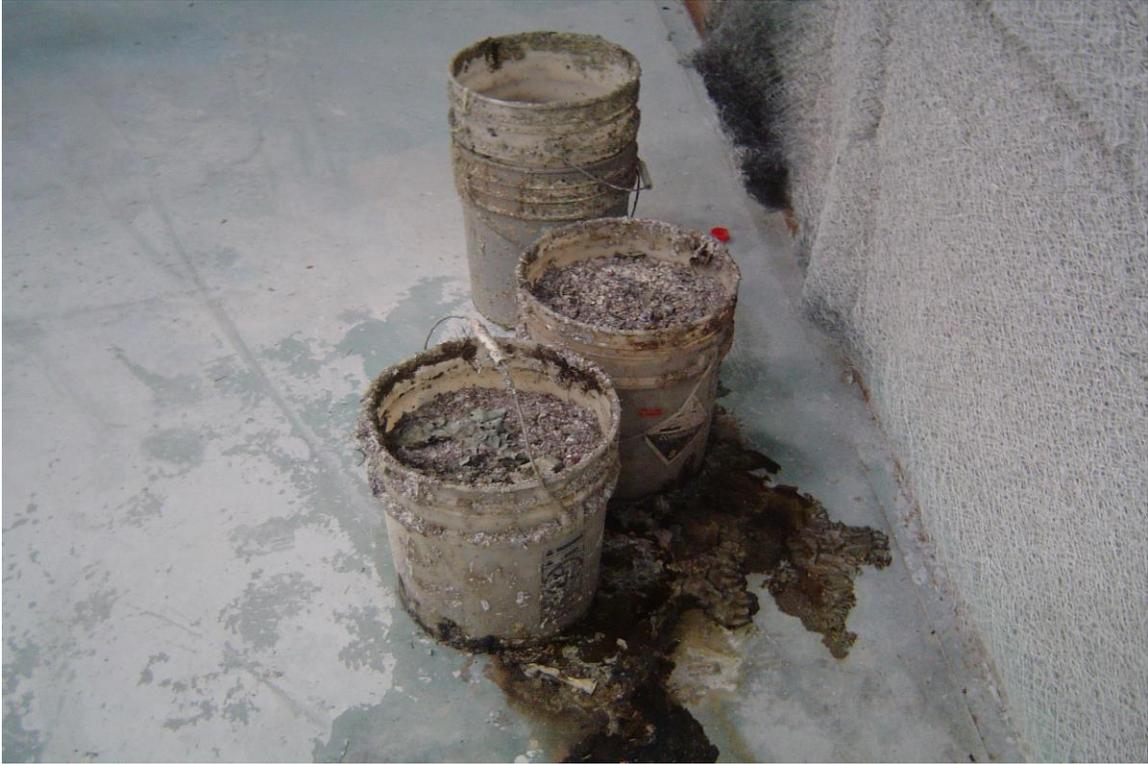
- **40 CFR 262.34 (d)(4) referenced at 40 CFR 265.31** - Aircraft Painting & Interiors, LLC is in violation of this regulation in that the facility has failed to minimize the possibility of a release of hazardous waste to the environment. There were (3) 5-gallon containers of hazardous waste paint chips/stripper that were leaking onto the facility's hangar floor. Hazardous waste has also been released by the facility's paint stripper evaporation process.

Picture shows three 5-gallon containers of waste paint chips/stripper/water. The containers are leaking intentionally to promote fast evaporation.

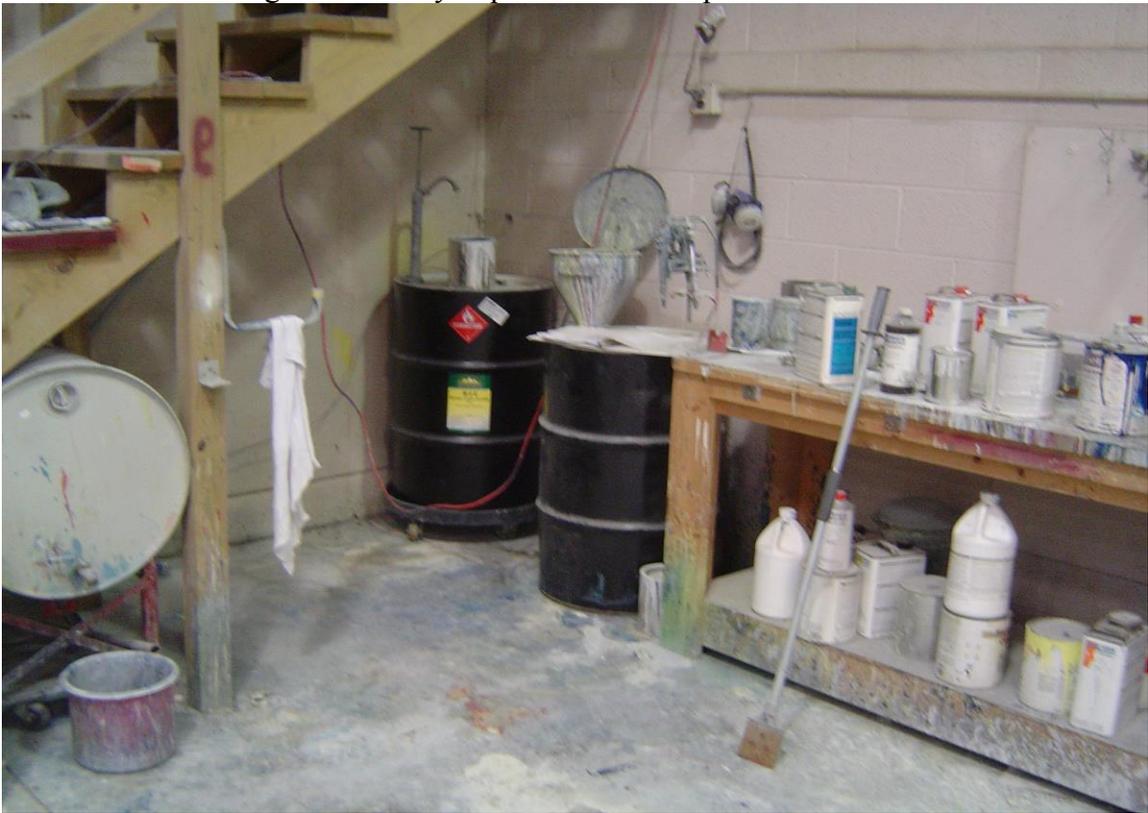
Picture shows one 55-gallon container of waste paint material.

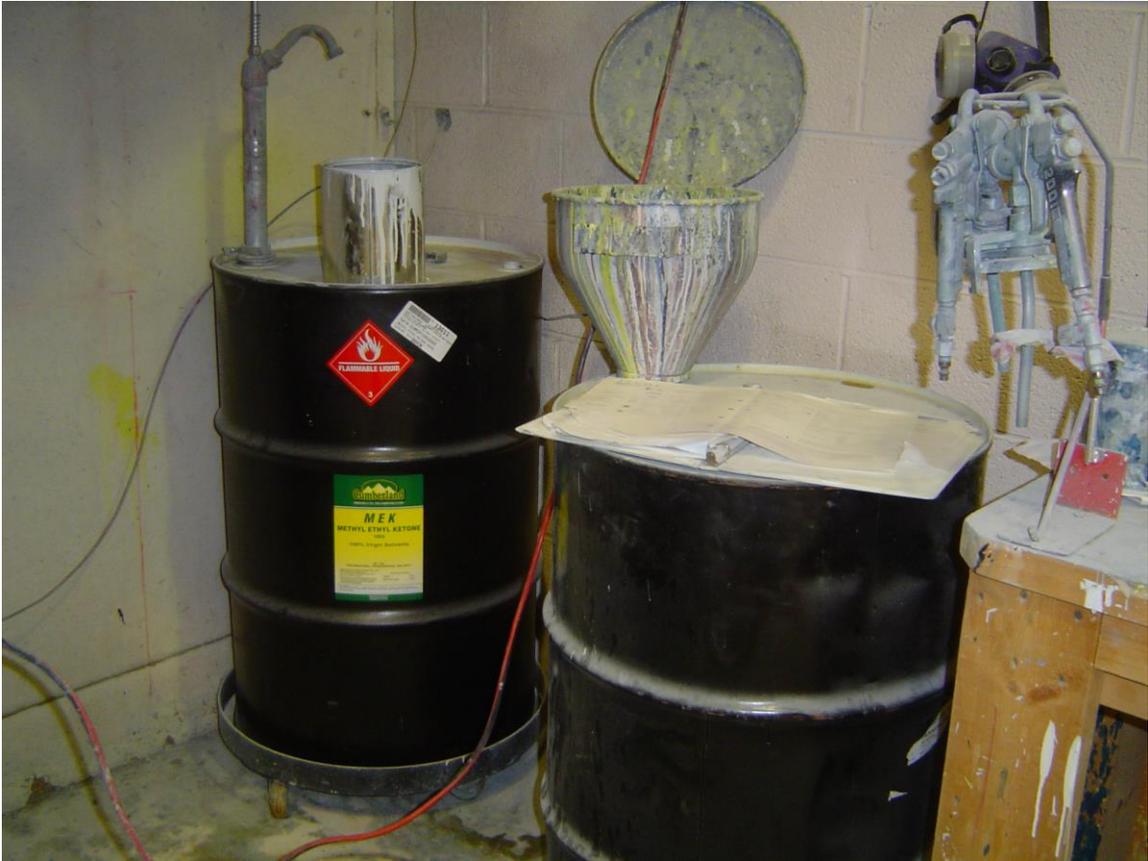
Picture shows one 55-gallon container of waste paint material located in the hangar.
