**PHASE I
ENVIRONMENTAL SITE ASSESSMENT
Cooperage Tract
Belhaven, Beaufort County, North Carolina**

**Project Number P03177
March 200~~3~~4**

PHASE I ENVIRONMENTAL SITE ASSESSMENT
"THE COOPERAGE"
BELHAVEN, BEAUFORT COUNTY, NORTH CAROLINA

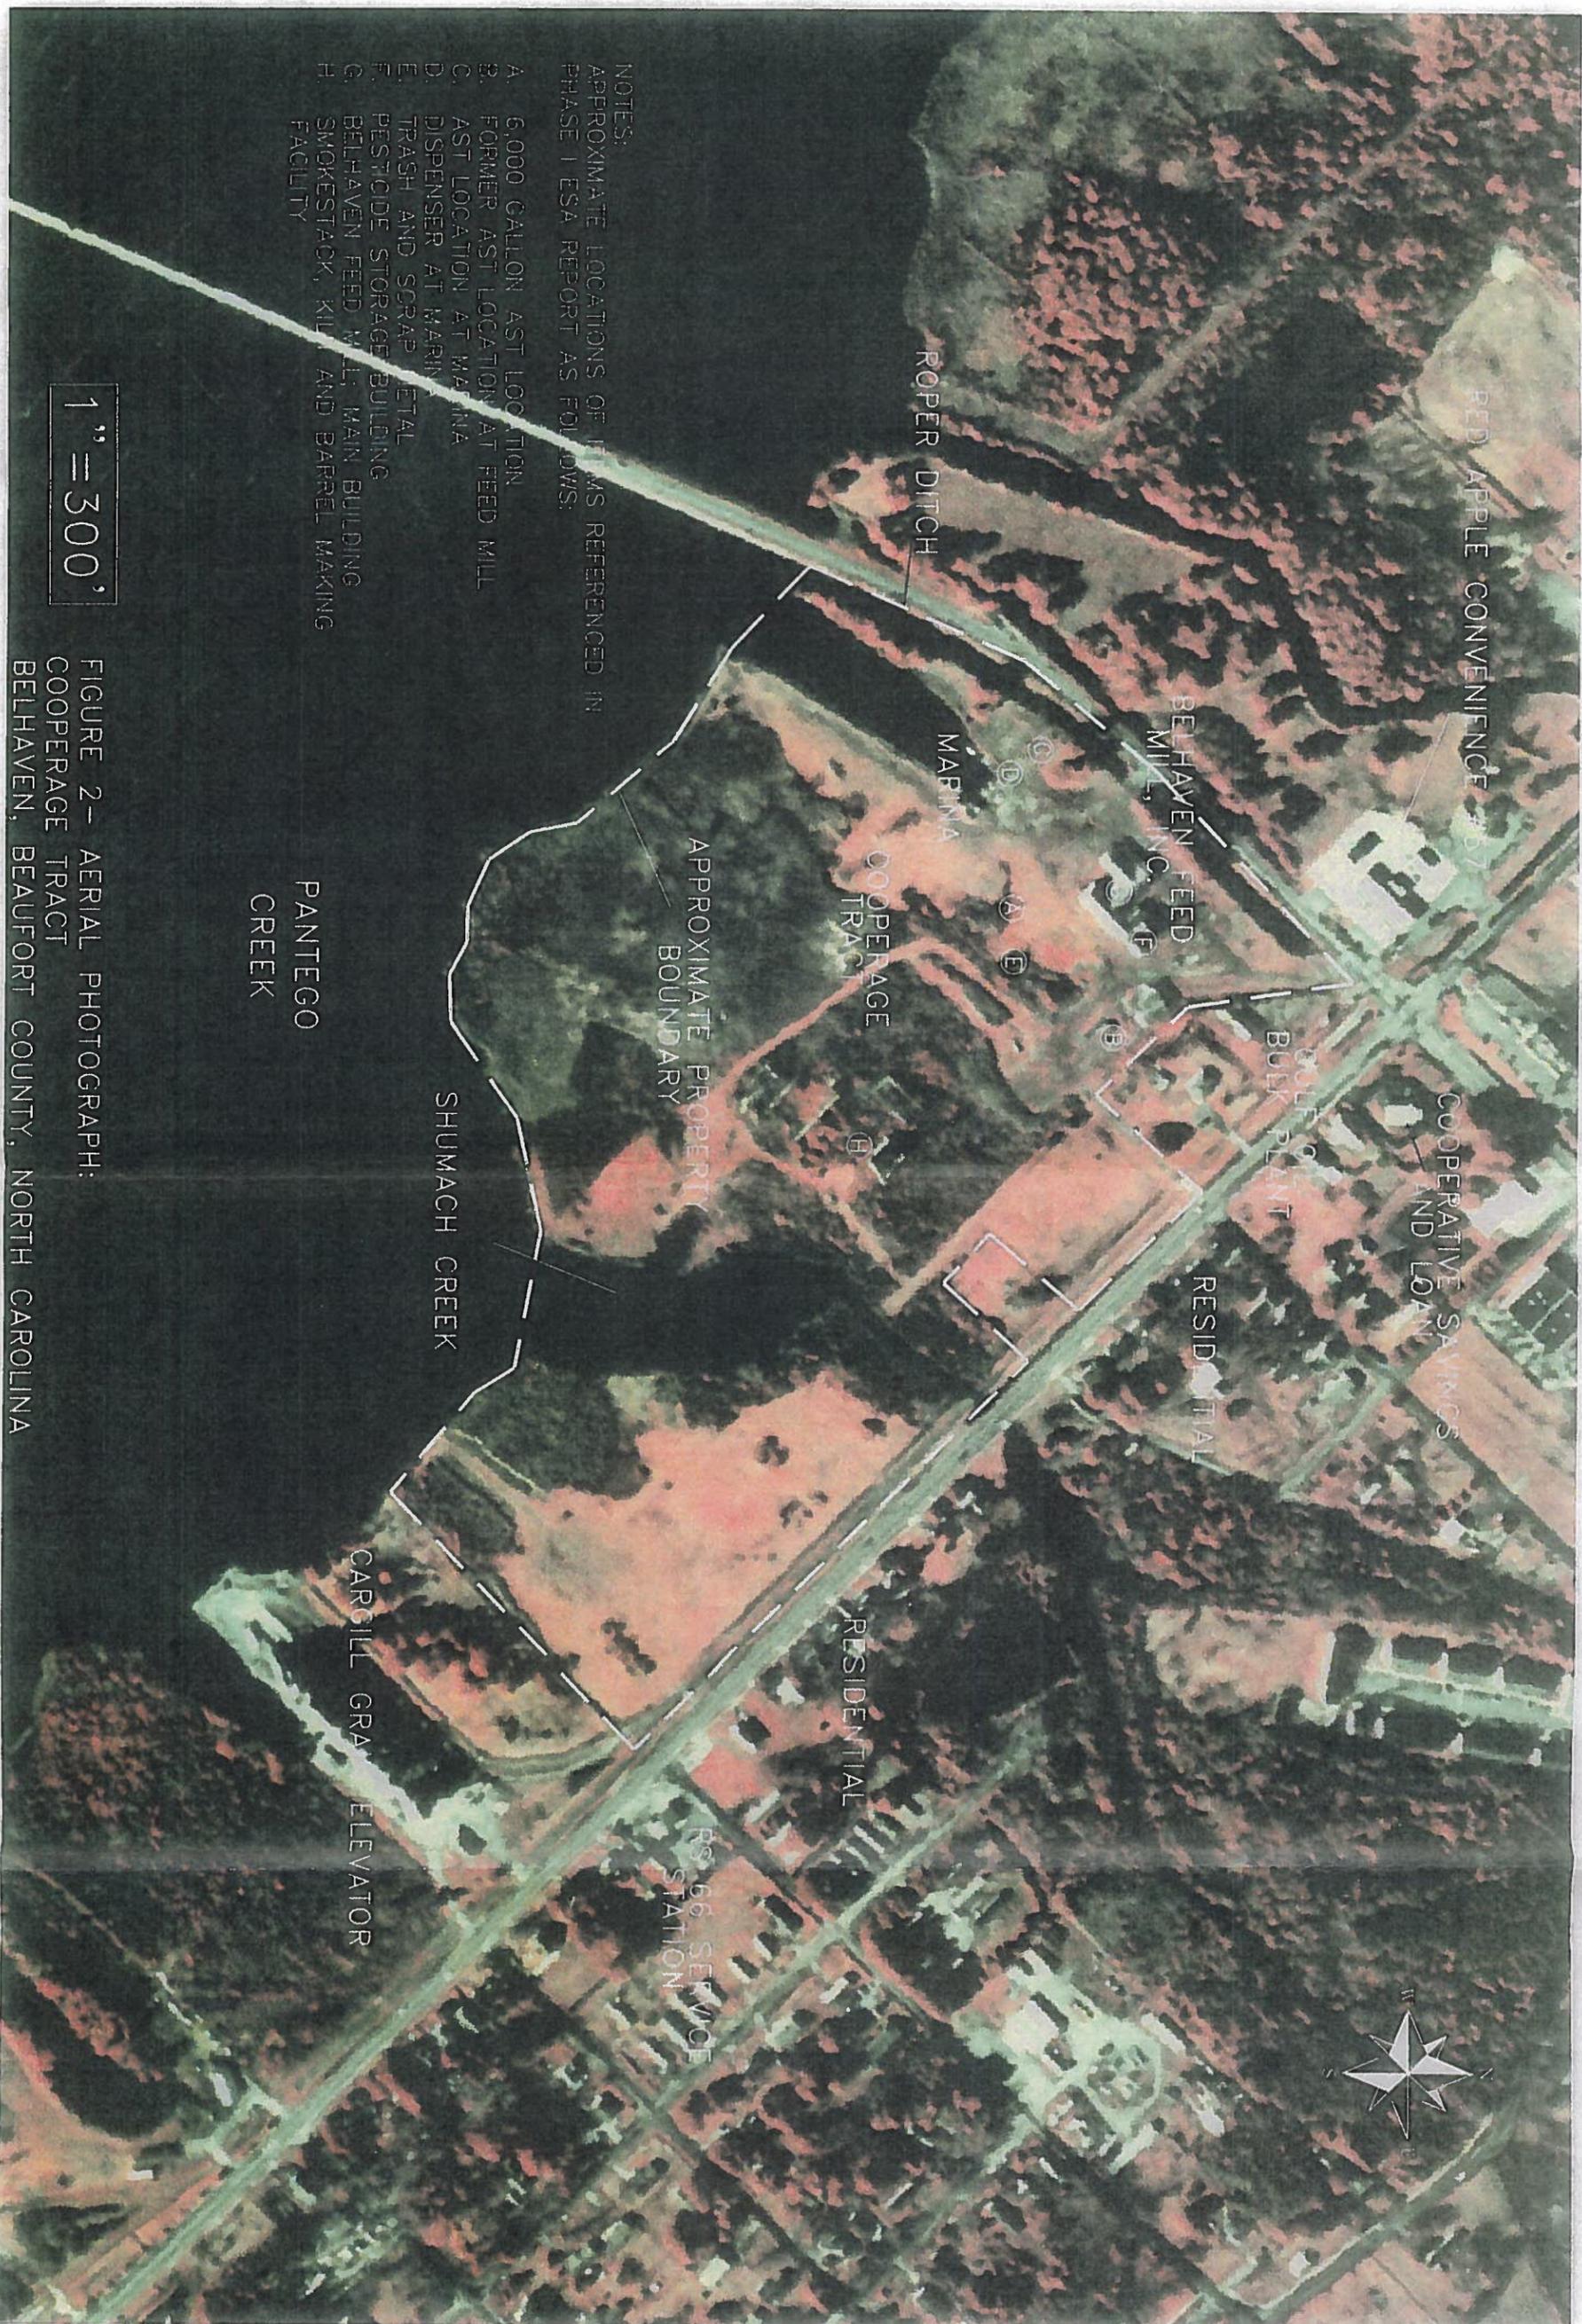
FIGURE 2- AERIAL PHOTOGRAPH:
 COOPERAGE TRACT
 BELHAVEN, BEAUFORT COUNTY, NORTH CAROLINA

Evidence of several above ground storage tanks (AST's) were observed on the property. The approximate positions of each of these tanks and locations of the dispensers are shown on **Figure 2**. A 6,000 gallon AST, reported to have been a liquid nitrogen tank, is located on the property, but appears to have been moved from its original location. According to Mrs. Laughinghouse, a bulk facility used to operate on the adjacent property immediately to the north across the railroad spur. There is no visible physical evidence that the facility ever existed, and according to the Groundwater Section database, there are no reports of ground water or soil quality violations associated with this bulk plant. This does not mean that unreported releases or spills did not occur. Photographs of the former AST area associated with the marina and the reported nitrogen AST are included as **Attachment B**.

The subject property is connected to the Town sewer system and all wastewater treatment is off site. Discarded materials on site include an AST that appears to have been moved to its current position, small piles of scrap metal and an old rusted drum. Approximate locations of these materials is shown on **Figure 2**.

- NOTES:
 APPROXIMATE LOCATIONS OF ITEMS REFERENCED IN
 PHASE I ESA REPORT AS FOLLOWS:
- A. 6,000 GALLON AST LOCATION
 - B. FORMER AST LOCATION AT FEED MILL
 - C. AST LOCATION AT MARINA
 - D. DISPENSER AT MARINA
 - E. TRASH AND SCRAP METAL
 PESTICIDE STORAGE BUILDING
 - F. BELHAVEN FEED MILL MAIN BUILDING
 - G. SMOKESTACK, KILN AND BARREL MAKING
 FACILITY
 - H.

Based on the database searches, property owner interviews and site reconnaissance, activities that could potentially lead to the contamination of the soils and ground waters at the site have been conducted on the property in the past. To make a better determination of whether or not there are any contaminated soils and or ground waters at the site a Phase II Environmental Assessment would be required. A possible and recommended sampling regimen would include collection of soil and ground water samples from areas discussed herein and identified on **Figure 2** where deleterious materials were reportedly stored and dispensed.

Given the relative shallow depth to the water table at the site ground water sample collection and analysis for pesticide, herbicide, and fertilizer contaminants may be sufficient. However, if contaminant concentrations are reported in any of the ground water samples collected it may be necessary to collect and analyze soil samples. Recommendations for sampling locations are indicated on the attached **Figure 2**. The number of samples collected will depend on the degree of confidence desired. However, at a minimum one sample should be collected from the locations indicated on **Figure 2**.

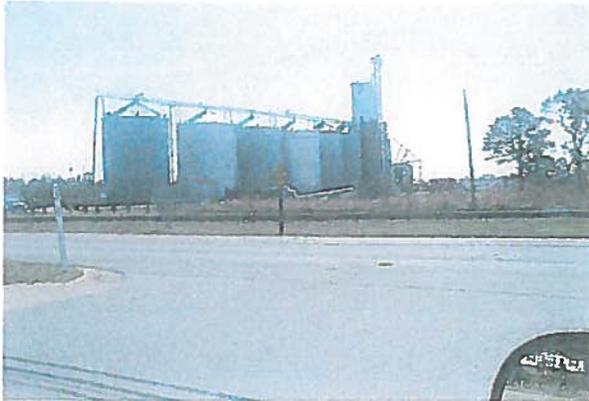
The adjacent property to the east is a large parcel operating as the Cargill Grain Elevator. A release was reported in August of 2000 during the removal of an UST, however, this facility is currently not listed in the UST release database. The contamination was listed as minor in the EnviroData Report.

Looking southeast at Cargill Grain Elevator from across Hwy 264.

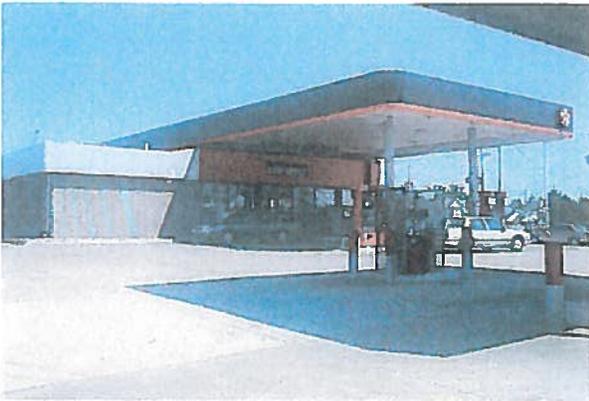
The site is bound to the west by the Roper Ditch and further west across Hwy 92 by expanses of wetlands. Red Apple Market #57, a convenience store offering petroleum products for retail sale, is located at the western intersections of US Hwy 264 and NC Hwy 92 and has a confirmed release and an ongoing ground water assessment. However, the site has been given a low risk classification and the State of North Carolina is not currently funding any sites of this ranking.

Red Apple Convenience #57.

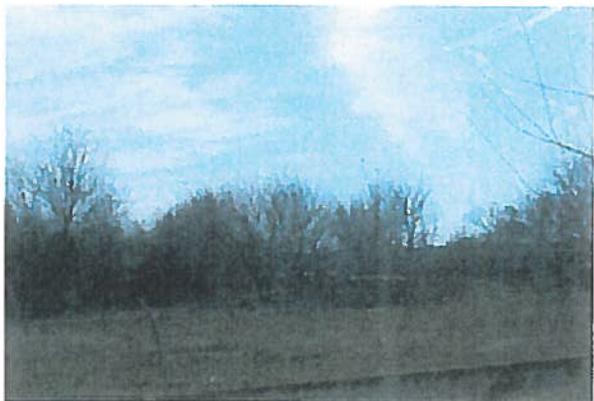
AST located on property.

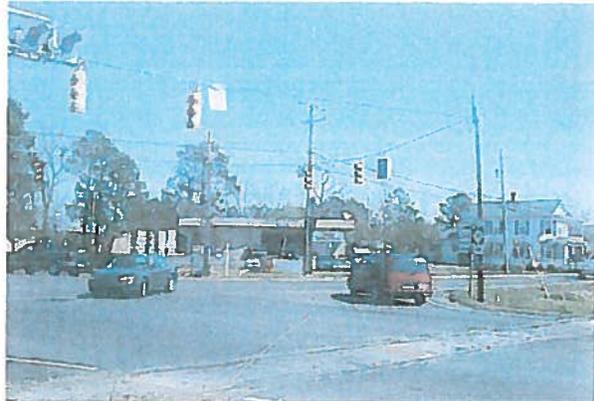
Cooperative Savings and Loan, formerly a gasoline station located north of the subject site across Main street.

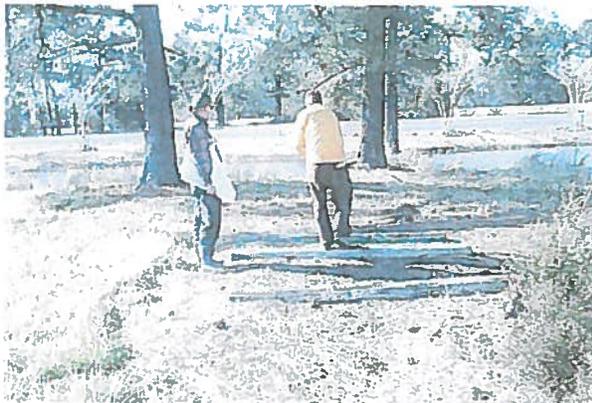
Location of AST at marina.

Soil samples collected from areas associated with the storage and distribution of petroleum products should be analyzed for total petroleum hydrocarbons (TPH) gasoline-range organics (GRO), and diesel-range organics (DRO) by methods 8015/5030 and 3550, respectively. Soil and/or ground water samples should also be collected from areas around the former pesticides, herbicides and fertilizer storage building(s) and analyzed for total nitrogen by the TKN method or EPA method 351.1, total phosphorous by EPA method 365.1 and ammonia by method 350.2. In addition, these soil and/or ground water samples should be analyzed for pesticides and herbicides by EPA methods 8081 and 8151, respectively. A soil sample should also be collected from the area where the rusted drum and scrap metal are located. It is unclear what may have been stored in the drum, if anything at all. However, at a minimum, the drum and scrap metal should be removed from the site and disposed of properly. If any stained soils or vegetation are discovered during the removal of the scrap metal and other solid waste, the affected soils should be analyzed for those materials known to have been stored and sold at the site.

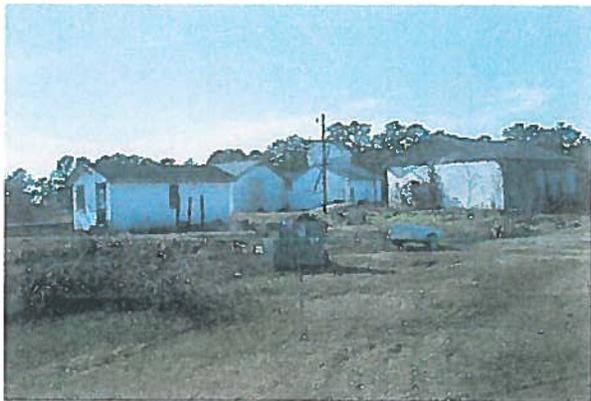
A one story block building adjacent to the Roper Ditch operated as a marina offering petroleum products for retail sale. There are several large block buildings located in the northwest corner of the property that were utilized for the sale and storage of agricultural equipment and supplies. In addition, in the central portion of the site there are several large brick structures, mostly in ruins, and a large smokestack that were associated with the barrel manufacturing that occurred on site. Building inspections and chemical analysis for hazardous materials such as asbestos and lead is recommended if the buildings are going to be razed.

Buildings associated with the Belhaven Feed Mill, Inc.

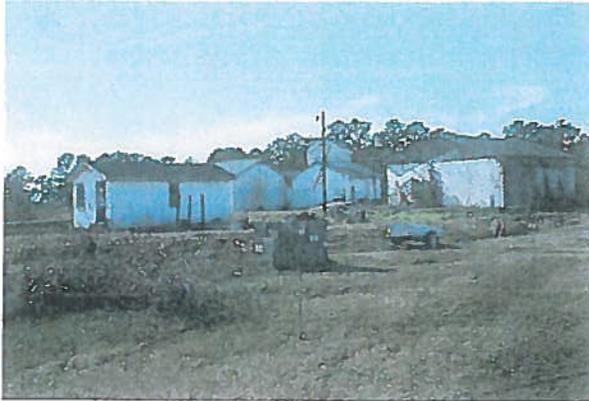
The USDA was contacted to determine if and when pesticides and herbicides, which are potentially hazardous, may have been stored at the Belhaven Feed Mill, Inc. facility. Pesticides are registered to individuals, not companies or stores, therefore, it is difficult to determine precisely what chemicals may have been stored and sold at the facility without direct knowledge of the individuals who worked at the agricultural supplier. A field representative with the USDA who is familiar with the Belhaven area was contacted and as of this date has not offered any information regarding the storage or sale of pesticides, herbicides and fertilizers at the site.

Pesticides reported to have been stored in building on right, AST shown on picture at right located beside building pictured here on the left.

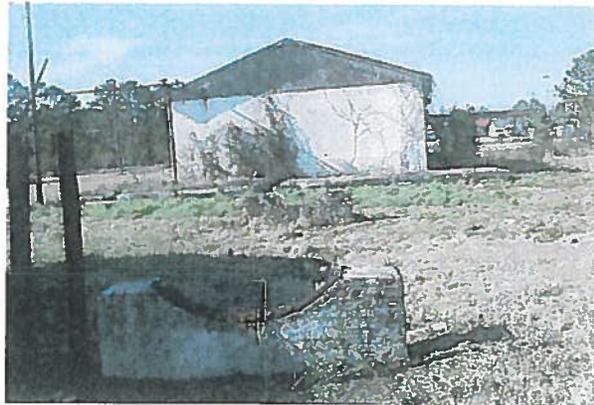
Former AST location in the foreground and a chemical storage building of the Belhaven Feed Mill in the background.

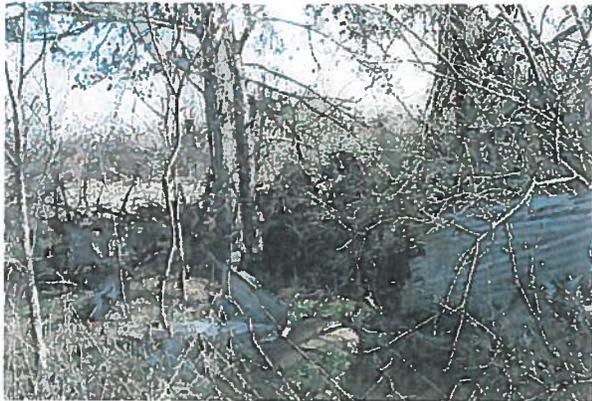
Solid waste and miscellaneous drum dumped on site.

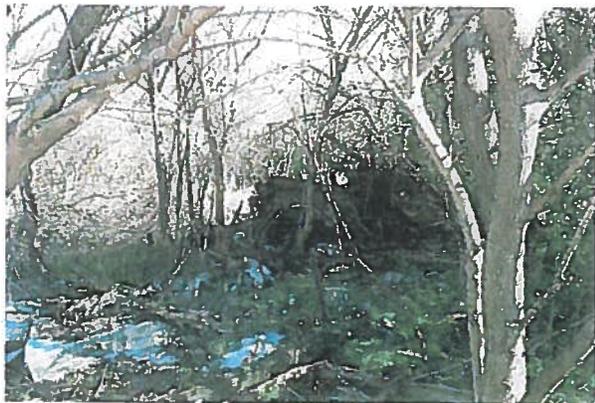
Another view of dumped solid waste and scrap metal.
