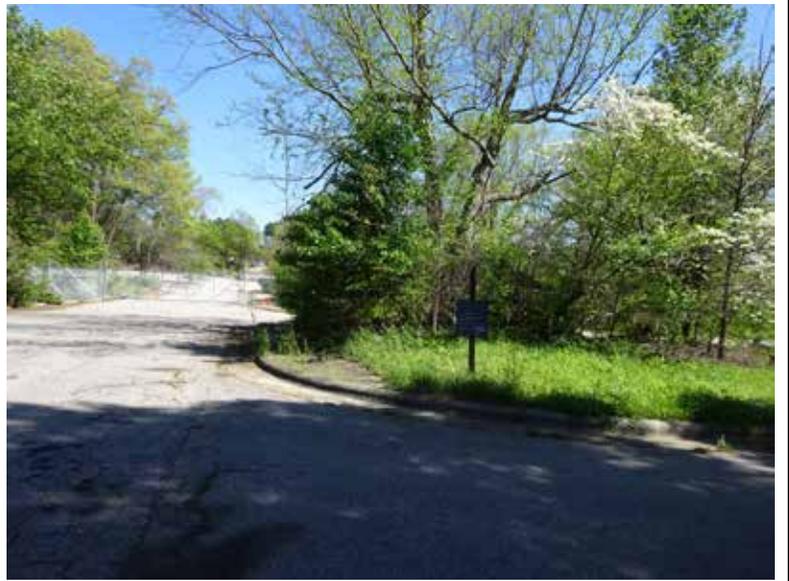
**Photograph 1:**

View front entrance to Subject Property from Wake Forest Road. Property is fenced off for safety and to deter trespassers. Partial view of the northeast portion of the property that is currently used as a commuter parking area.

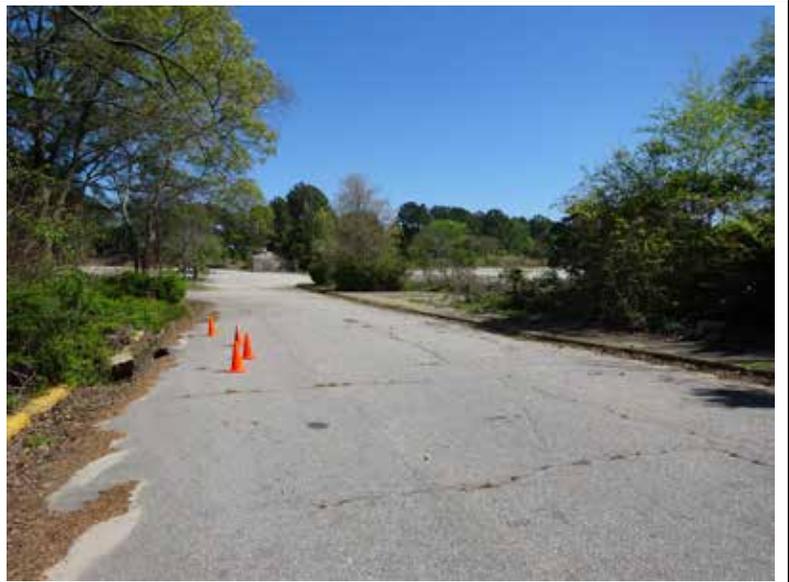
**Photograph 2:**

View from driveway accessing property off of Wake Forest Road facing west.

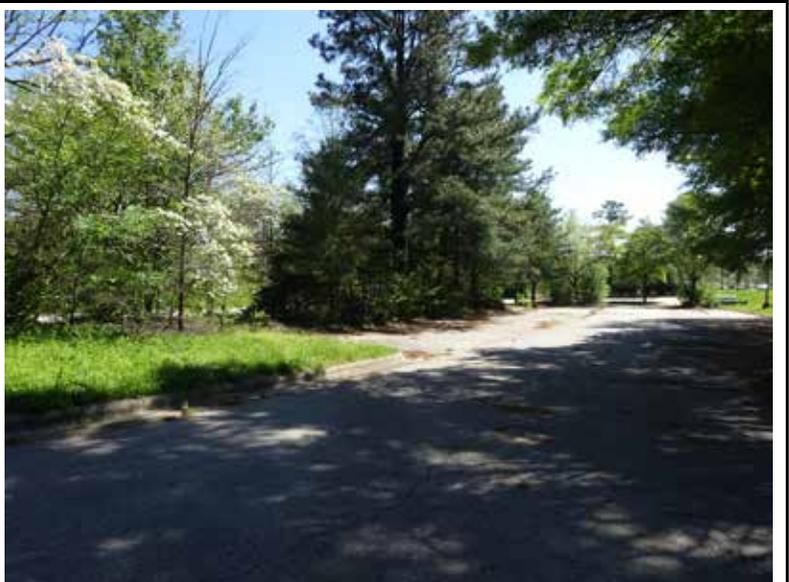
**Photograph 3:**

View of former facility parking lot along Wake Forest Road on the southwestern portion of the property accessed from Wake Forest Rd driveway. This area is located outside of the secured fenced portion of the property.

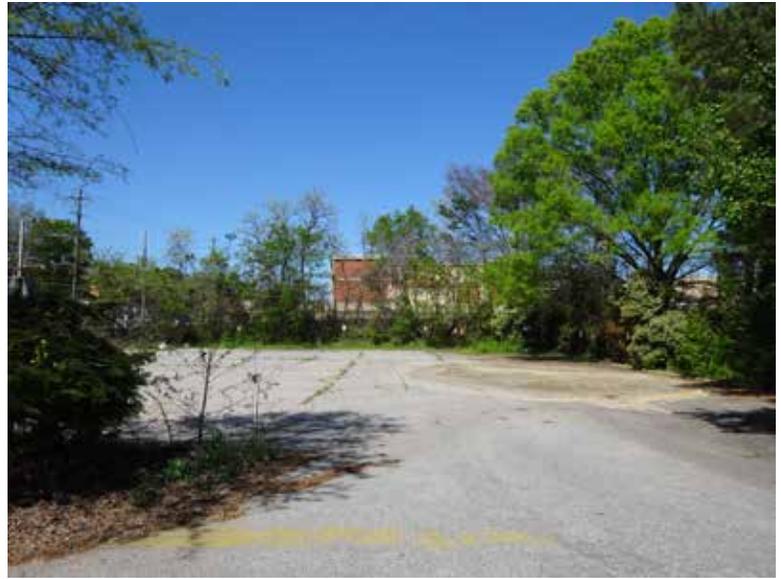
**Photograph 4:**

View of former facility parking lot along Wake Forest Road on the northwestern portion of the property accessed from Wake Forest Rd driveway. This area is located outside of the secured fenced portion of the property.

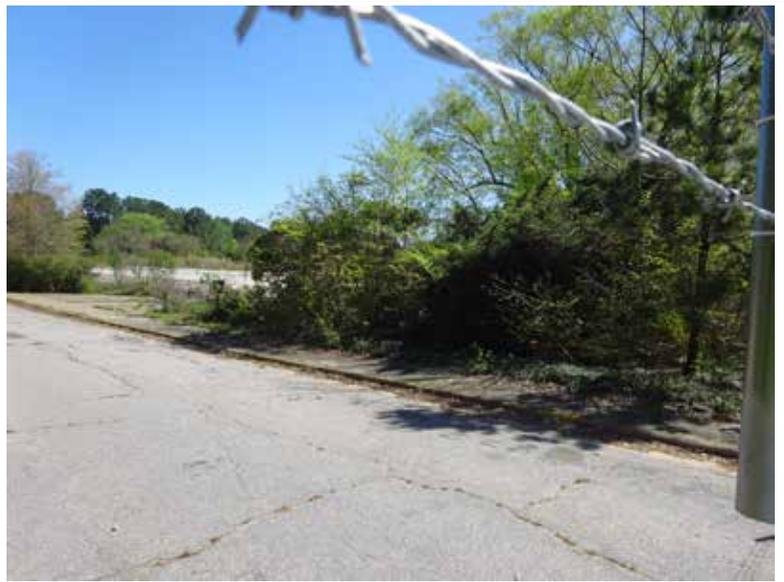
**Photograph 5:**

View of the concrete pad and former building location facing southwest from the Wake Forest Rd driveway.

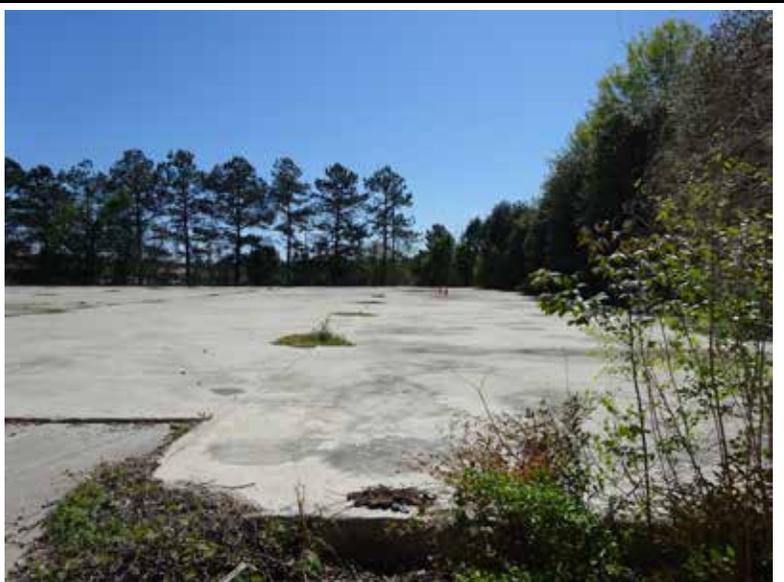
**Photograph 6:**

View of the concrete pad and former building location facing south from the former main entrance of the building along Wake Forest Rd.

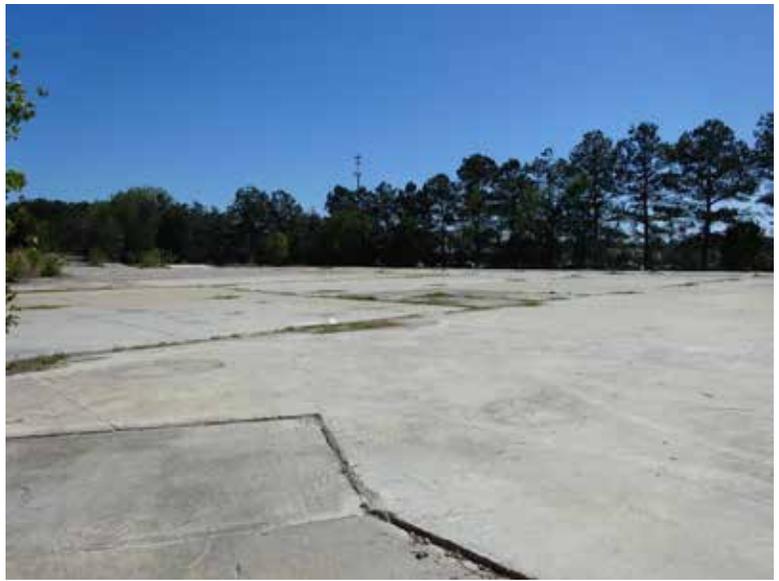
**Photograph 7:**

View of the concrete pad and former building location facing southeast from the former main entrance of the building along Wake Forest Rd.

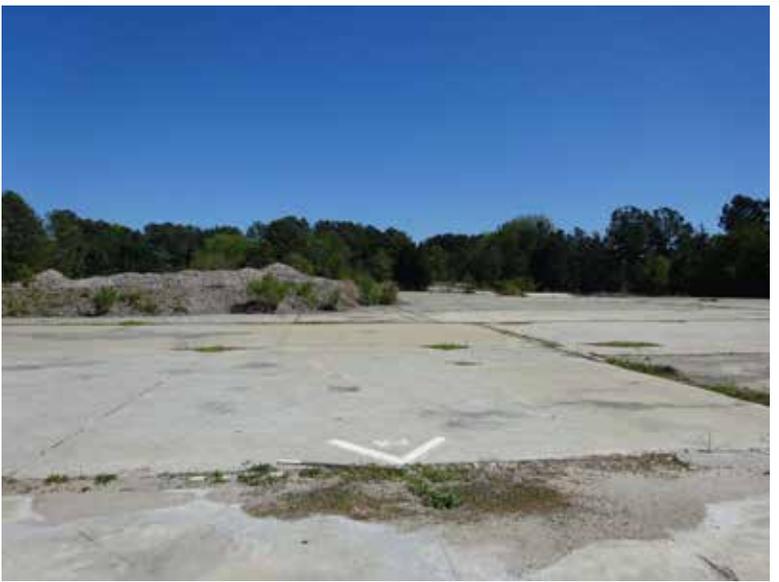
**Photograph 8:**

View of the concrete pad and former building location facing east from the former main entrance of the building along Wake Forest Rd. Recycled crushed concrete building material is shown stockpiled on the site. A portion of this crushed concrete building material was used as backfill during the soil blending in-situ remediation activities.

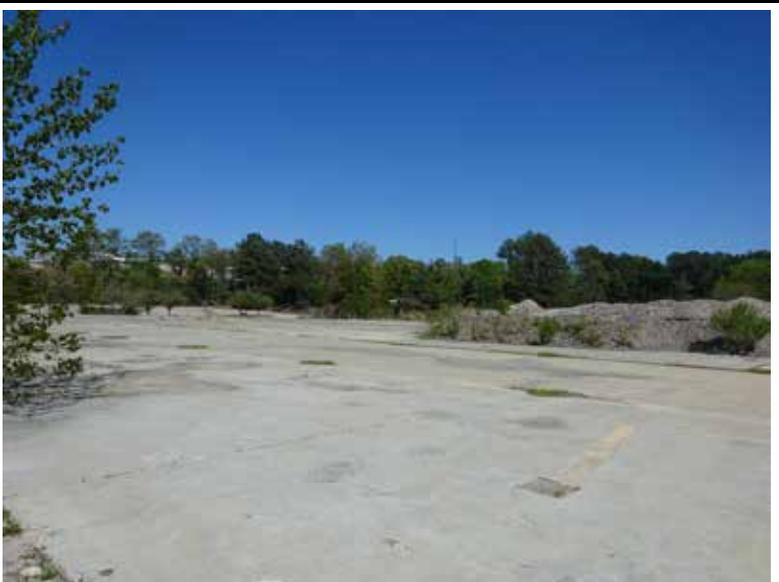
**Photograph 9:**

View of the concrete pad and former building location facing northeast from the former main entrance of the building along Wake Forest Rd.
