FACILITY COMPLIANCE INSPECTION REPORT
Division of Waste Management
Solid Waste Section

Date of Site Inspection: 06/15/2016

Landfill No. 6
1155 Incinerator Rd
Canton, NC 28716

Comprehensive Inspection

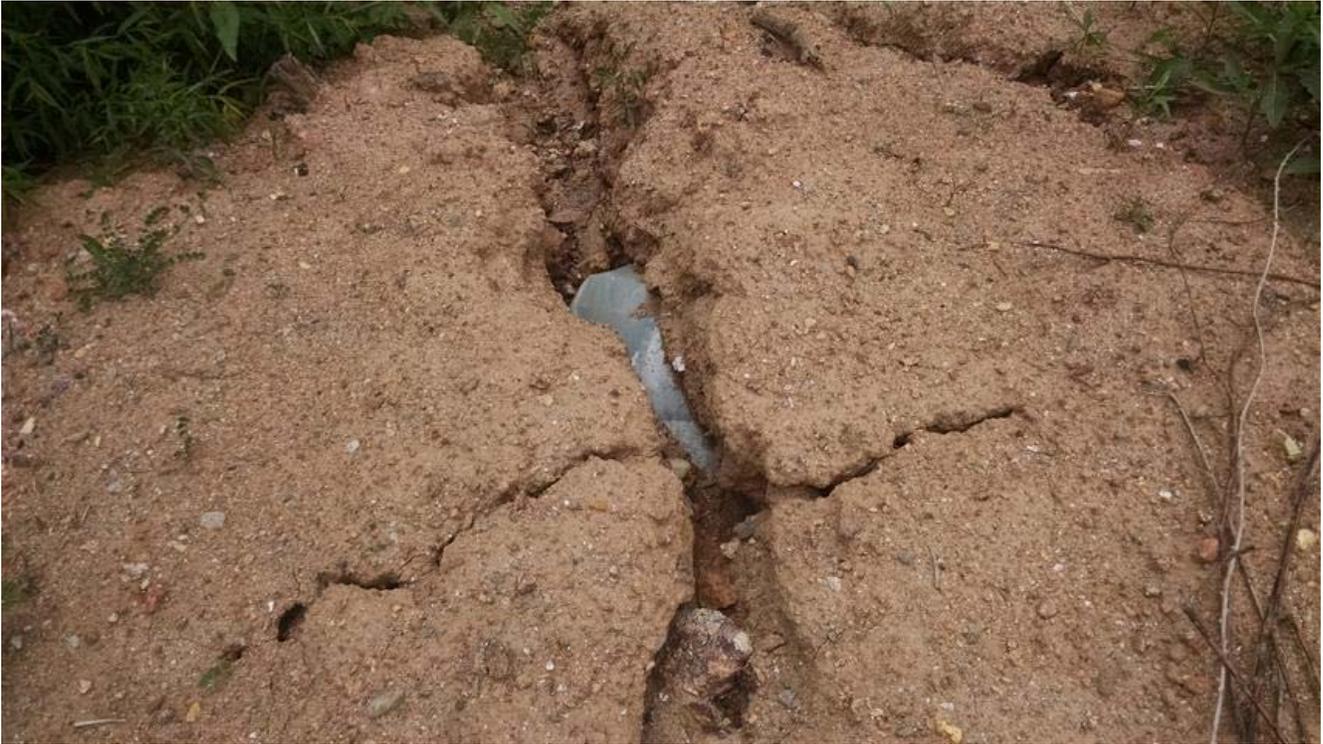
During the June 15, 2016 inspection, exposed asbestos bags were observed in several areas in the Asbestos Containing Materials (ACM) disposal area. It appeared that the ACM had been covered with adequate soil cover at time of disposal,

however excessive rill erosion and lack of groundcover caused the material to become exposed.

Exposed Waste in Asbestos Containing Material (ACM) disposal area

- Major rill erosion was observed in the Asbestos Containing Material (ACM) disposal Area. It appeared that proper soil coverage was over waste at the time of disposal however cover had been eroded. **Please see observed violations section of this report.**

- Four locations of exposed asbestos waste bags were observed during the inspection. **This waste must be covered immediately. Please see observed violation of this report.**

Within ten (10) days Evergreen Packaging Inc. and Blue Ridge Paper Products Inc. must repair the rill erosion, replace the 18 inches of cover soil as specified in the “*Operations & Maintenance Manual Landfill No.6, section 2.9.3.2 Site Security and Maintenance.*” Seed and mulch the area with the intent to establish a groundcover sufficient to restrain erosion in the Asbestos Containing Material (ACM) area.

- Facility staff stated that the ACM area is not used on a frequent basis. **Groundcover sufficient to restrain erosion needs to be established to prevent further erosion issues in this area.**

- On June 16, 2016 facility staff sent pictures of repairs to the cover soil that were made in the Asbestos Containing Material (ACM) area. **Please ensure that 18 inches of cover soil is replaced in the eroded areas as specified in the “Operations & Maintenance Manual Landfill No.6, section 2.9.3.2 Site Security and Maintenance.”**

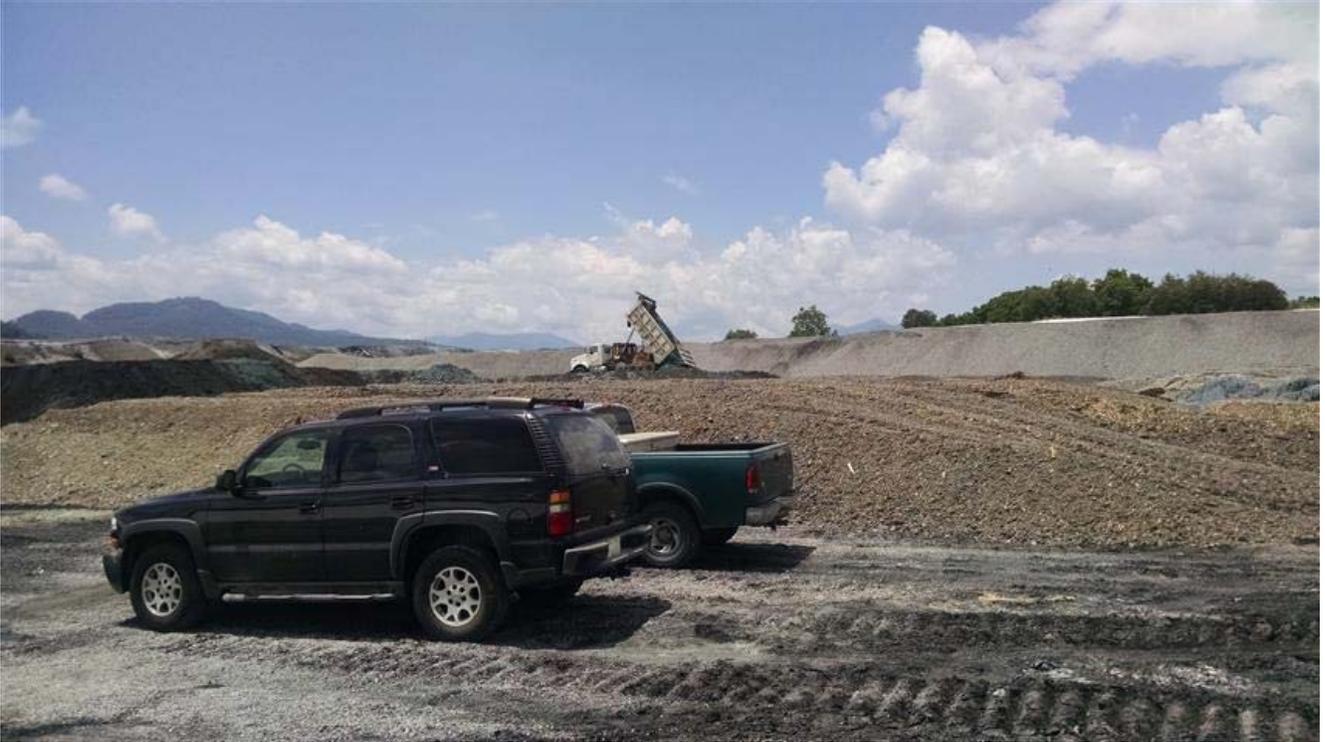
- Multiple working faces were being utilized at the time of inspection depending on the consistency of the fill material.
- No unapproved material was observed at the time of inspection.

Working Face of Landfill

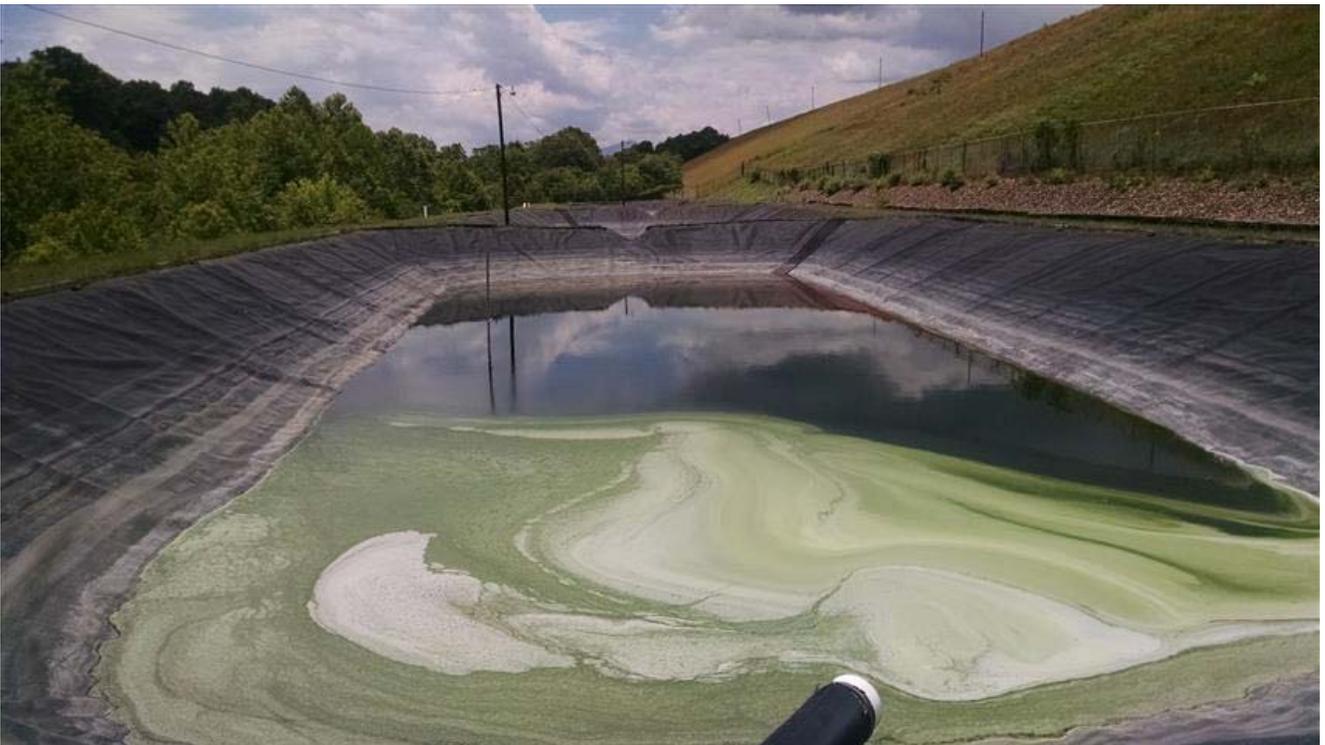
- Landfill side slopes were being maintained at the time of inspection.
- Edge of Waste Markers were observed on all fill areas on the landfill.
- Three leachate ponds were observed at the time of inspection and the liners appeared to be in good condition.

Leachate Collection Pond
