FACILITY COMPLIANCE INSPECTION REPORT
Department of Environmental Quality
Division of Waste Management - Solid Waste Section

Date of Site Inspection: 2/24/2016 **Date of Last Inspection:** 4/27/2015

Duke Energy Corporation
 Belews Creek Steam Station
 Structural Fill (Equipment/material staging area and overflow parking lot)
 Pine Hall Road
 Belews Creek, NC 27009

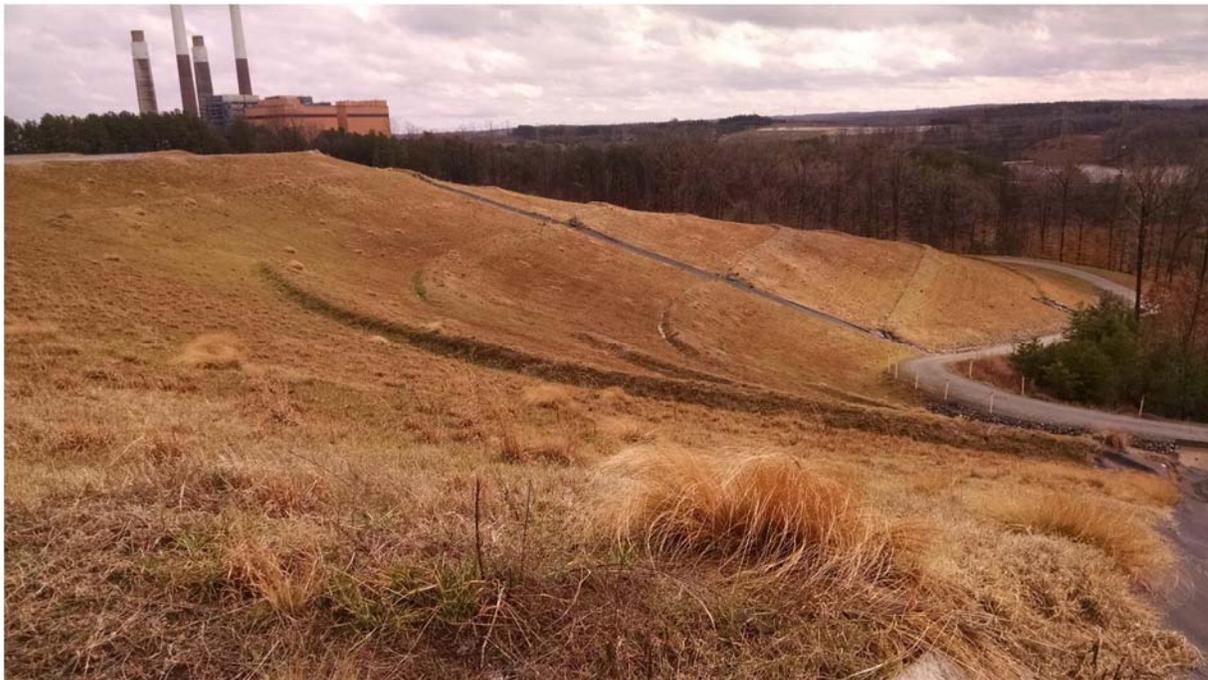
5. Final cover is being well maintained. Native vegetation is covering the side slopes of structural fill. The top of the fill is covered in compacted stone. No erosion or ponded water was observed during the inspection.

Side slopes on the southeastern corner.

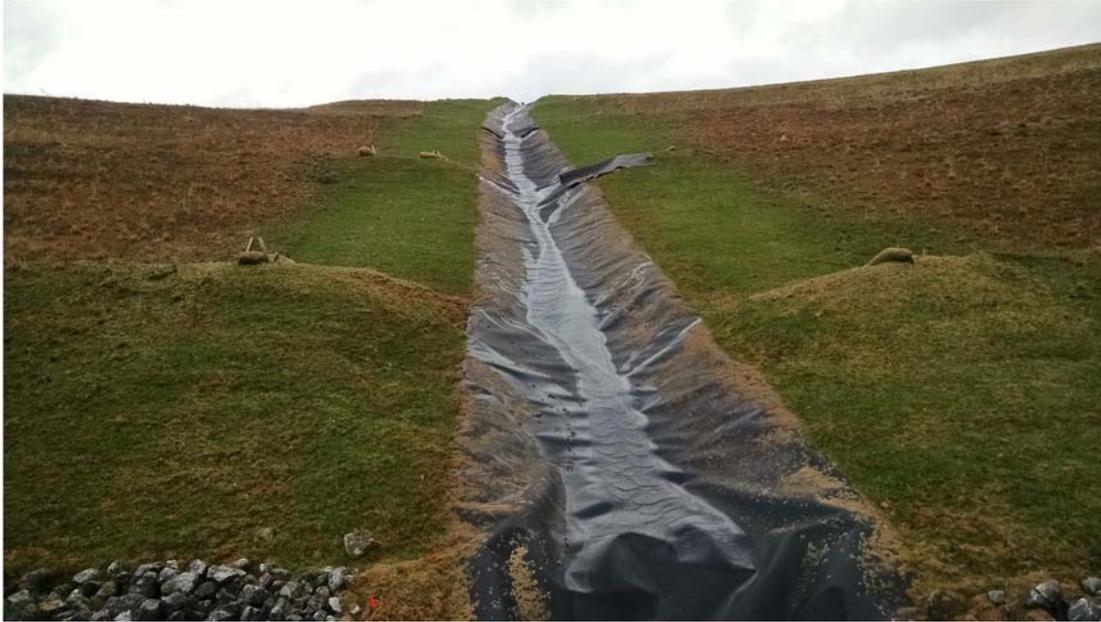
6. A slope drain on the southeastern side of the structural fill had been recently repaired due to some undercutting having occurred around the drain.

Repaired slope drain
