PHOTOGRAPHIC RECORD

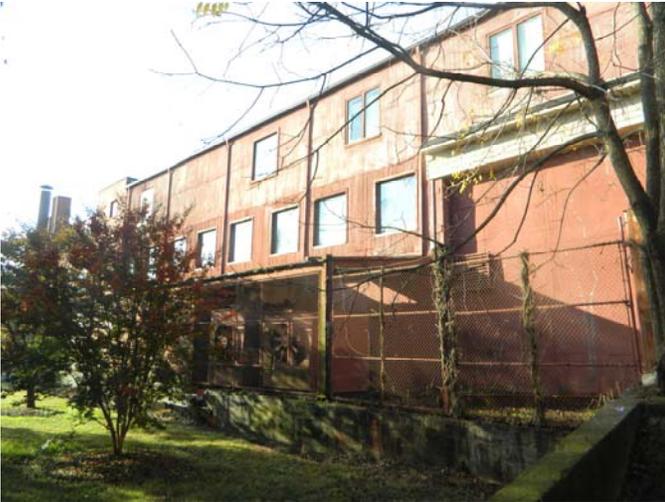
Photograph 1 - Subject Site - East Side

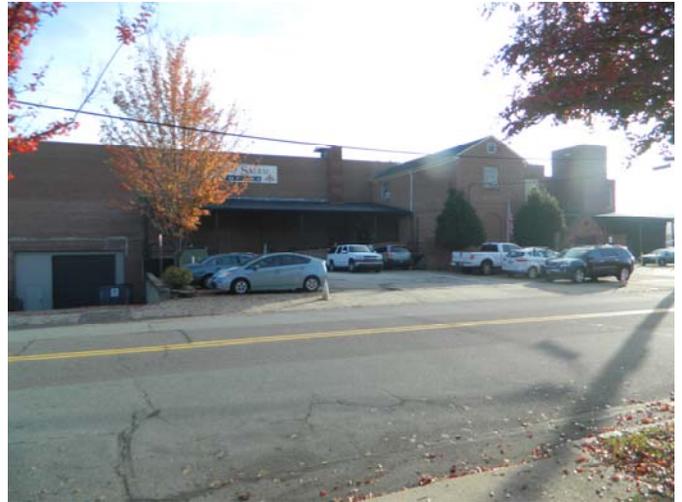
Photograph 2 - Subject Site - West Side

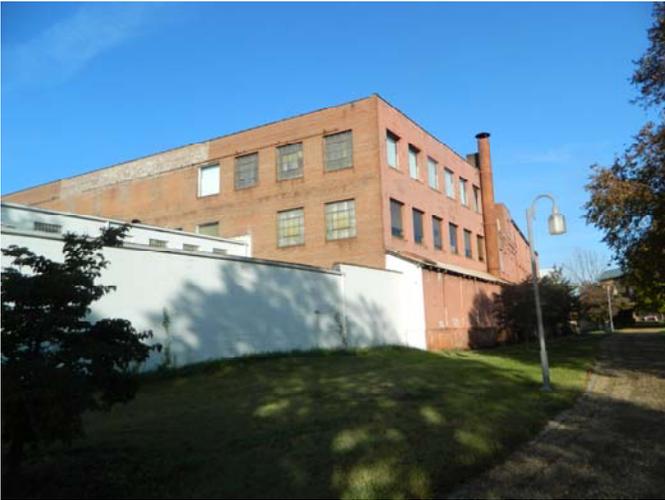
Photograph 3 - Subject Site - Southeast Side

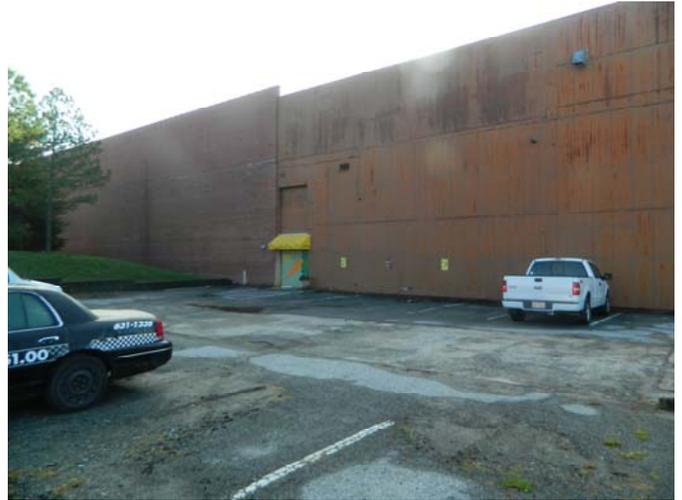
Photograph 4 - North Side

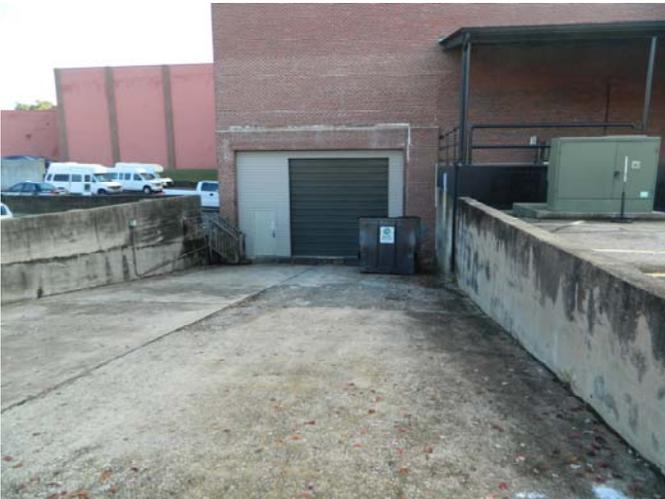
Photograph 5 - Subject Site - Northwestern Loading Dock

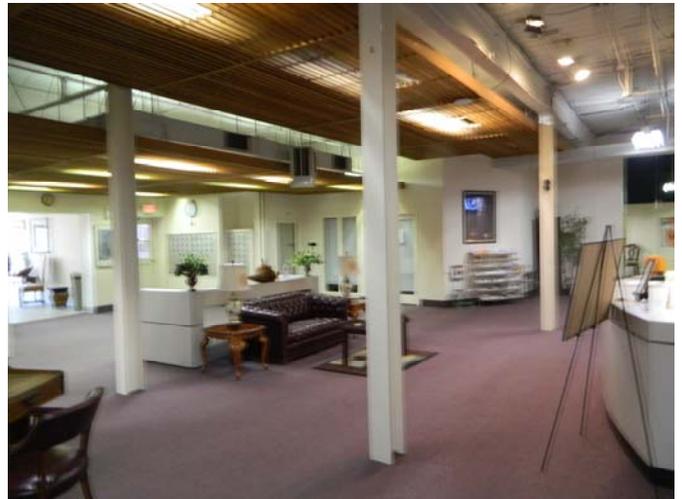
Photograph 6 - Subject Site - 1st Floor Interior

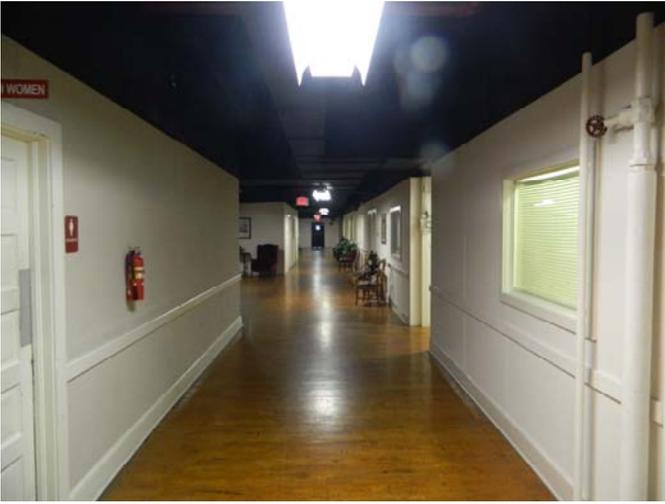
Photograph 7 - Subject Site - Typical Interior Hallway

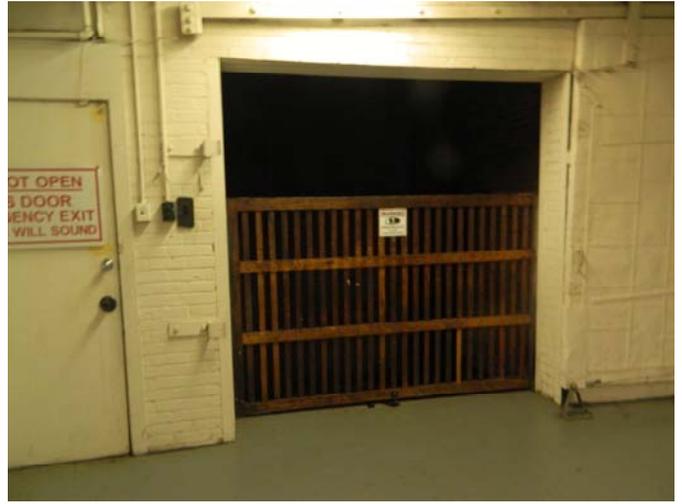
Photograph 8 - Subject Site 1 of 2 Elevators

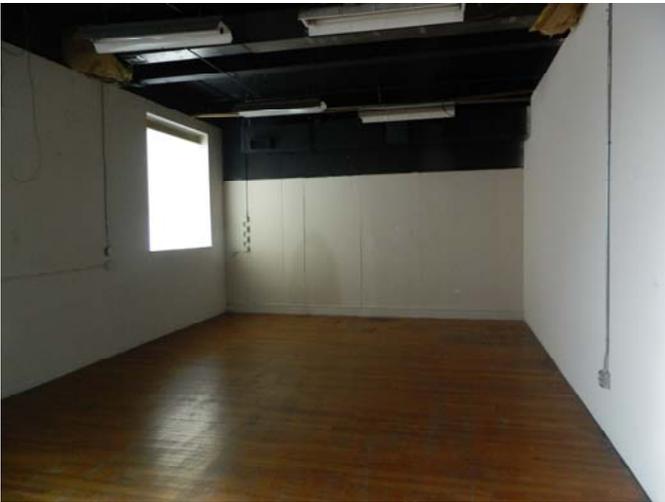
Photograph 9 - Subject Site - Typical Available Office Space

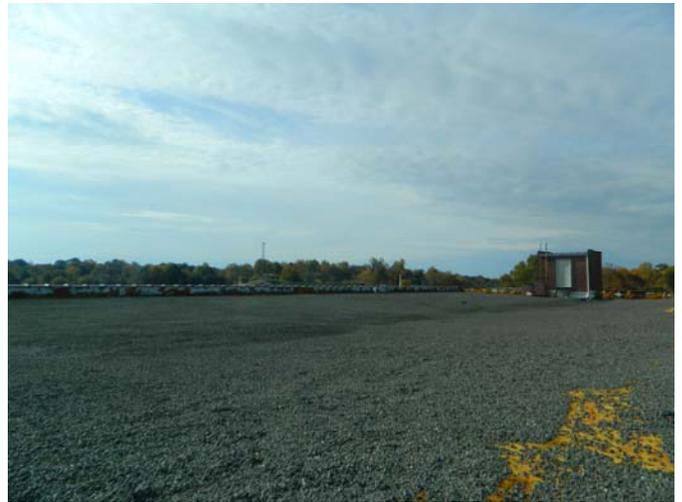
Photograph 10 - Subject Site - Tar and Gravel Roof

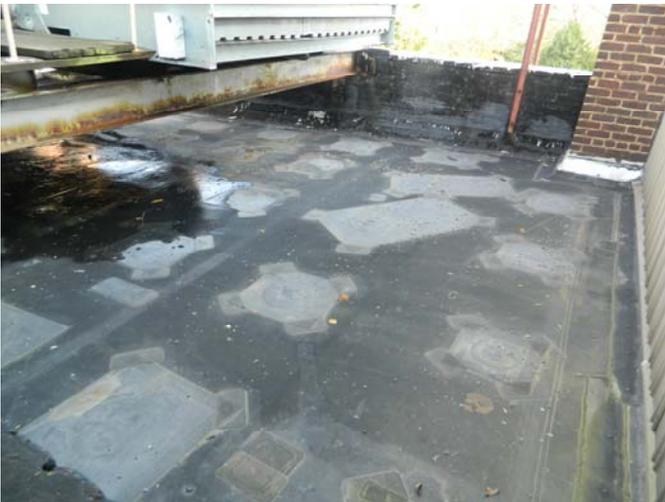
Photograph 11 - Subject Site - Rubber Membrane Roof

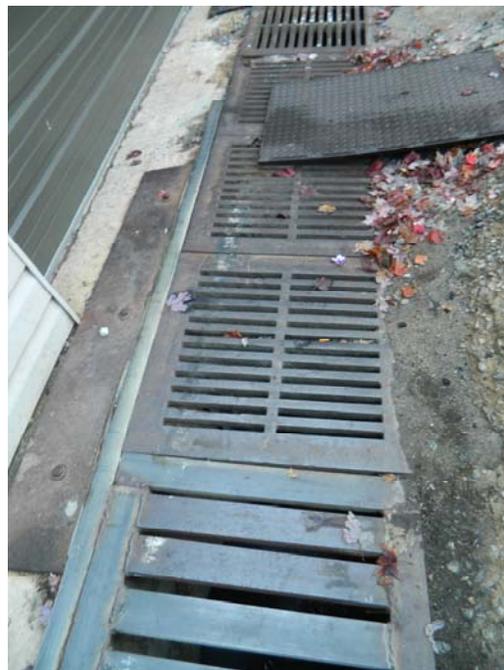
Photograph 12 - Drop Inlet (Loading Dock)

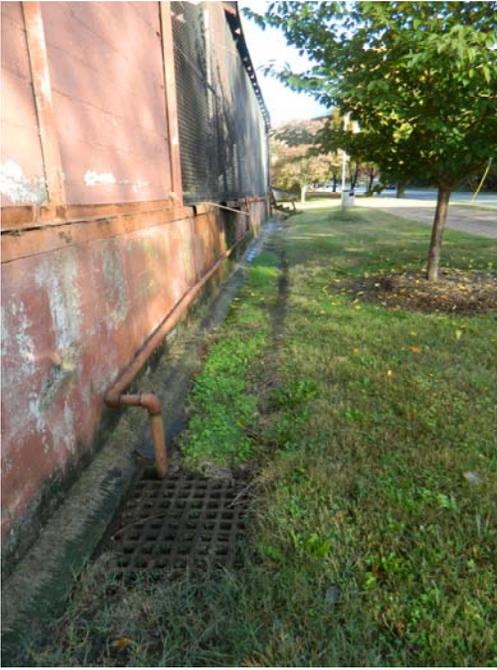
Photograph 13 – Drop Inlet Eastern Side of Property

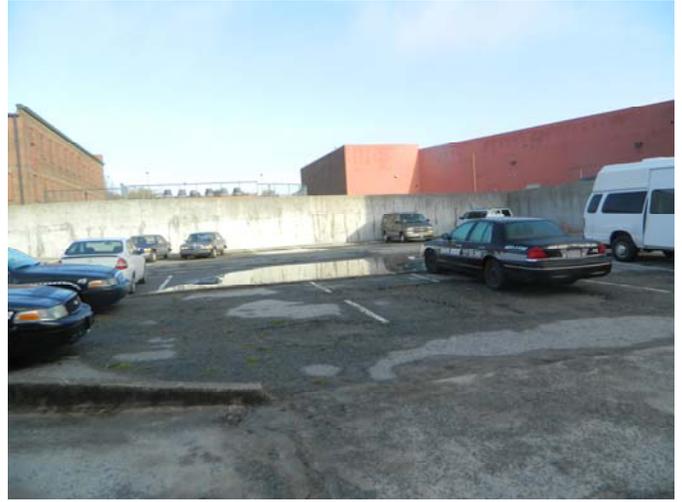
Photograph 14 – Northern Adjacent Property

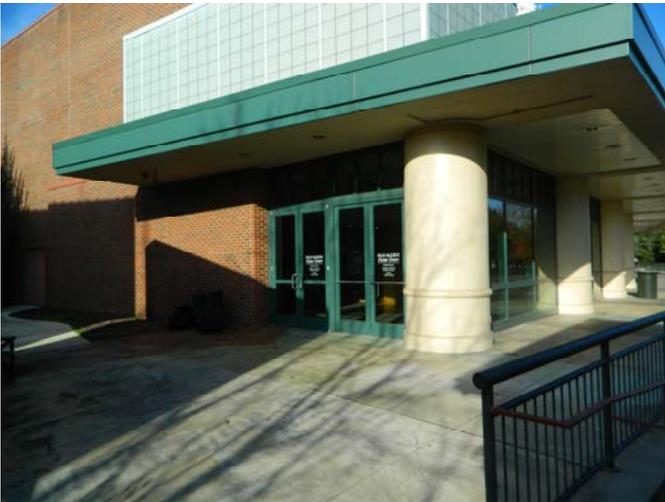
Photograph 15 – Northern Adjacent Property (Old Salem Visitors Center)

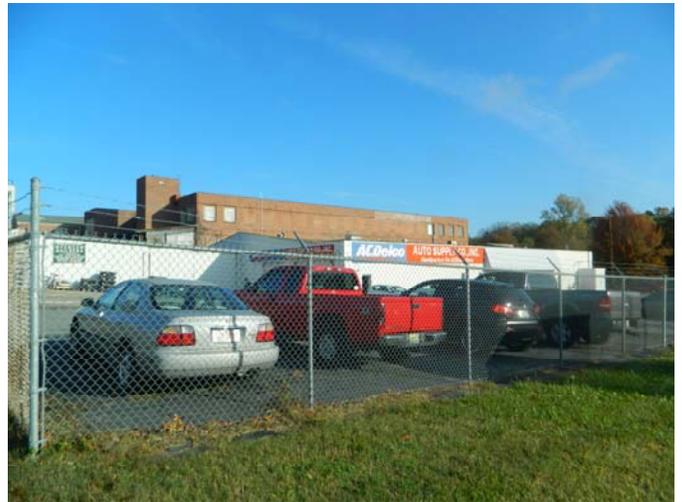
Photograph 16 – Southern Adjacent Property (Delco)

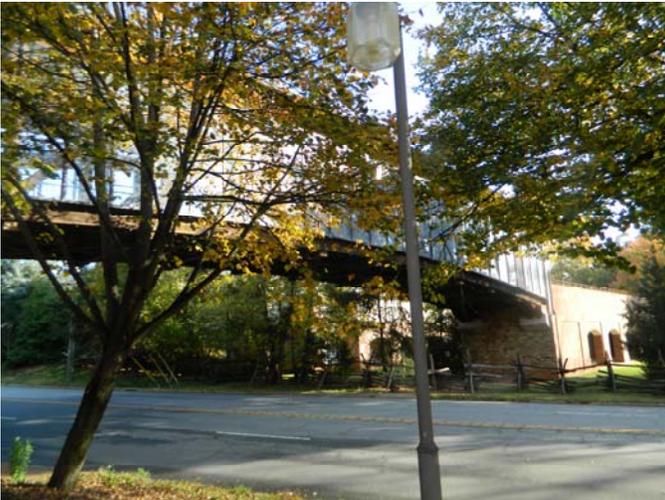
Photograph 17 – East View Across Old Salem Road

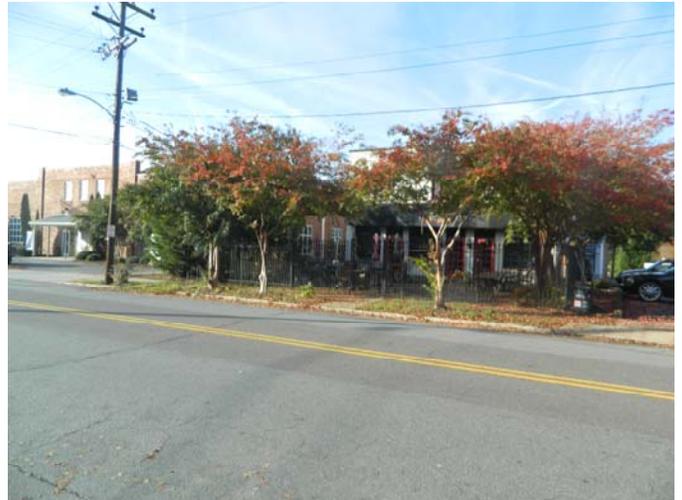
Photograph 18 – West View Across Marshall Street, SW

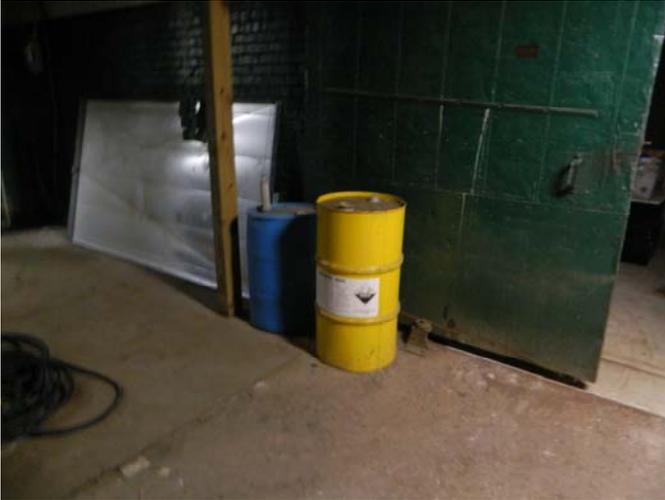
Photograph 19 - Drum - Biocide

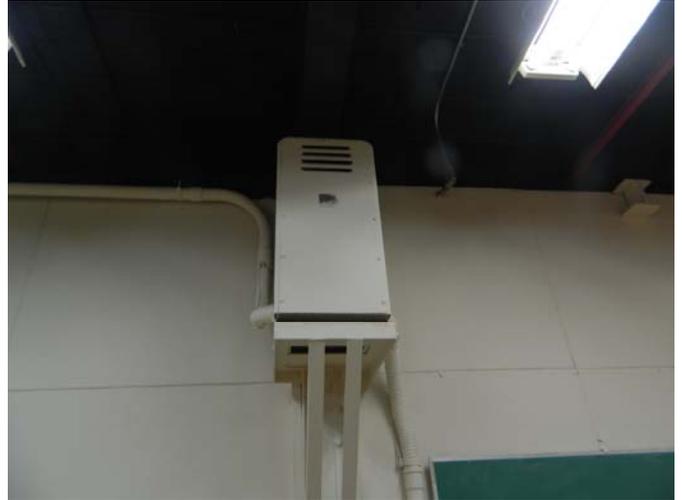
Photograph 20 - Wall Mounted Transformer

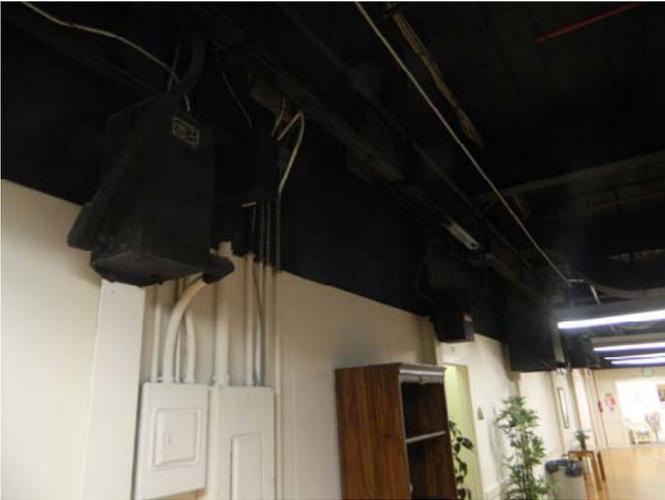
Photograph 21 - Wall Mounted Transformer

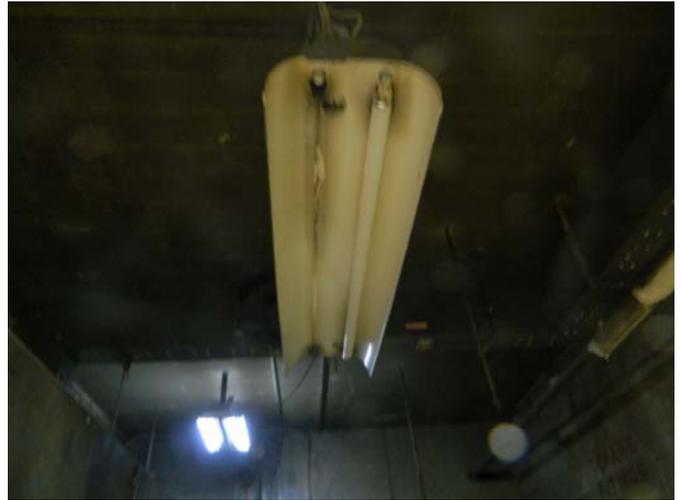
Photograph 22 - Subject Site - Fluorescent Light

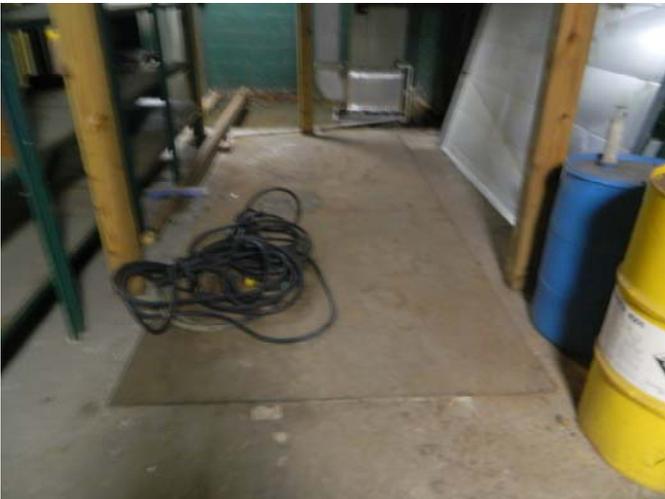
Photograph 23 - Steel Covered Process Drain

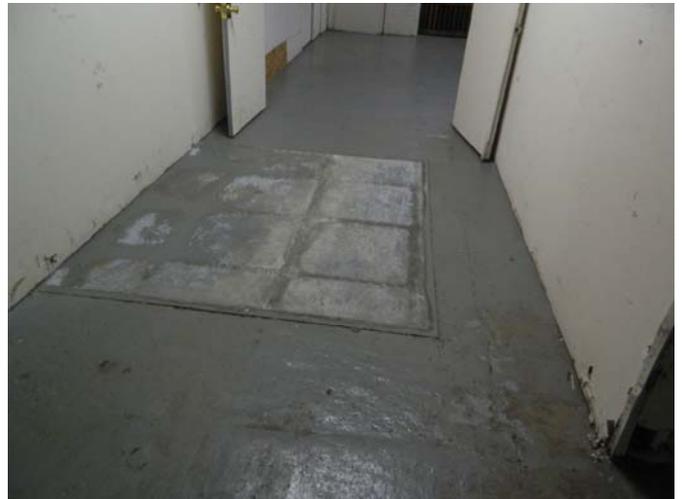
Photograph 24 - Concrete Filled Process Drain or Scale

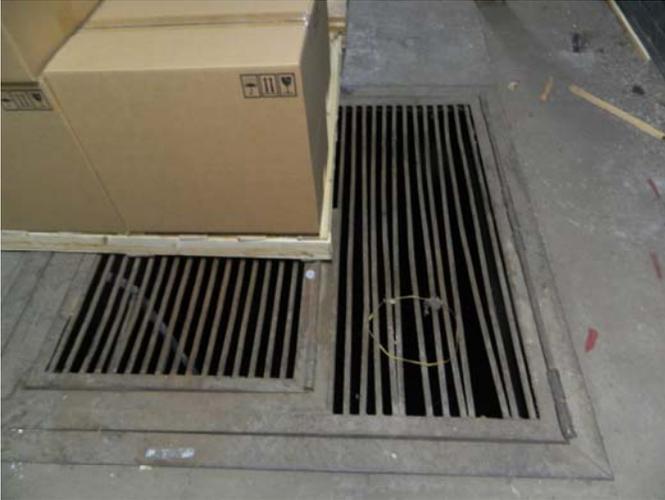
Photograph 25 - Process Drain

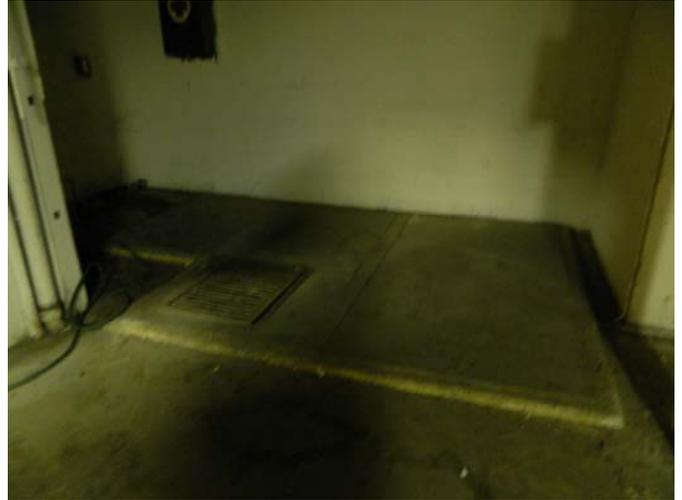
Photograph 26 - Process Drain

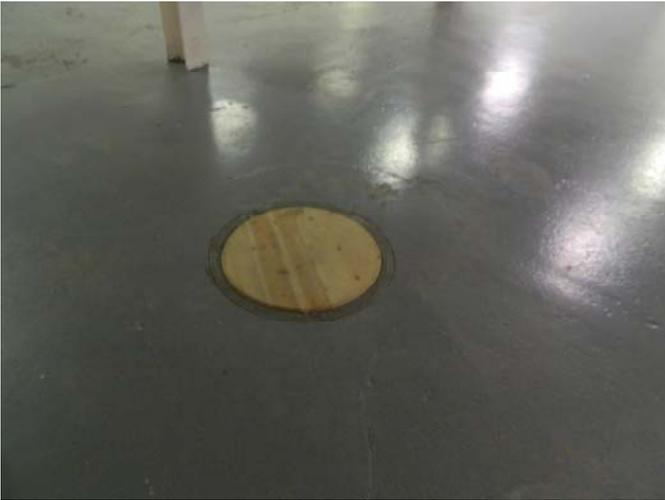
Photograph 27 - Sewer Manway

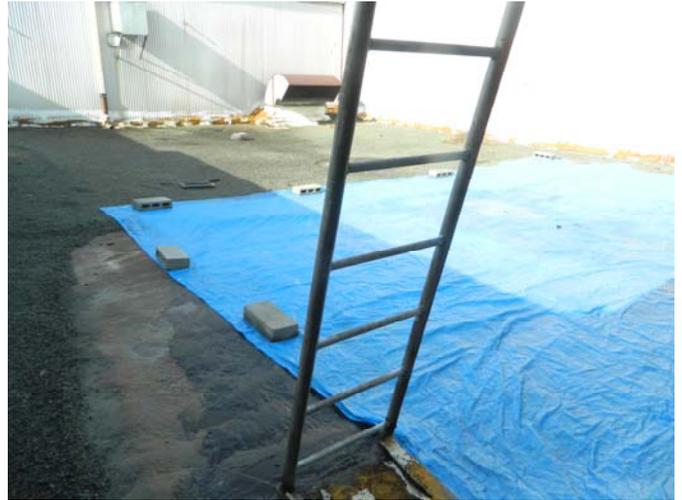
Photograph 28 - Roof Tarp

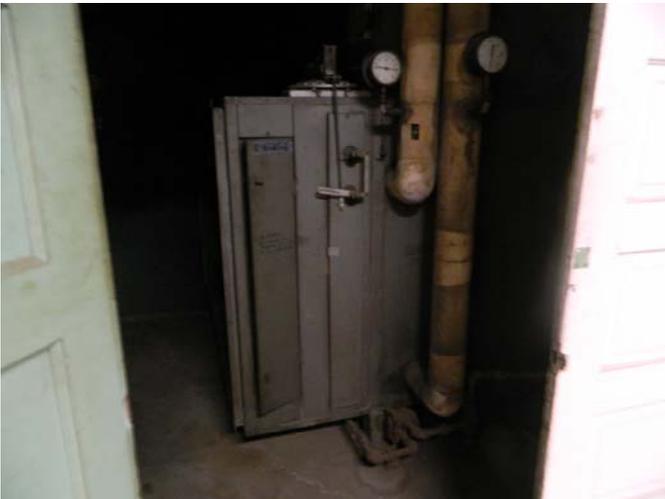
Photograph 29 - Suspect ACM Pipe Wrap

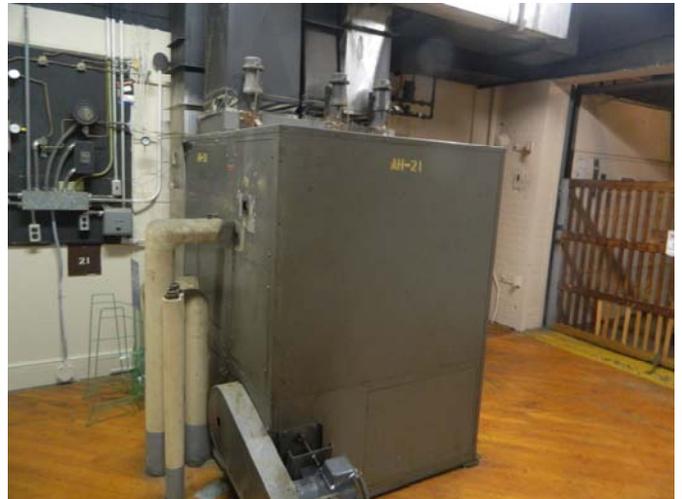
Photograph 30 - Suspect ACM Pipe Wrap
