FACILITY COMPLIANCE INSPECTION REPORT
Division of Waste Management
Solid Waste Section

Date of Inspection: 28 July 2016

Garner LCID Site
Lake Road
Havelock, NC 28557

N1060_INSP_20160728

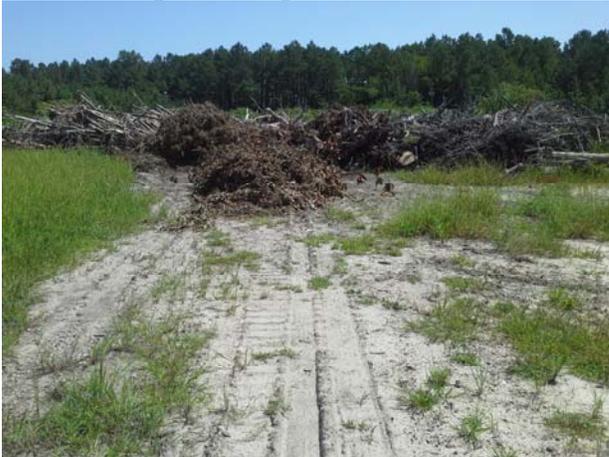
- 13) The waste type being disposed is LCID waste only; no unacceptable waste streams were observed during this Facility Compliance Inspection.

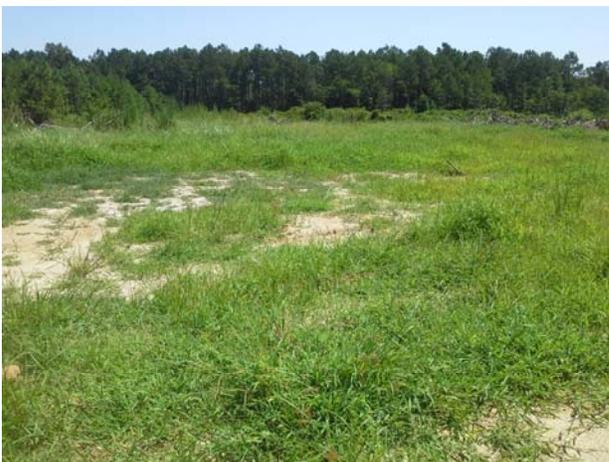
- 14) The area around the toe of the landfill has been cleared and mowed, providing for access around the landfill.
- 15) Overall, the inactive areas of the landfill have been covered with native warm season grasses and/or a natural coppice-type cover.

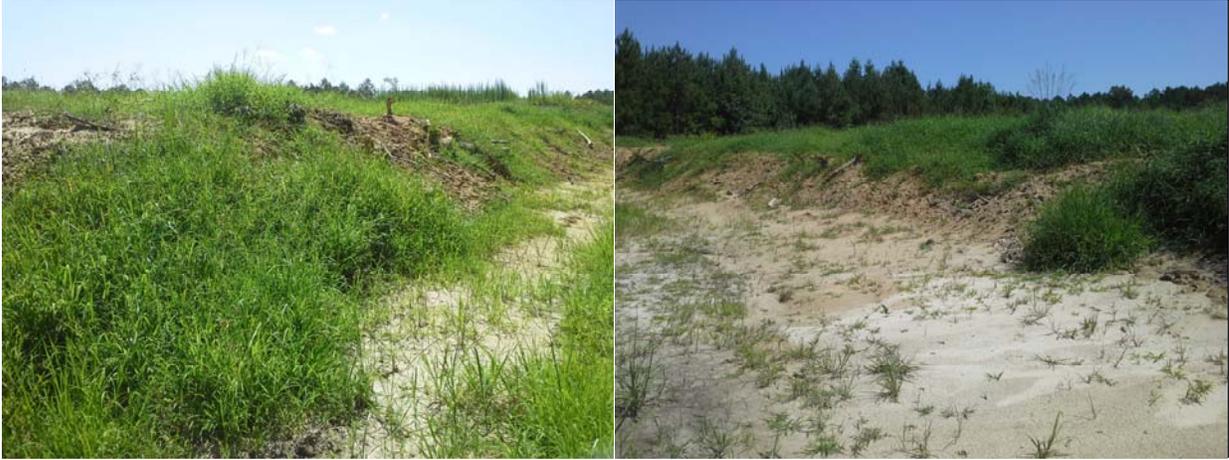
- 16) Many of the uncovered and uncompacted areas noted in the previous Facility Compliance Inspection Report (please see N1060-20160217INSP) have been covered, graded, and seeded. However, portions of the outside slopes are still in need of compacting and covering. *Please continue working to ensure that all outside slopes

are covered and graded at a slope not greater than 3:1, and are seeded and mulched to establish a groundcover suitable to prevent erosion of the landfill cap system.
