SITE ASSESSMENT FIRST PHASE REPORT

Gaston County Landfill (Mt. Holly Landfill)

NONCD0000321

June 1, 2010

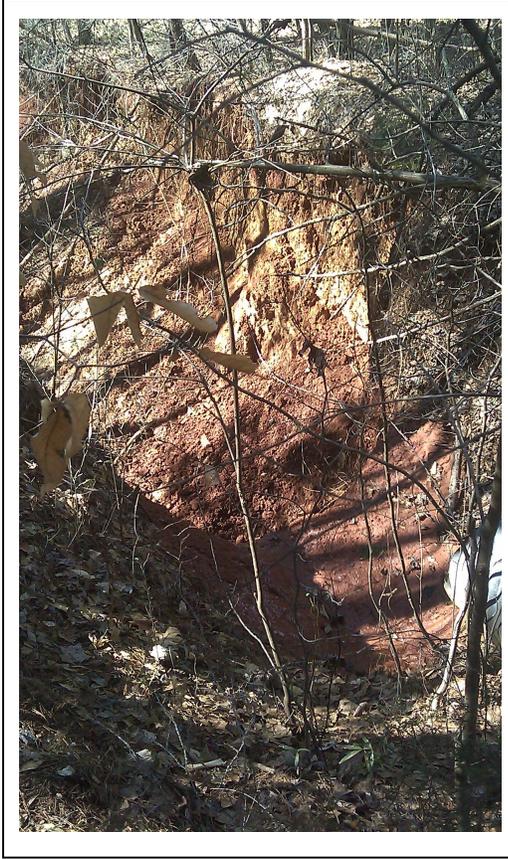
Frame No. 1 View of scoured ditch from former sediment pond to stream that traverses southwest portion of Robert Shannon property.

Correction of the stormwater discharge from the property will be necessary to prevent the scoured area at this outfall from expanding. It appears that left uncorrected the scour will eventually advance the limits of the eroded ditch northward through the berm of the former stormwater control pond. Eventually this erosion will reach the limits of the disposal area, however, the timeframe required to produce that level of destruction is uncertain.

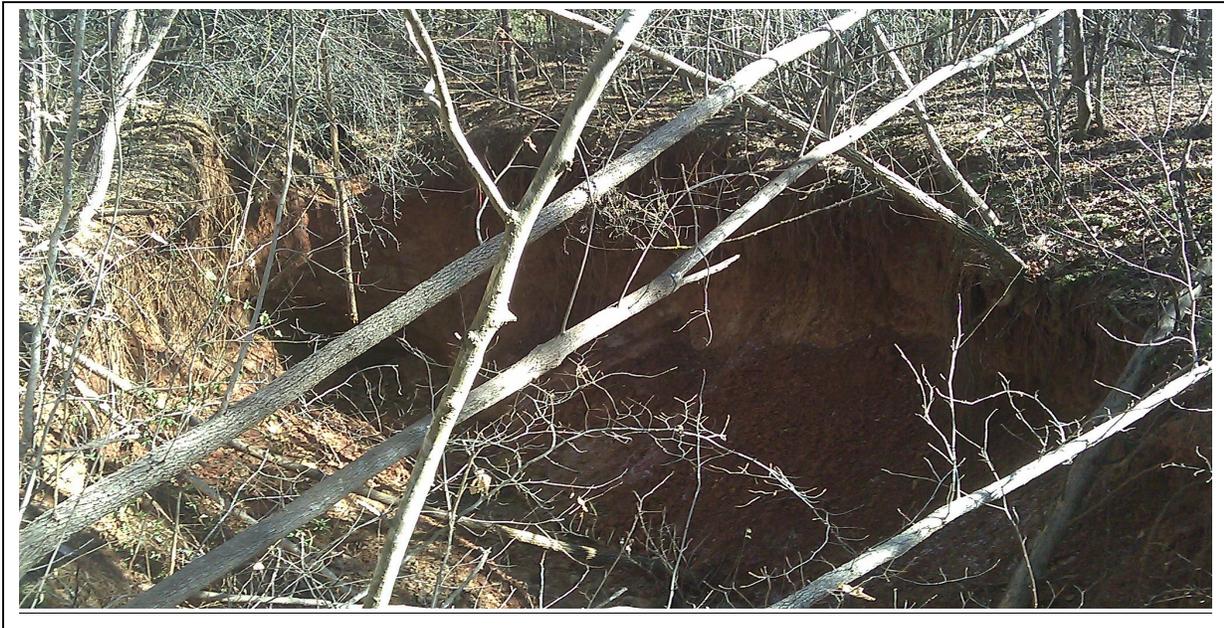
Frame No. 2 Another view of scoured ditch line.

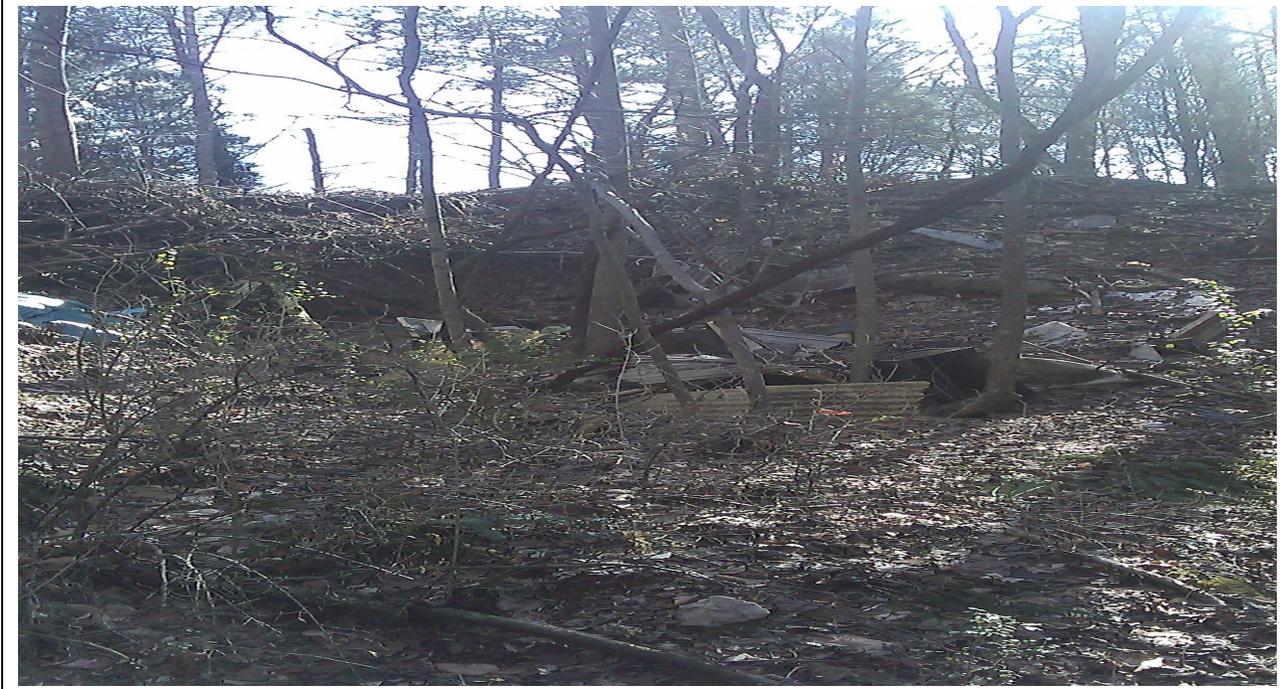
The majority of the 10.00- acre-disposal area is located beneath the cleared portion of the site used as pasture land. An area of surface dumping is present on the southwest property boundary with the mobile homes along Angel Ham Road. The refuse appears consistent with rural dumping of mainly household items, appliances, tires, etc. along the property boundary. This portion of the property is wooded and the refuse is deposited along the steep slope in this location.

Frame No. 3 View of apparent surface dumping along the southwest property boundary.

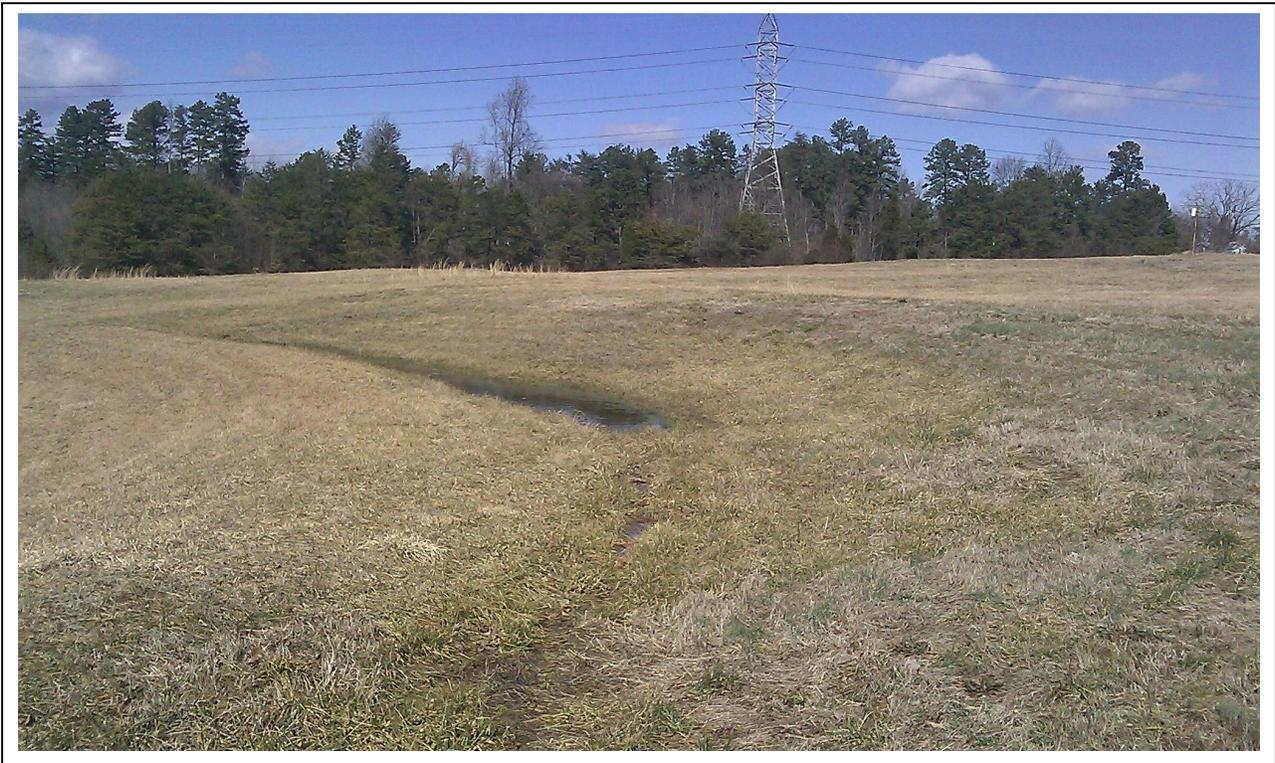
The disposal area has several grassed terraces serving as stormwater diversions that are aligned across the short axis of the grass covered field. Numerous areas of ponded water were observed along the berms. The non-uniform surface flow of water along the berms appears attributable to possible settlement of the disposal area with time and or the deposit of silts and sediment along the berm alignments. Photographs are included in Appendix A.

Frame No. 4 View of ponded water at terrace/berm on landfill cap.

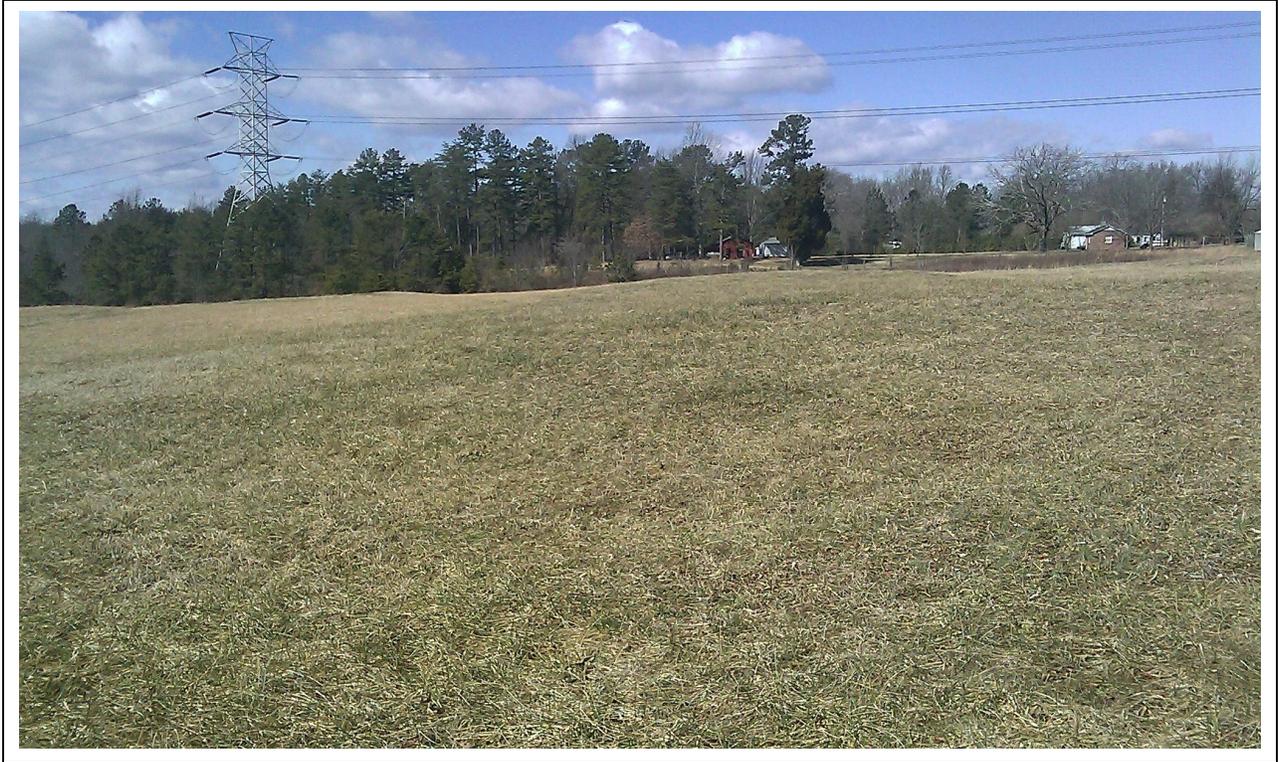
The surface condition of the disposal area appears in overall good condition. No exposed waste, attributable to the reported disposal area limits, was observed during the site visit. It is apparent that the hay cultivation practices have served to maintain the cover cap condition and has for the most part prevented erosion of the cover by maintaining a permanent vegetated cover.

Frame No. 7 View of landfill cap condition.

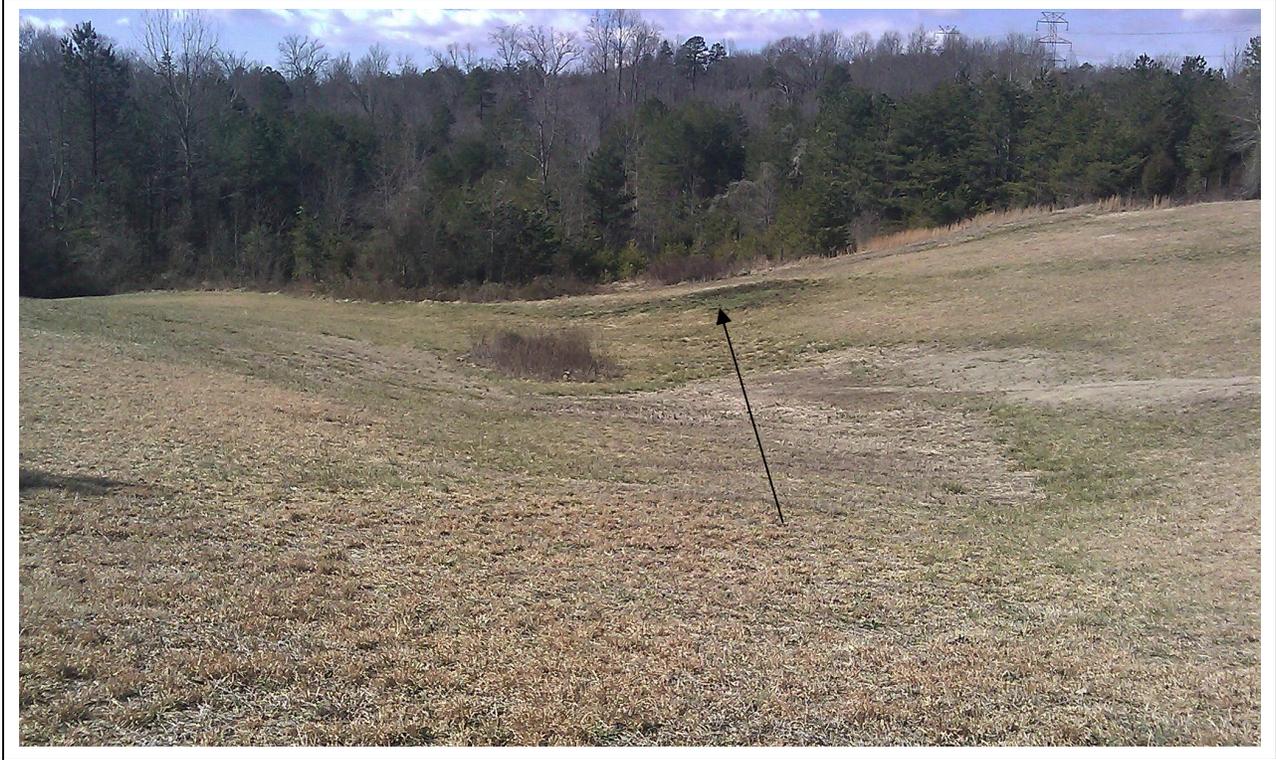
Schnabel reported that potential gas migration pathways were observed on the disposal area and site. A stormwater grate and drainage pipe was observed west of the seep on the disposal area.

Frame No. 11 View of drain inlet and area of seep in background.

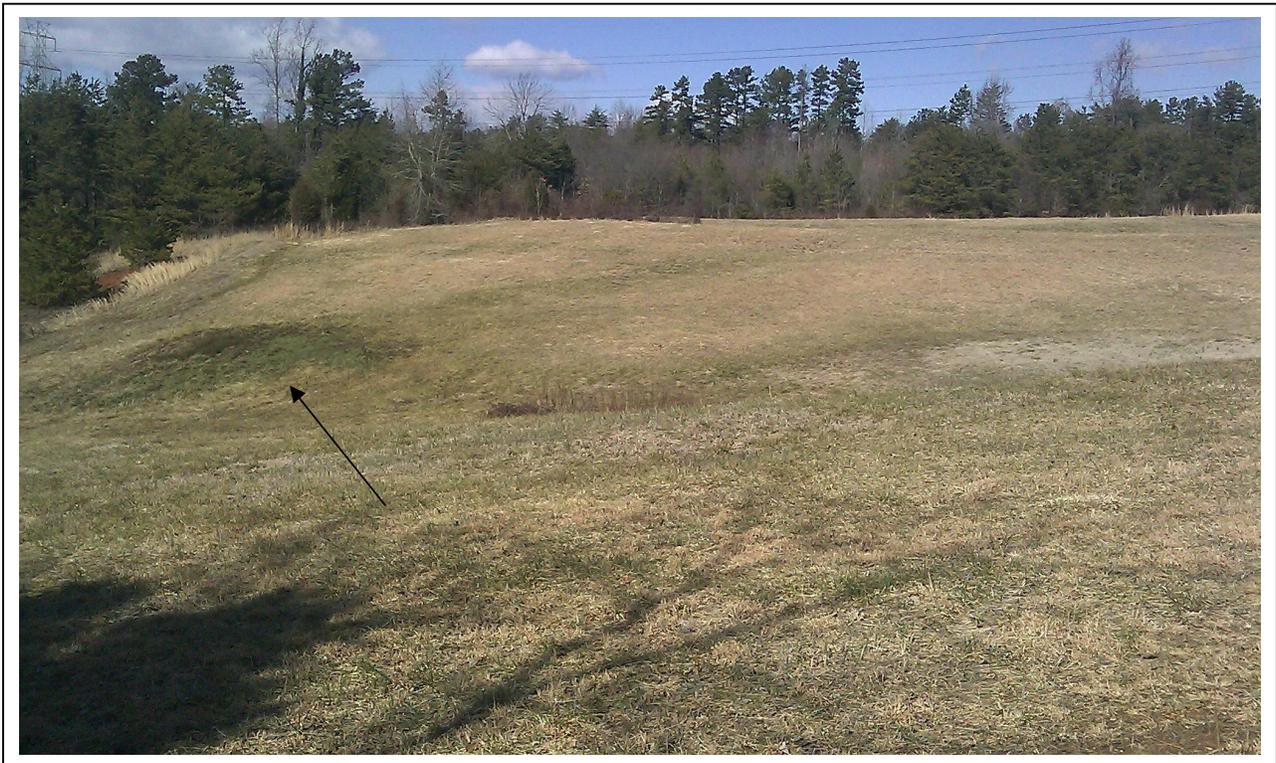
The southwest corner of the disposal area contains an obvious surface seep of water through the cap. This area is approximately 25 by 25 feet. One the day of the February visit the water from the seep did not contain obvious staining, however, the vegetation in the area appeared to be a deeper shade of green and slightly more dense than the surrounding pasture grasses which were dormant from the winter months. Although a log of the type and species of grasses was not maintained as part of this initial site investigation, it appeared that on the date of our visit the vegetation within the seep area contained the presence of algae or moss, distributed between the blades of established pasture grasses. The seep may be associated with a possible thin surface cap in this location coupled with the upslope ponding and preferential infiltration of water at the stormwater diversion berms. A second smaller seep was observed east of the larger berm within the disposal area.

Frame No. 12 View of seep on grassed slope.

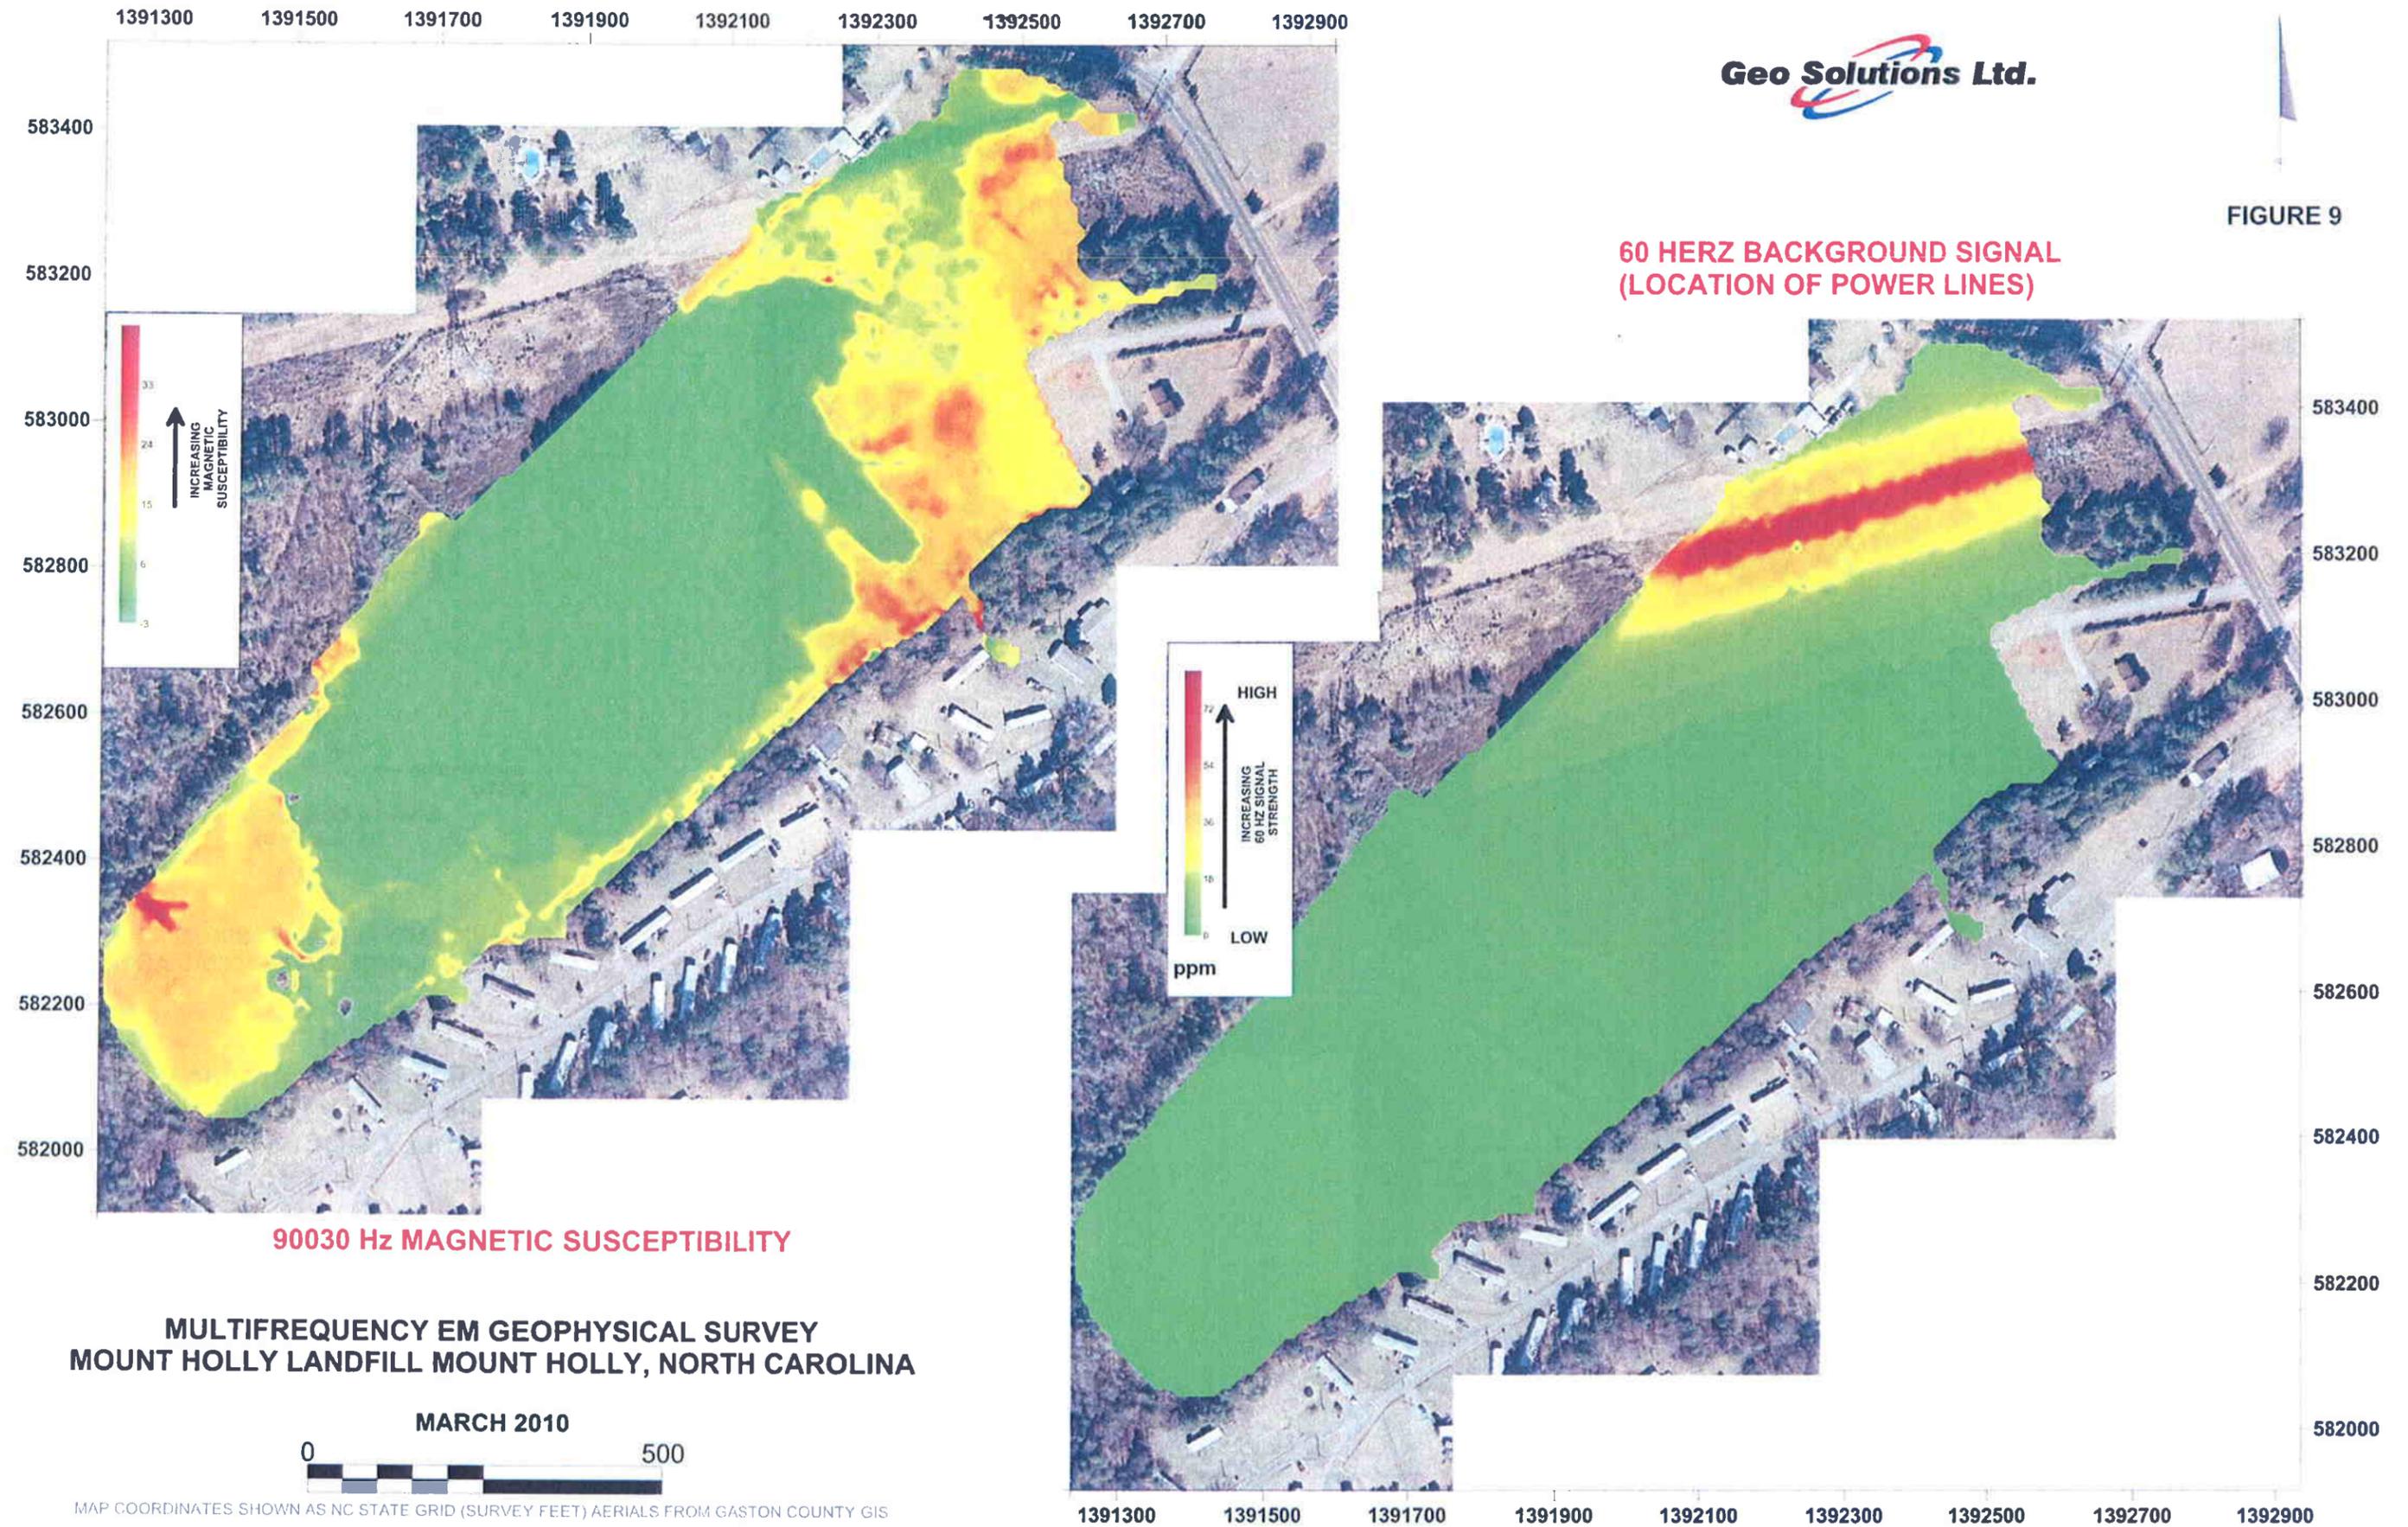
FIGURE 9

Additionally, Geo Solutions prepared a figure showing the magnetic susceptibility of the site soil at the 90030 Hz frequency, and the location of energy levels from 60-cycle alternating current (AC) "Hum" (Figure 9). The magnetic susceptibility indicates that the natural soil conditions are higher than the fill material in the landfill proper. The lack of large anomalies in the fill likely excludes the presence of large metal objects, and/or reinforced concrete debris.

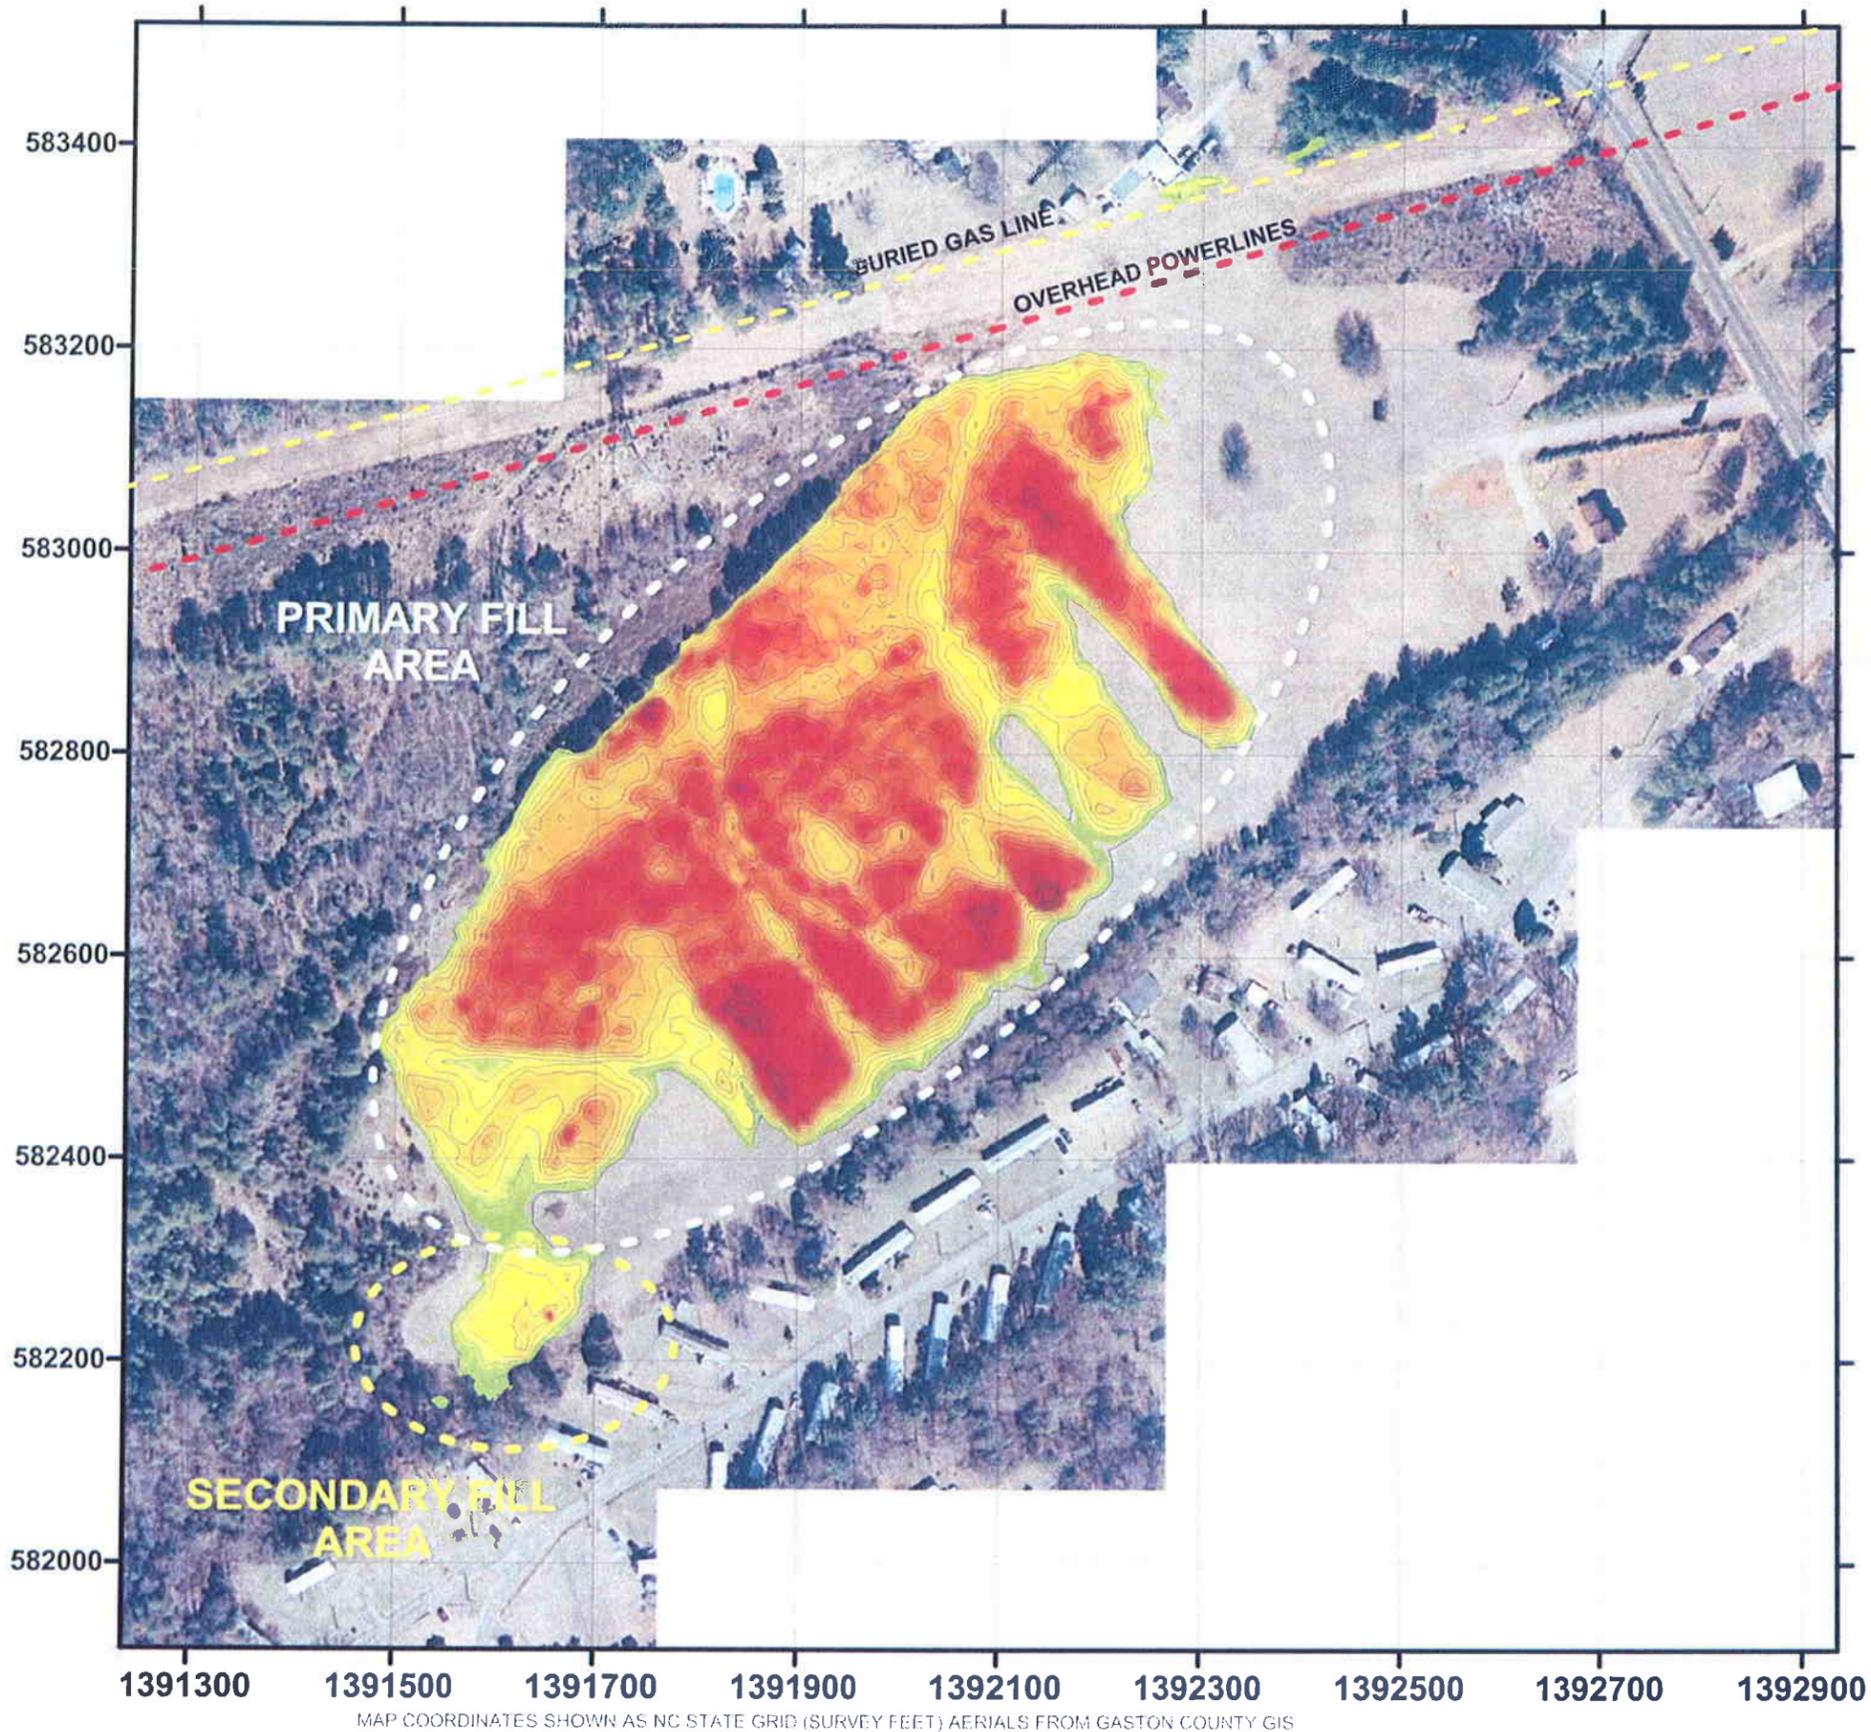
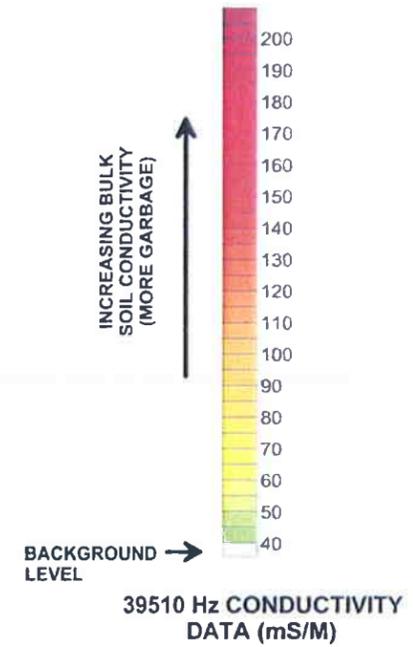
FIGURE 10

GeoSolutions field survey identified the presence of two disposal areas, a main disposal area (Area A) and a secondary, much smaller, disposal area (Area B). Figure 10 of the GeoSolutions report attached in Appendix D of this report depicts their interpretation of the disposal areas. For a detailed description of the geophysical investigation results refer to Geo Solution's Geophysical Investigation report dated April 1, 2010.

SUMMARY OF EM FINDINGS
OUTLINE OF LANDFILL DISPOSAL AREA

W&R recommends that the survey intended to document those limits of waste identified during the recent geophysical evaluation be surveyed as soon as practicable. It was the intention of the landowner to continue active cultivation of his fields to include, plowing, disking, planting, and fertilization; and those activities could be detrimental to the completed landfill limits staking outlined in the project scope.
