FACILITY COMPLIANCE INSPECTION REPORT
Division of Waste Management
Solid Waste Section

Date of Site Inspection: 08/17/2016 Date of Last Inspection: 08/04/2016

Davidson County Integrated Solid Waste Management Facility
220 Davidson County Landfill Road
Lexington, NC 27292

Partial Inspection

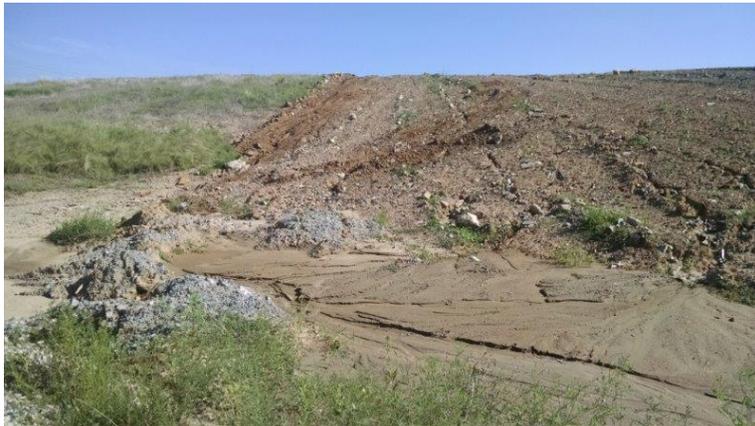
1. Additional soil had been added to the top and side slopes of the C&D landfill. The cover soil appeared to be very rocky, making it difficult to ensure even coverage and grading.

3. Some erosion was still evident at the toe of the C&D landfill, but temporary berms had been created to contain the silt and runoff (see photo below).

*Toe of C&D landfill with silt ponded at temporary berm. Note uneven grade with some uncovered waste resulting from the rocky cover soil.*

2. Mr. Sink stated that cover and grading work will continue until the required final grades are established at the C&D landfill. He added that he is working with Pieter Sheer, Smith-Gardner, to ensure that the landfill is being properly prepared for the closing process.

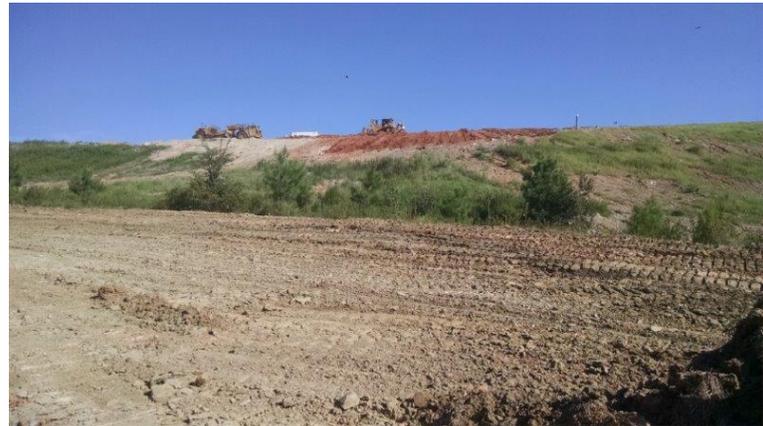
*Repairs being made along the south slope of the active MSW landfill in the area of the working face.*

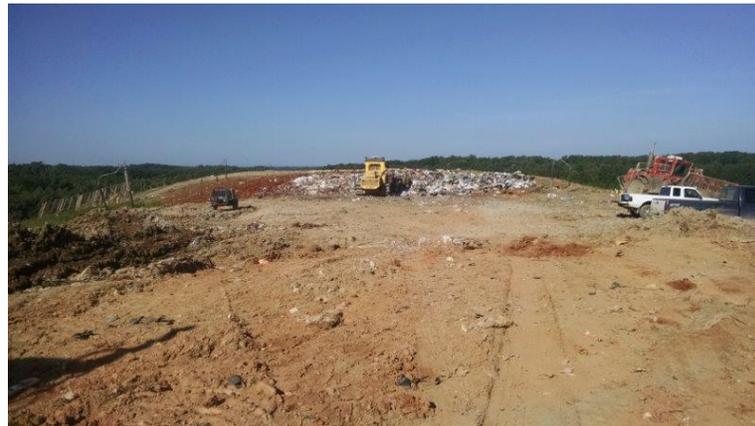
4. The working face of the MSW landfill was very compact and level and had been configured to match the final grades of the active cell. Mr. Sink estimated that there were less than five days of capacity remaining. Areas of uncovered waste were observed on the side slopes and in the area of the working face, and buzzards were seen scavenging. Ensure that all exposed waste is covered at the end of each working day.

*Compact working face with only a few days of airspace remaining in active cell.*

9. A Permit to Operate the newly constructed cell (Phase 2, Area 2, Cell 2) was issued on August 18, 2016, post-inspection, alleviating concerns about the lack of remaining capacity in the current cell (Phase, 2, Area 2, Cell 1). On August 19, Mr. Sink advised me in a telephone conversation that he intended to begin diverting household trash to the new cell immediately.

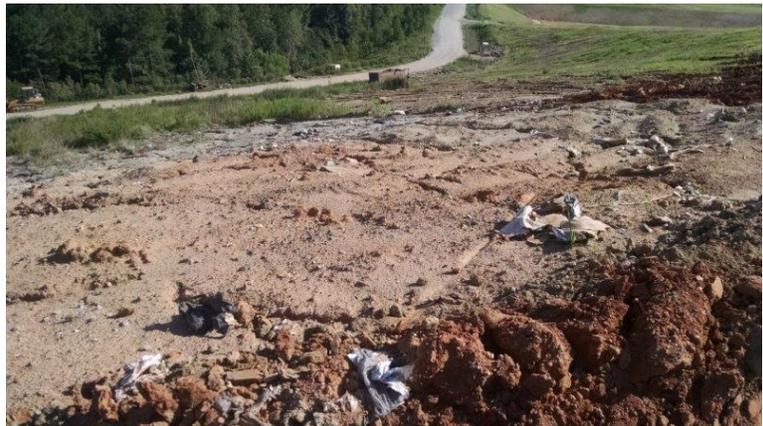
5. **CORRECTIVE MEASURES IN PROGRESS:** 15A NCAC 13B. 1626(7)(b) cited for failure to prevent on-site erosion. Progress was observed in providing additional cover and regrading some of the eroded areas of the slopes of Phase 2 of the MSW landfill. Significant work is still needed on the northern slope that faces the new cells. Mr. Sink stated that slope repairs and regrading will be completed as quickly as possible so that reseeding can be scheduled.

*Erosion from heavy rain events on north slope of active MSW landfill.*

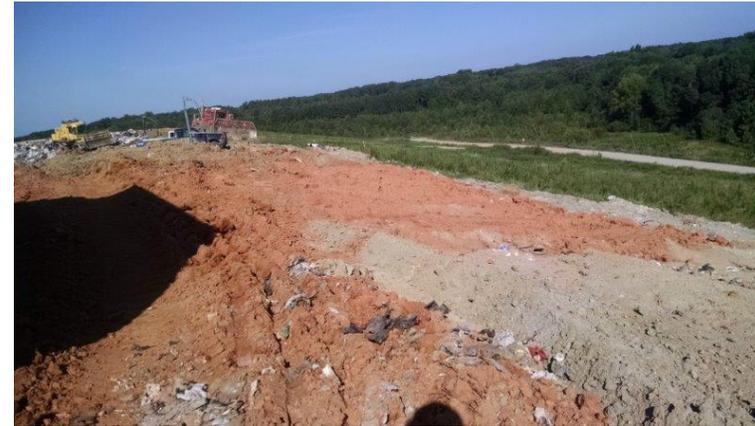
*Erosion evident, some uncovered waste, repairs underway on north slope of active MSW landfill.*

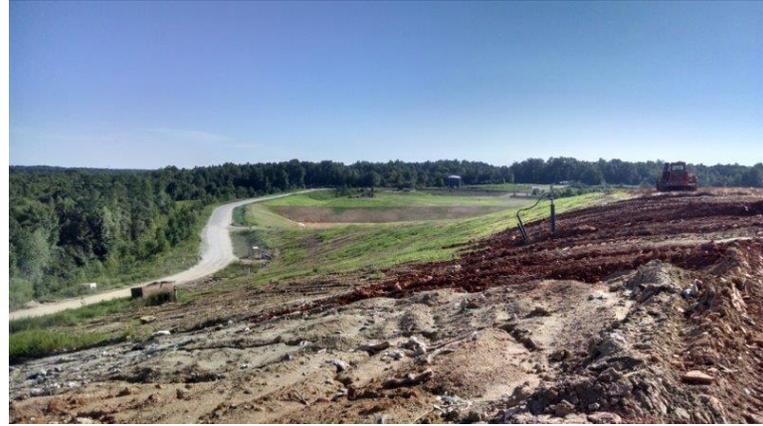
*Eroded areas and repaired areas along northern slope with new cell in the background.*
