FACILITY COMPLIANCE INSPECTION REPORT
Division of Waste Management
Solid Waste Section

Date of Inspection: 22 August 2016

Coastal Environmental Partnership
7400 Old Hwy 70
New Bern, NC 28560

2509\_INSP\_20160822

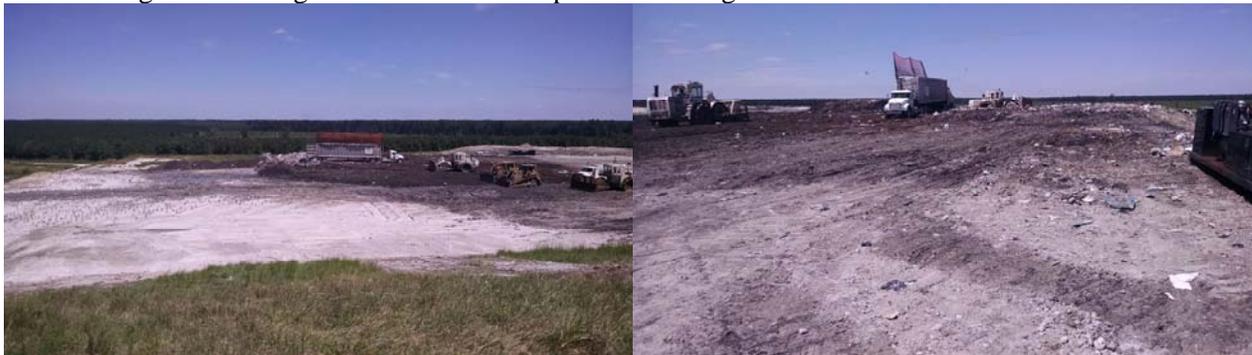
- 11) The working face is being maintained in a compact and manageable size.

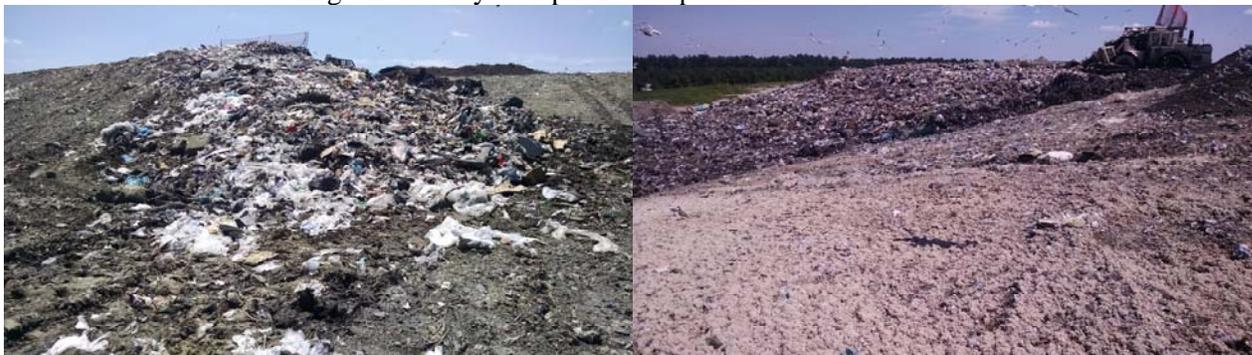
- 12) The waste type in the landfill was reviewed; the waste type being disposed is MSW and no unpermitted wastes were observed during this Facility Compliance Inspection.

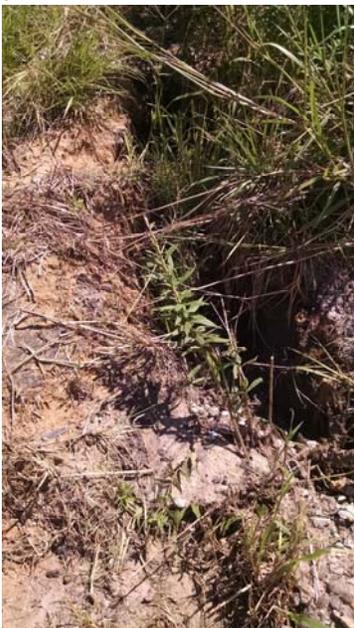
- 16) The surface water drain system that conveys surface waters from the top of Phase III to the toe of the western sideslope near the Phase II/Phase III transition area is conveying waste to the toe of the slope. \*As per our conversation, the surface water collection area should be redesigned to prevent solid waste from being conveyed by surface waters away from the active working face. All solid waste that has collected at the toe of the slope should be collected and properly disposed at the active working face.

- 17) An area of erosion was observed near the toe of the western sideslope across from the inert debris area. \*As per our conversation, please repair this area by filling and grading the eroded area at a slope not greater than 3:1. After completing the repair, please seed and mulch the repaired area to establish a groundcover suitable to protect your landfill cap system.

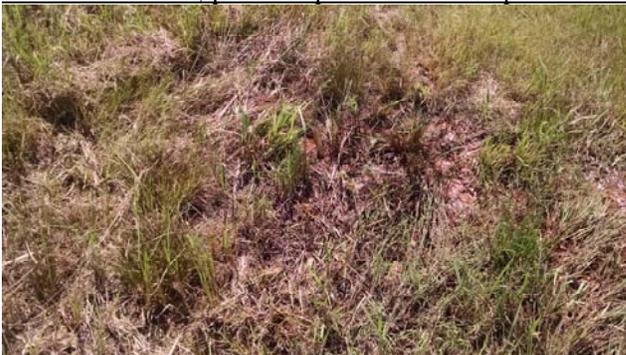
- 18) No off-site erosion was observed during this Facility Compliance Inspection.
- 19) A possible leachate seep was observed near the toe of the western sideslope approximately 50 yards south of the Phase II/Phase III transition. No leachate was observed leaving the footprint of the liner system. \*As per our conversation, please repair this area to prevent further seeping of leachate from the landfill.

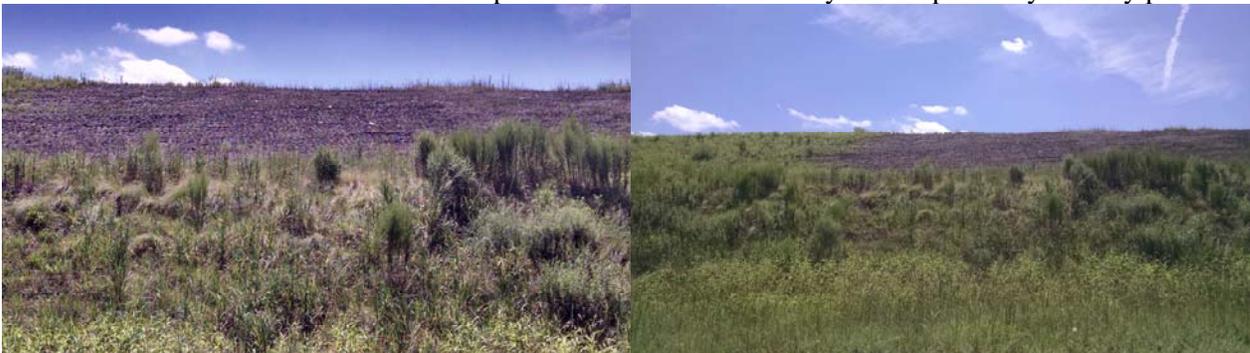
- 20) The outside slopes of Phase III have been covered and graded. The first lift has a well-established cover crop of native warm season grasses.
- 21) Several areas of erosion on the outside slopes of Phase III have recently been repaired by Facility personnel.

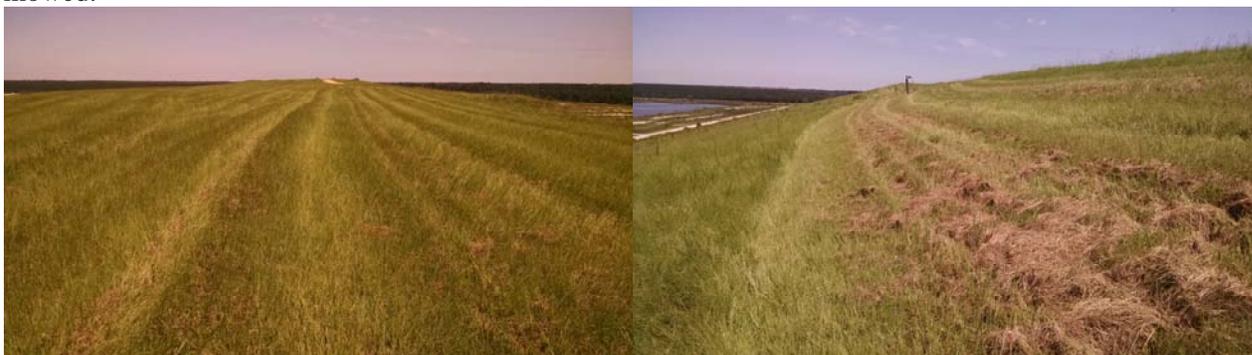
- 26) No areas of differential settlement or ponding water were observed in the closed areas of the landfill during this Facility Compliance Inspection.
- 27) The stormwater/sedimentation control basins were clear of vegetation and wind-blown debris and appear well maintained at this time.
- 28) The inert debris storage area was reviewed. No unpermitted waste types were observed in this area during this Facility Compliance Inspection.
- 29) The leachate collection system cleanouts are highly visible, readily accessible, protected, and well maintained.
- 30) Leachate is treated and stored in on-site leachate containment lagoons until pumped by force main to the City of New Wastewater Treatment Plant.

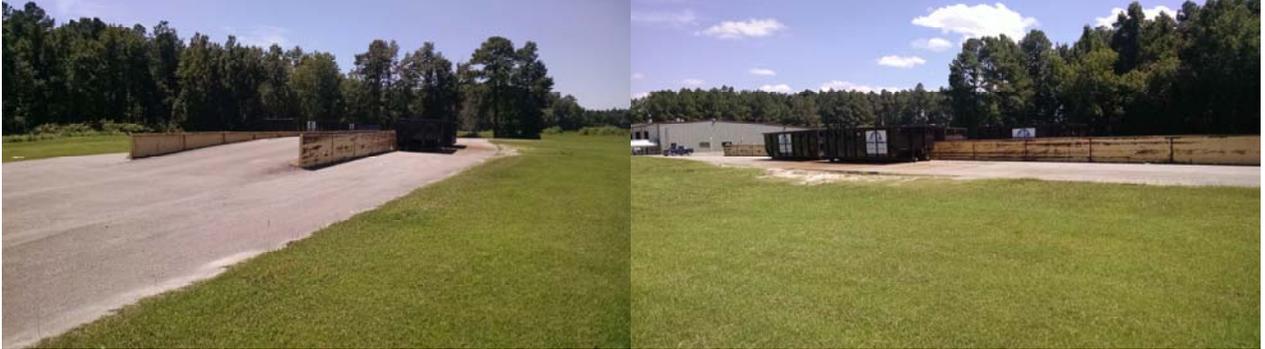
- 37) All dimensional lumber is maintained separate from the vegetative debris piles. All dimensional lumber is ground for removal from the site and used as boiler fuel.
- 38) A residential waste management area is maintained off of the main landfill access road to reduce the amount of small vehicle/small load traffic at the landfill working face. Roll-off containers are staged in this area for the collection of residential waste. Full containers are transported to the landfill working face to dispose of the collected waste as needed. The area around these containers appears well-policed and maintained at this time.
