FACILITY COMPLIANCE INSPECTION REPORT
Division of Waste Management
Solid Waste Section

Date of Site Inspection: 08/16/2016 & 08/22/2016

Riverside Stump Dump at Mills River
5055 Old Haywood Rd
Mills River, NC 28759

Comprehensive Inspection

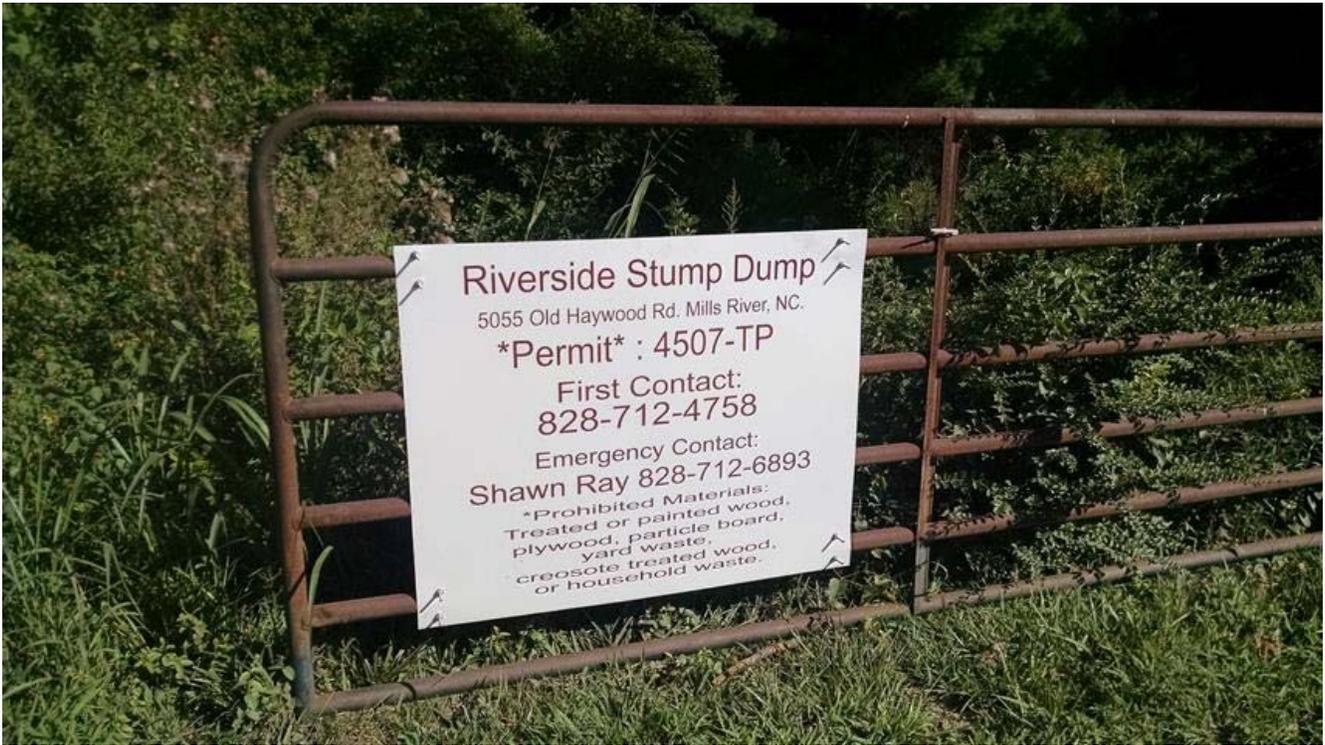
3. The facility is secured by gates at both entrances.
4. Signage has been installed at the entrance of the facility providing site information including the permit number, prohibited materials, and emergency contact information.

Facility Signage (photo taken August 16, 2016)

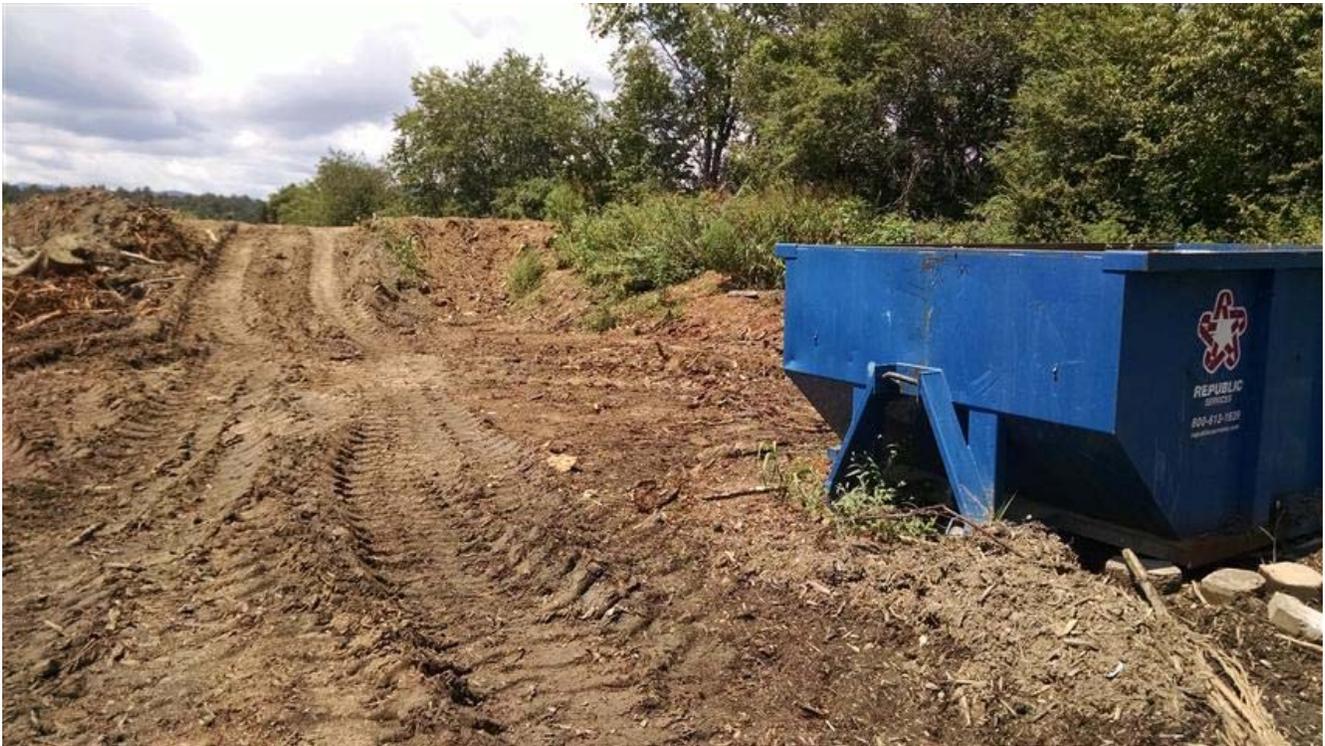
15A NCAC 13B .0203(d) states: "By receiving solid waste at a permitted facility, the permittee(s) shall be considered to have accepted the conditions of the permit and shall comply with the conditions of the permit." Permit to Operate 4507-TP, Attachment 3 Conditions of Operating Permit, #8 states that "All wood and processed materials must be maintained at least 50 feet from the property boundary lines and from the onsite surface water stream." Riverside Stump Dump was in violation of 15A NCAC 13B .0203(d) in that saw logs were observed within in the 50-foot buffer during the August 16, 2016 inspection. On August 22, 2016 the saw logs had been moved from the buffer. Therefore, the violation is resolved.

6. All ground material appeared to be outside 50-foot buffer around the facility. A stockpile of "saw logs" were being stored in the buffer area during the August 16, 2016 inspection. **All material, (ground and unground) cannot be stored in the 50-foot buffer.** On August 22, 2016 the "saw logs" had been removed from the buffer area.

Saw Logs removed from the Buffer (photo taken August 22, 2016)
