**FACILITY COMPLIANCE INSPECTION REPORT**  
**Division of Waste Management**  
**Solid Waste Section**

**Date of Site Inspection: August 11, 2016      Date of Last Inspection: August 14, 2014**

East Carolina Regional Landfill  
1922 Republican Road  
Aulander, North Carolina 27805

Comprehensive Facility Compliance Inspection

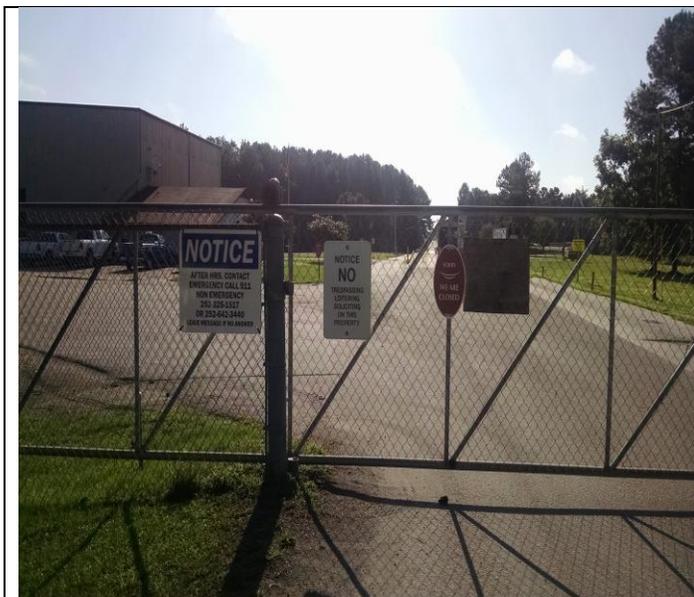
- Entrance Gate and Signage

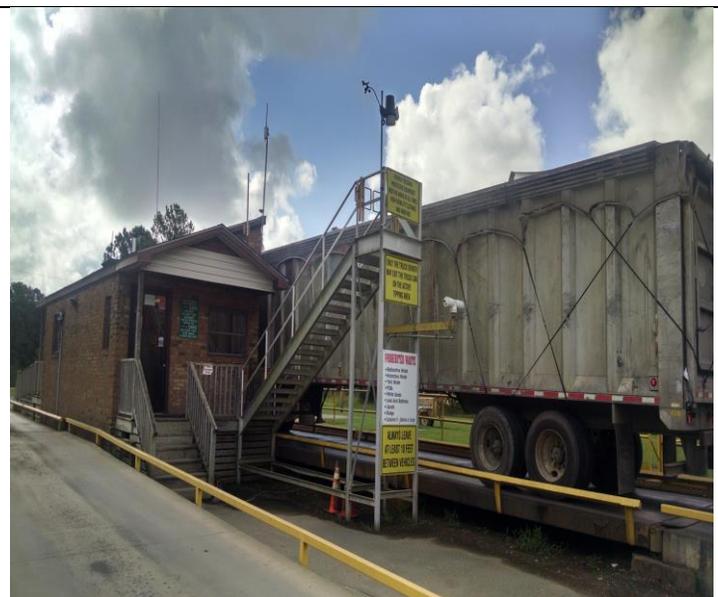
7. Screening records were reviewed and facility has an avg. of 1 per day from the records reviewed.
8. Contingency Plan is posted in the break room.
9. Scale house has Radiation detection and has a screening gantry to service trailers.

Scale House, Scales and Radiation Detector

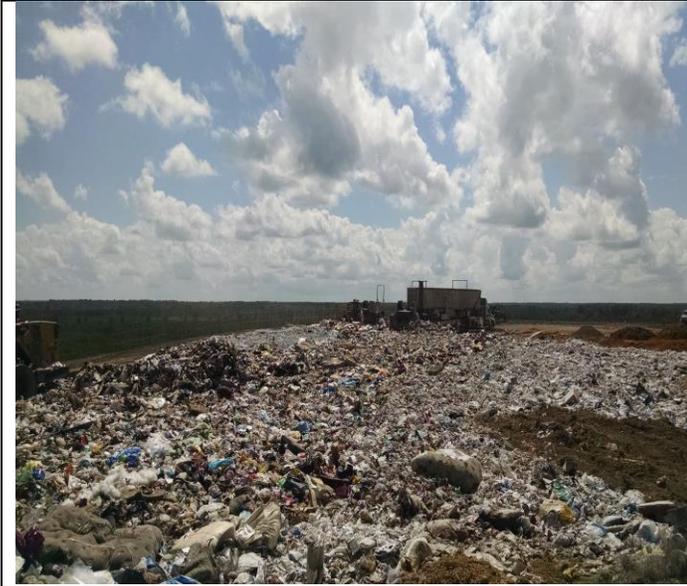
- Current Working Face – Cell 13

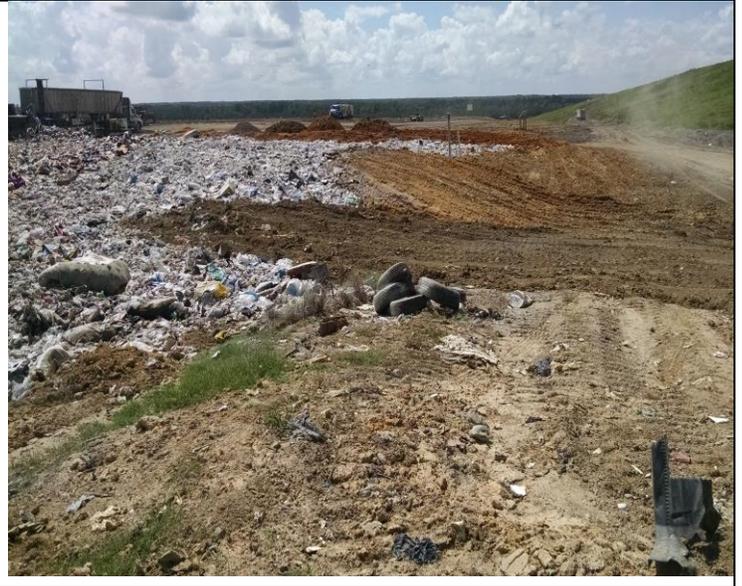
Scrap tires pulled out of waste stream

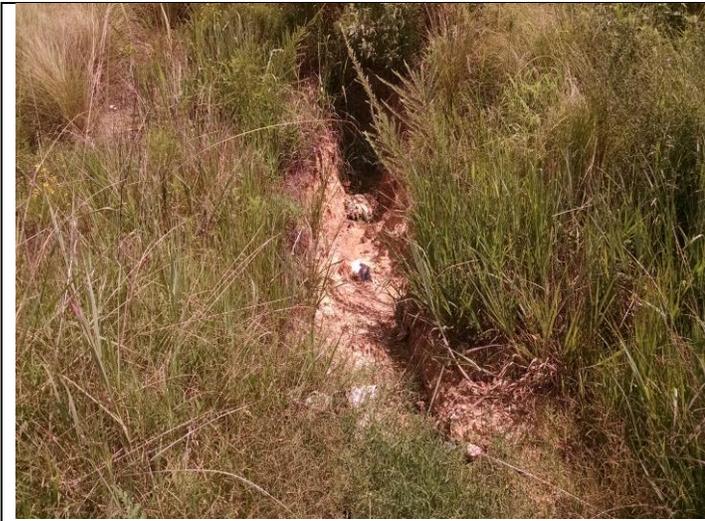
- 21. Several areas of Erosion were observed during this inspection. The tops of cells need additional soil cover as well as established vegetative cover. Proper cover and vegetation are required and necessary to assist with prevention of onsite erosion and ponding of water over waste. Areas of erosion on the landfill should be repaired as they are observed by facility staff.**

- Erosion with exposed waste

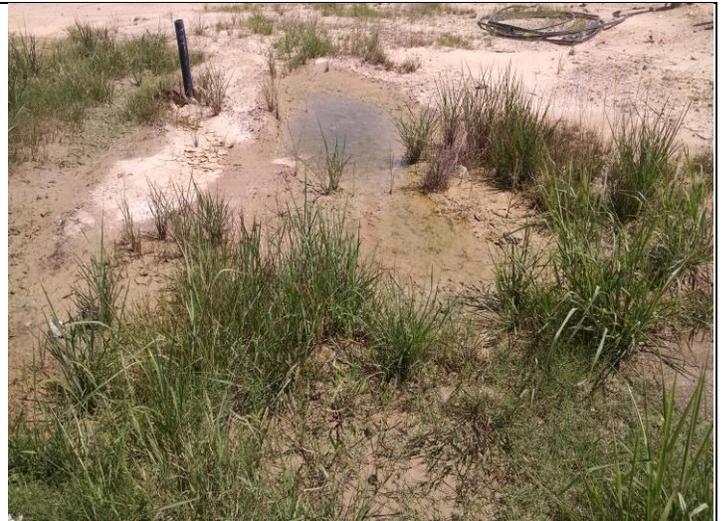
Top with #1 ponded water and needing cover

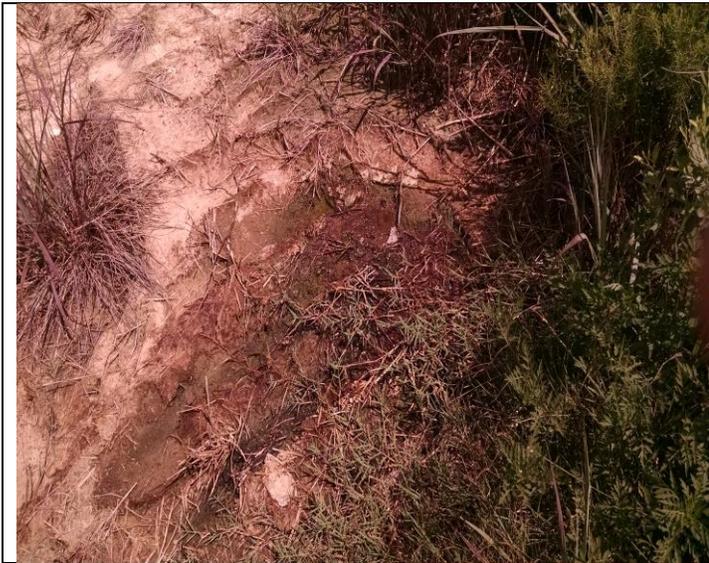
- 22. Leachate seeps were observed inside the lined landfill footprint during this inspection. Facility staff should make necessary repairs to leachate seeps as they are observed.
- 23. Corrective measures are necessary in the areas identified and discussed with facility staff during the inspection and should be completed within 30 days of receipt of this Compliance Inspection Report.
- 24. Digital pictures of this Compliance Inspection were taken and attached.
- 25. Overall this Facility appears to be managed well.
- 26. Currently accepting waste in cell # 13.

- Leachate

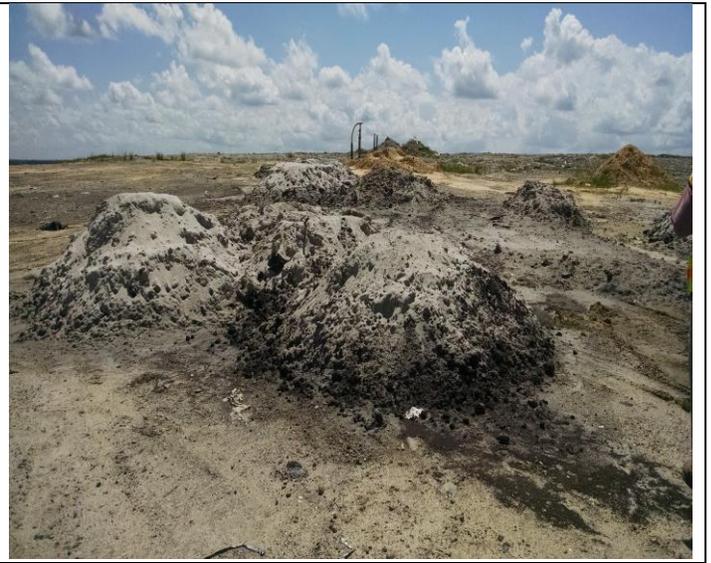
River silt on top for low area fill. Need to add Organic material and seed for cover,

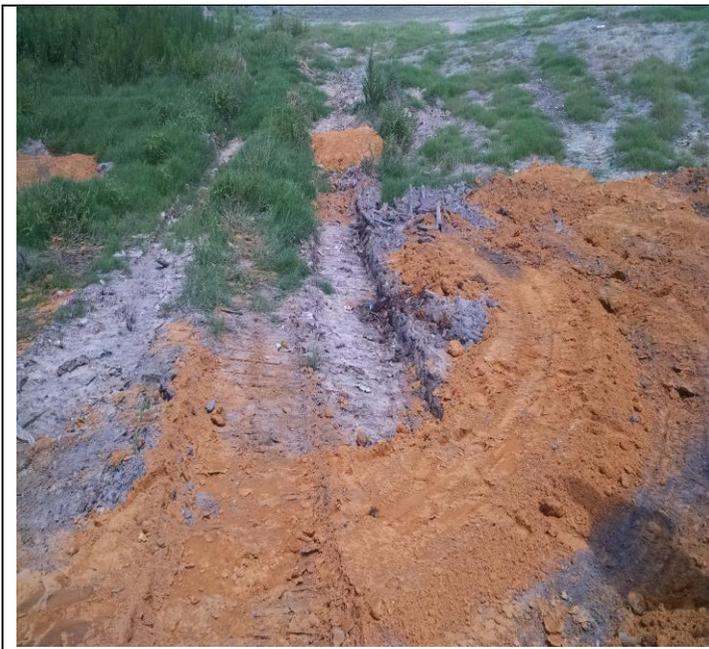
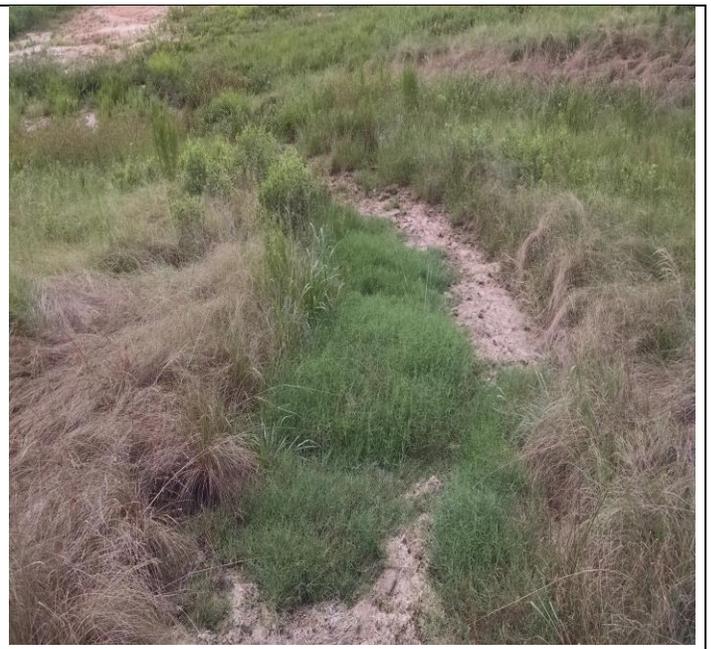
- Two areas of repair
