FACILITY COMPLIANCE INSPECTION REPORT
Division of Waste Management
Solid Waste Section

Date of Inspection: 25 August 2016

MCB Camp Lejeune MSW Landfill
Sneads Ferry Road
Camp Lejeune, NC 28452

6703_INSP_20160825

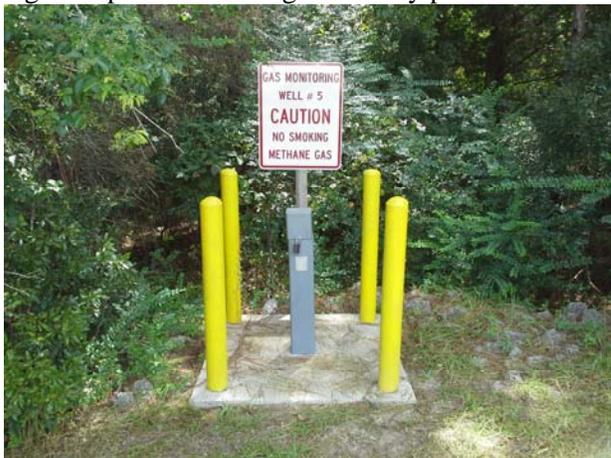
- 7) The trench fill area was reviewed. This area has a well-established cover crop and no areas of erosion were observed during this Facility Compliance Inspection.
- 8) The closed asbestos disposal area was reviewed. Overall, this area has a well-established groundcover of native warm season grasses and is well-maintained at this time.
- 9) The Facility monitoring wells were reviewed. All wells were locked and labeled with permanently affixed tags and painted with high visibility paint. Access to the wells was stable and clear of brush.

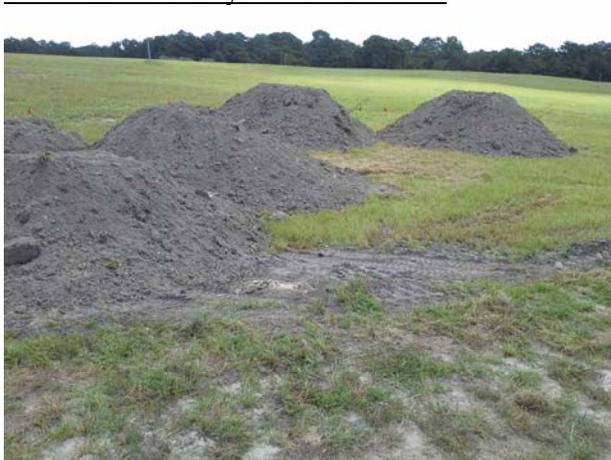
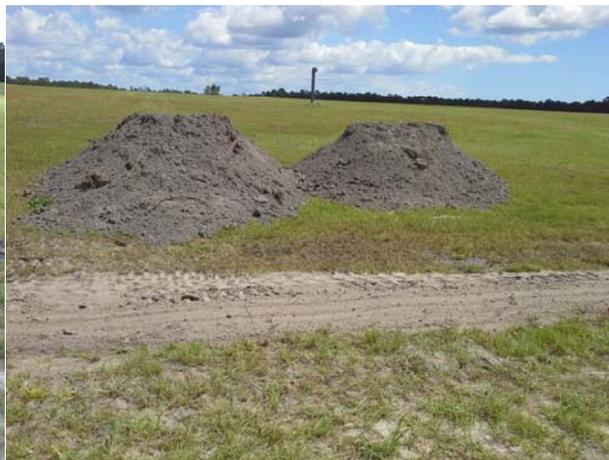
- 10) The Facility surface water ditches were reviewed. The ditches were clear of brush and other woody vegetation and appear well maintained at this time.
- 11) The cap repair project has been completed and no construction activities were underway during this Facility Compliance Inspection.
- 12) Areas of differential settlement were observed on the top lift of the landfill. Soil has been brought on-site to fill these areas. *After filling and grading, please monitor these areas to ensure that no ponding of surface waters occurs. If such ponding occurs, further actions should be taken to promote the positive drainage of surface waters away from the landfill.

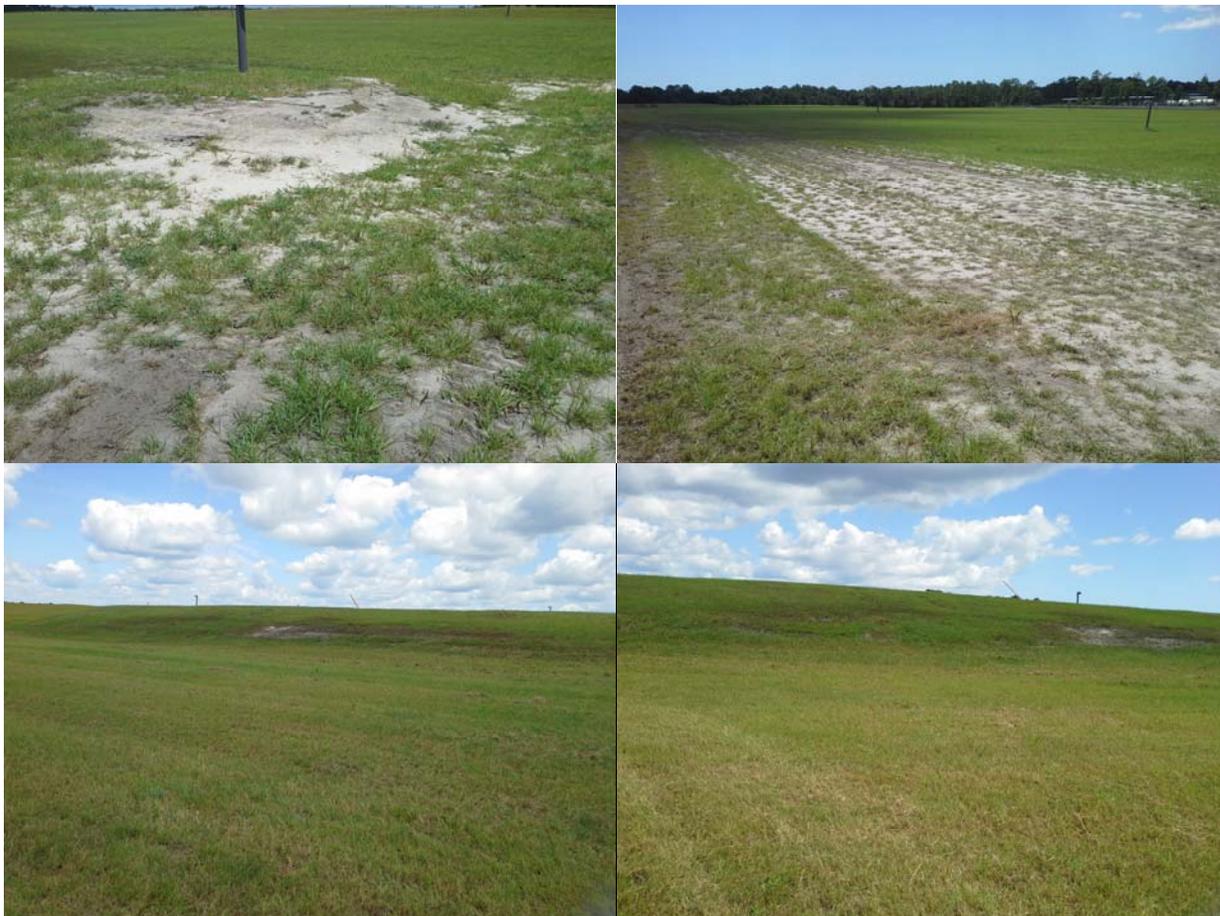
- 13) Overall, this Facility has a well-established cover crop of native warm season grasses. However, areas of sparse cover were observed in several places along the landfill sideslopes and on the top lift of the landfill. *These areas need to be seeded and mulch as soon as possible to establish a groundcover suitable to prevent erosion of your landfill cap system.

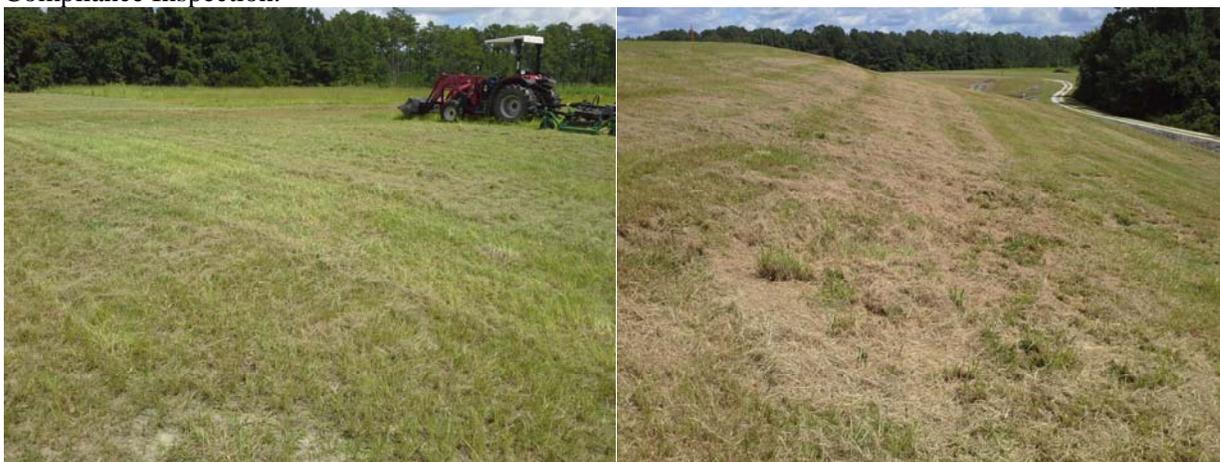
- 14) The Facility cover crop is mowed semi-annually. Mowing operations were underway during this Facility Compliance Inspection.

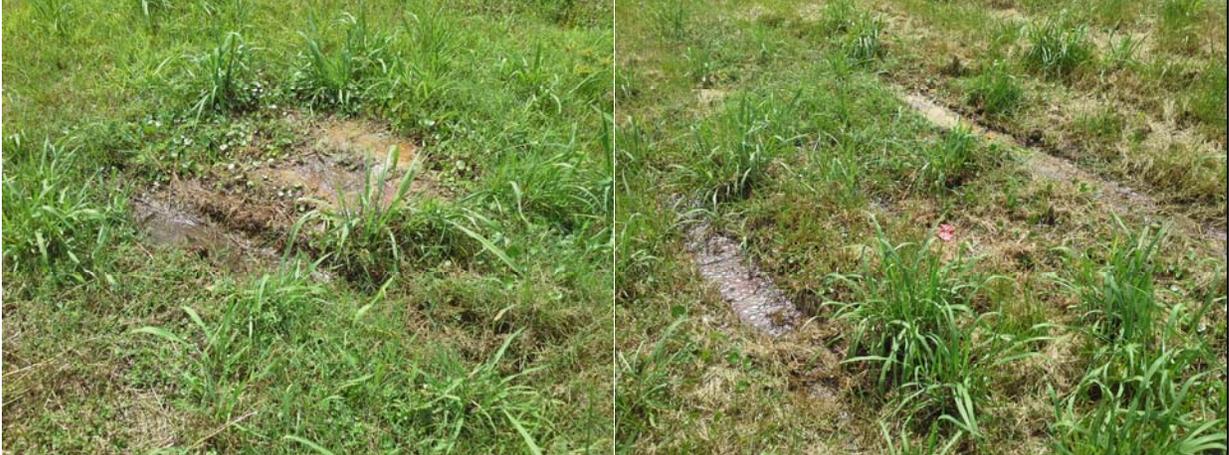
- 15) The Facility stormwater basins were reviewed. The basins have recently been cleared of brush and overall appear well-maintained. However, the rip-rap and gravel placed around the risers appears to be clogged with sedimentation. *Please ensure that this sedimentation is removed and that all areas of the ponds are properly maintained to ensure they function as designed.
- 16) Possible leachate seeps were observed in two areas along the norther sideslope. No leachate was observed leaving the landfill disposal boundary. *As per our conversation, measures should be taken to prevent the release of leachate from the landfill boundary. Any observed seeping areas should be repaired as soon as possible to prevent the release of the leachate from the landfill.
