FACILITY COMPLIANCE INSPECTION REPORT
Division of Waste Management
Solid Waste Section

Date of Site Inspection: August 5, 2016

Bryant Grading LCID Landfill
376 Spence Mill Road
Fuquay-Varina, NC 27526

NOV Follow-up Inspection

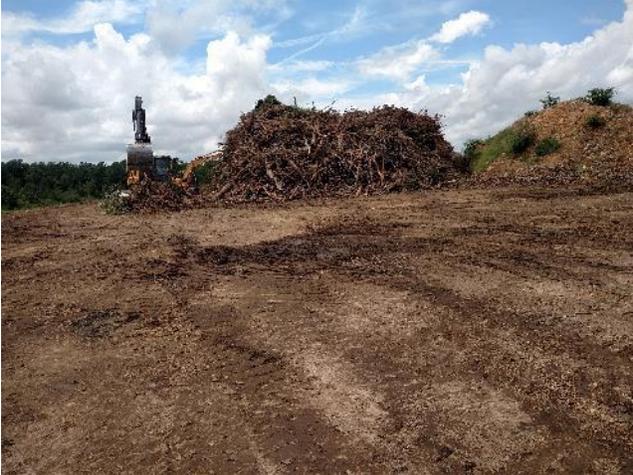
6. Access roads are of all-weather construction but vegetation has grown up over the road around the LCID and needs to be trimmed.
7. LCID has been graded accordingly and has a defined working face. All areas of waste that were not part of the working face have been properly covered. Active area was not exceeding one acre maximum size.

Top of landfill – working face

8. Continue to restrict solid waste to the smallest area feasible and compact as densely as practical into cells.
9. A ready supply of soil is available for cover material.

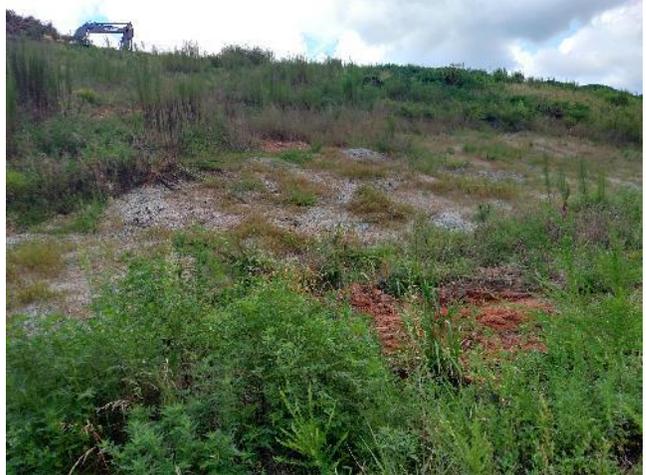
Leachate flow has been stopped, LCID have been graded to ensure positive drainage. Side slopes have been mowed and area of breakout has been repaired, covered, and seeded. Vegetation coming in nicely and no additional breakouts noted.

12. Property lines have been properly marked to ensure that waste is not being dumped into the 100' buffer for this facility.
13. Erosion on side slopes has been covered, repaired, and seeded. Ground cover is coming in nicely.

Erosion repaired and seeded on side slopes
