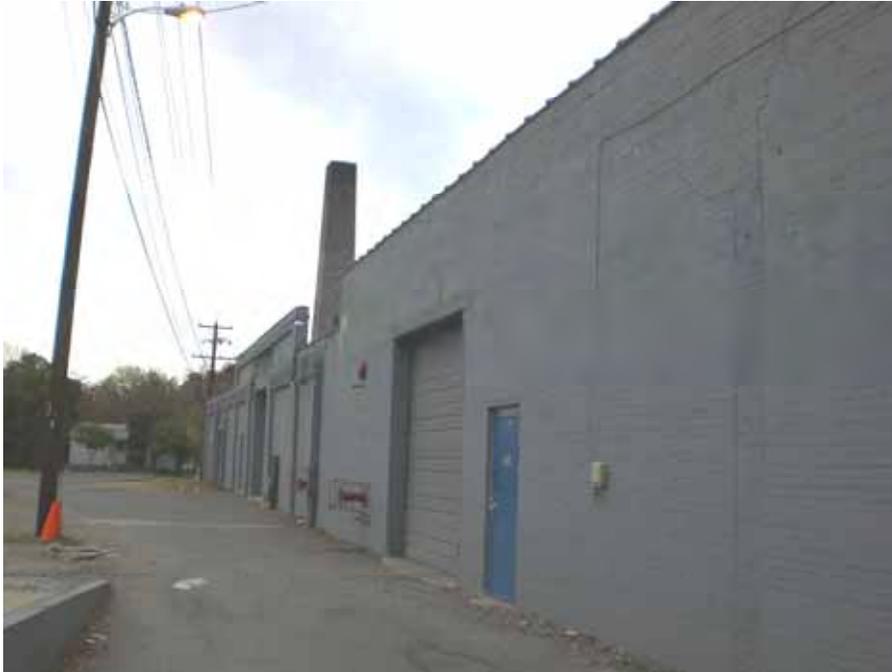
**Photograph 1: Eastern wall or eastern warehouse,
facing south along access road for Eden Street**

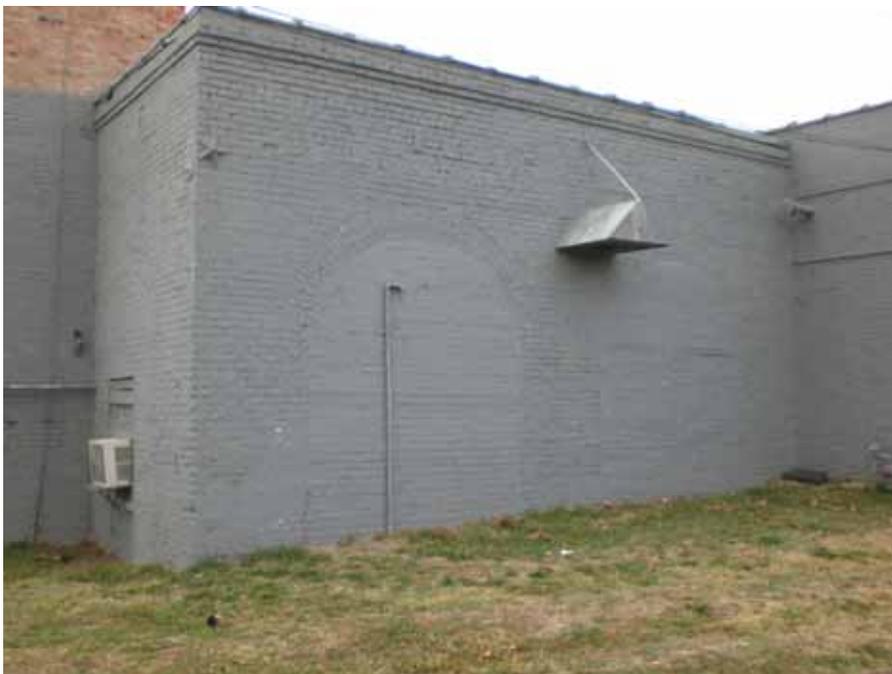
Photograph 2: Vent pipe along eastern wall of eastern warehouse

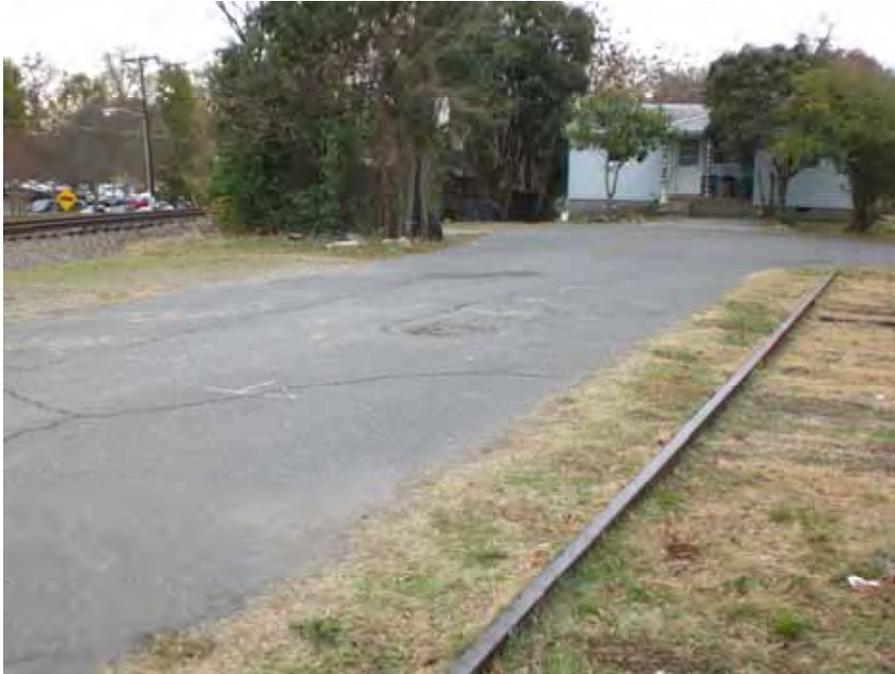
Photograph 3: Location of UST - beneath access road for Eden Street near the southeastern corner of the site

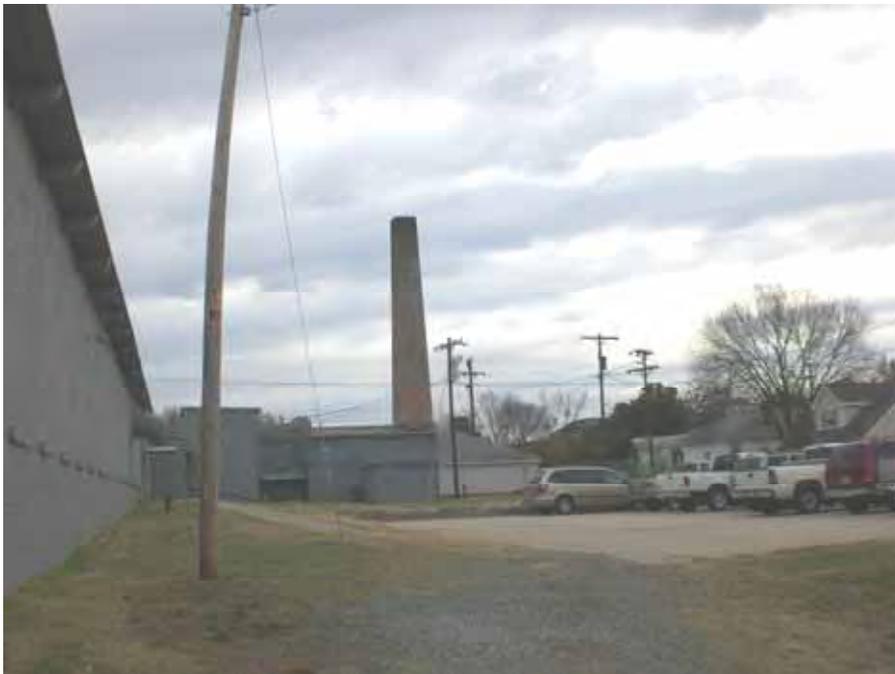
Photograph 4: Southern portion of site

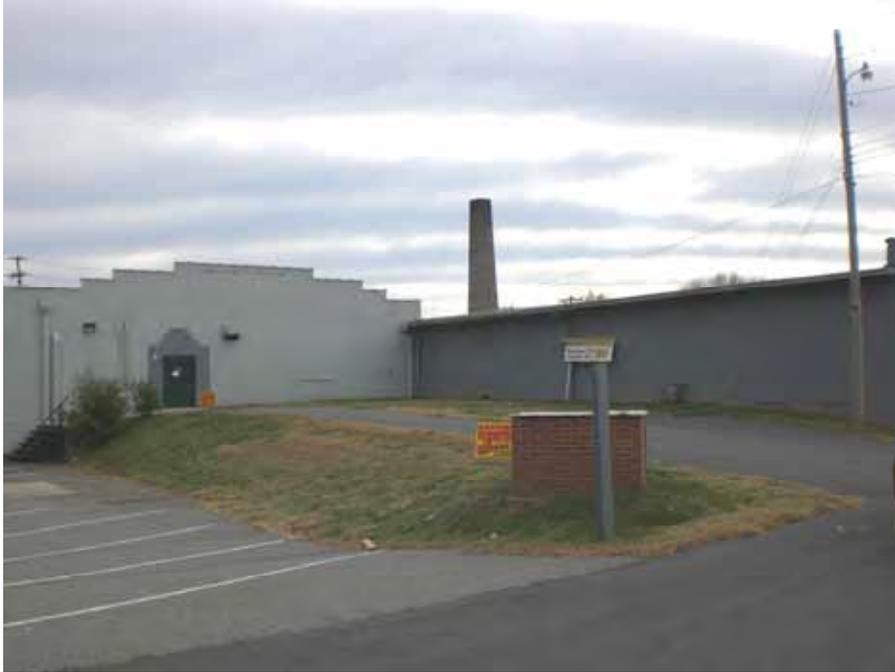
**Photograph 5: Rear of eastern warehouse.
Note water supply well pump house in foreground**

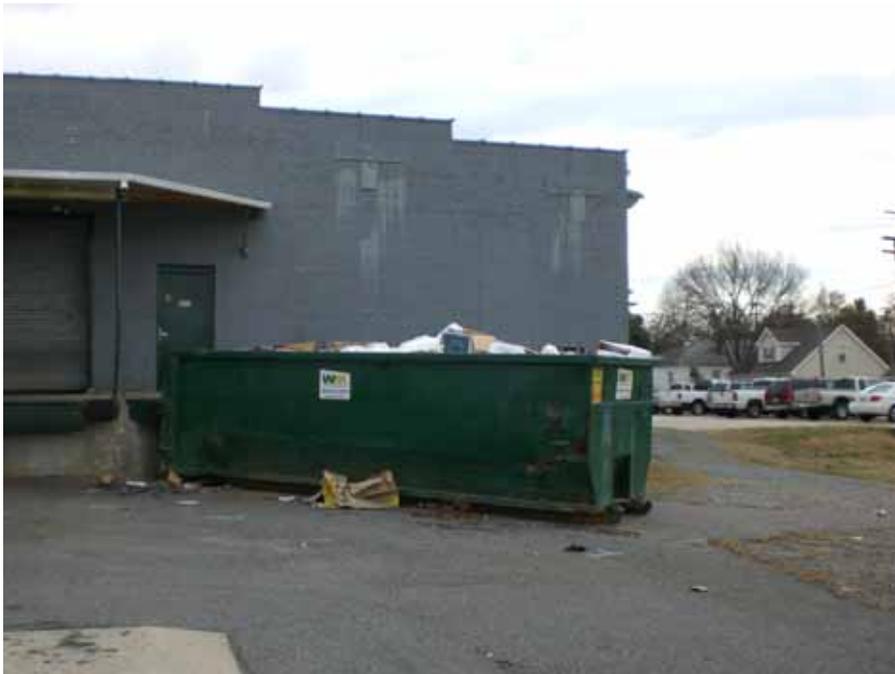
Photograph 6: Dumpster near southwestern corner of eastern warehouse

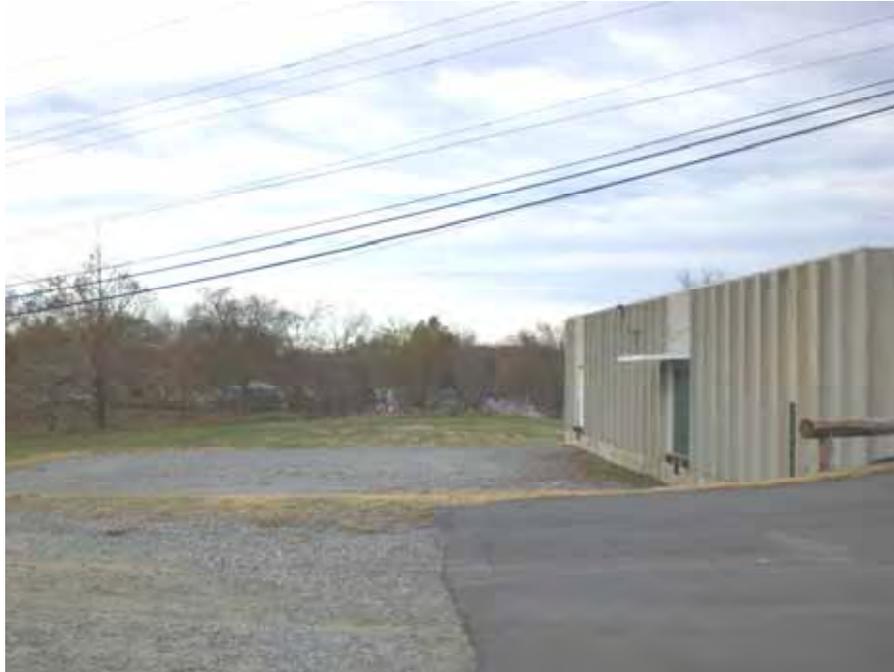
**Photograph 7: Western warehouse and gravel-lined parking area.
Note grassed area in background is location of buried asbestos containing materials**

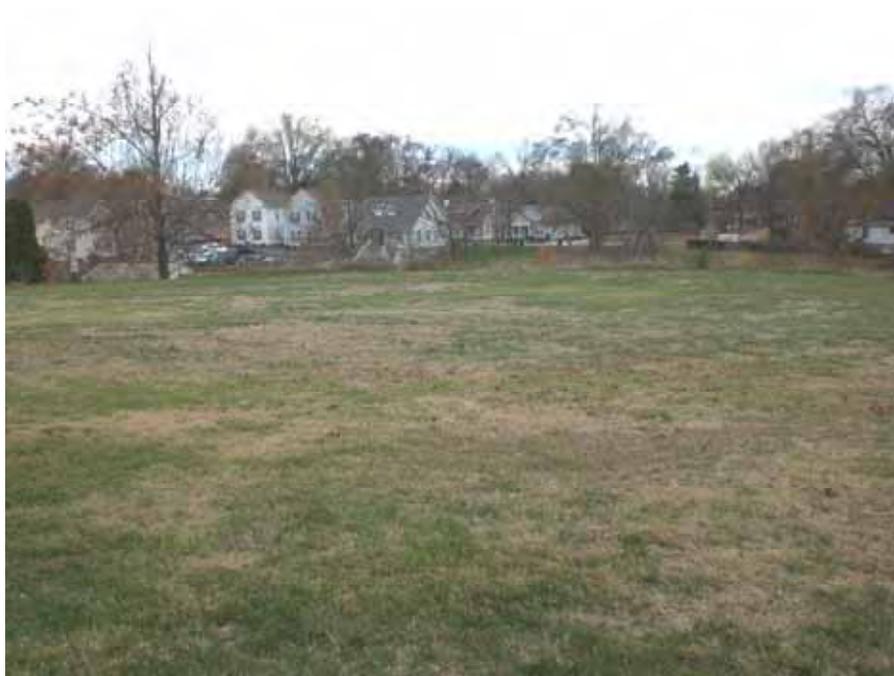
Photograph 8: Location of buried asbestos containing materials

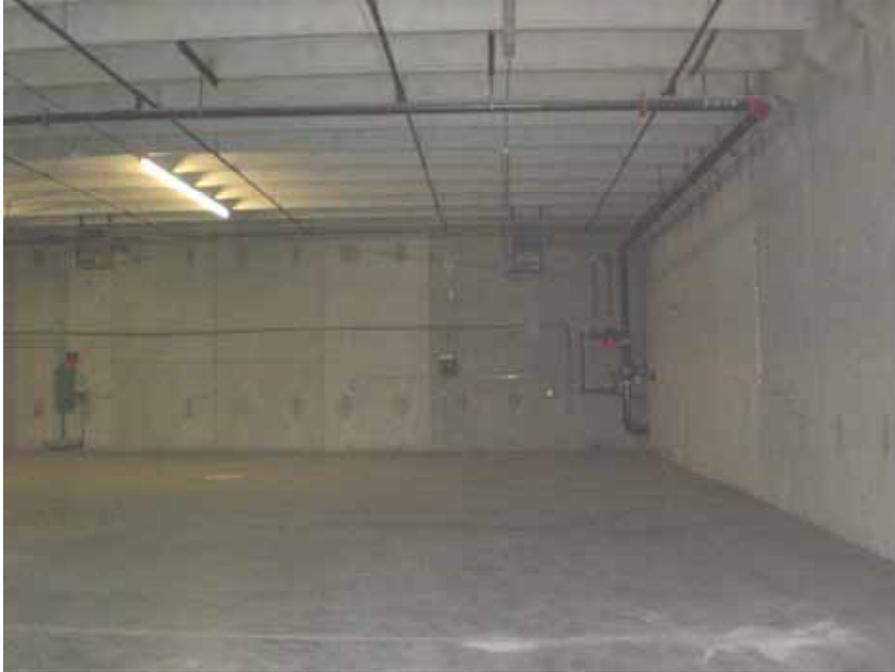
Photograph 9: Vacant space in western warehouse

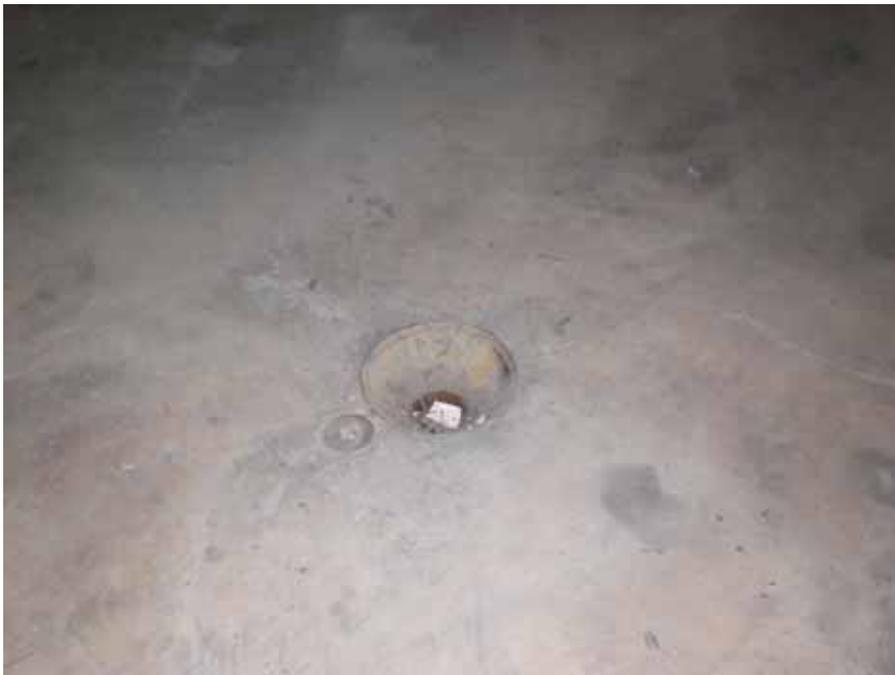
Photograph 10: Floor drain in western warehouse

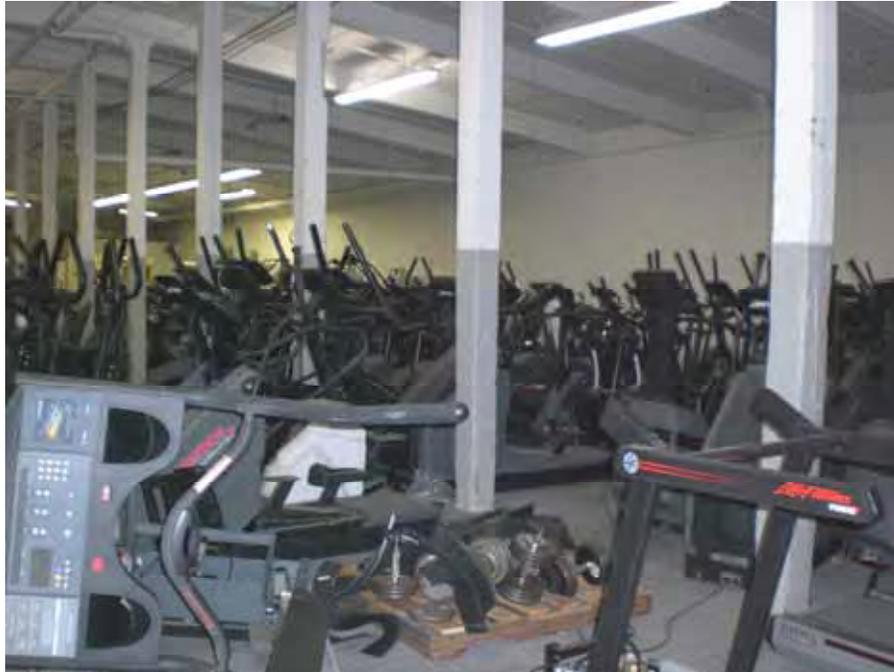
Photograph 11: Typical storage space in eastern warehouse

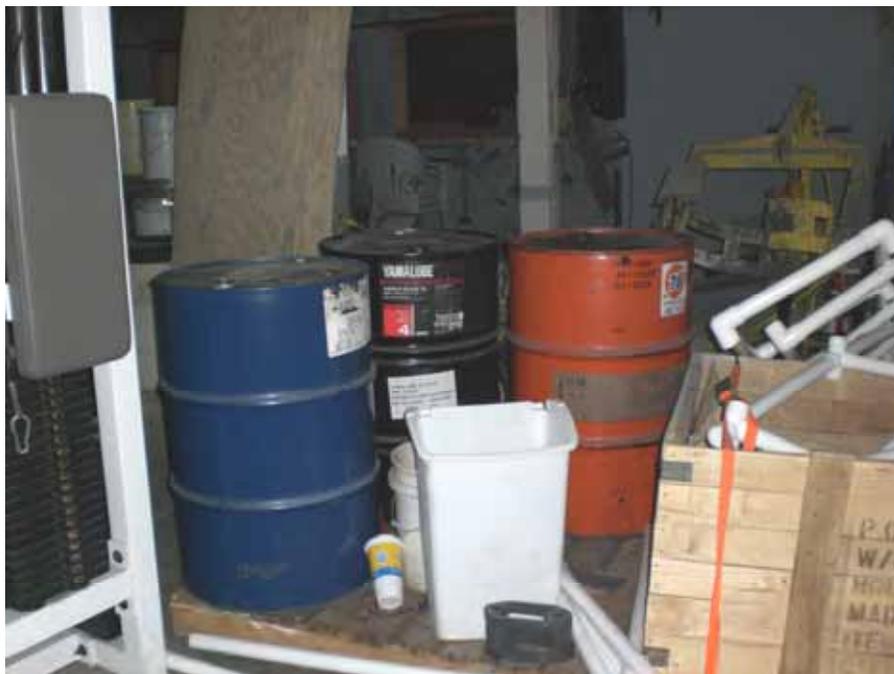
Photograph 12: Three 55-gallon oil drums located in paint recycling business' area

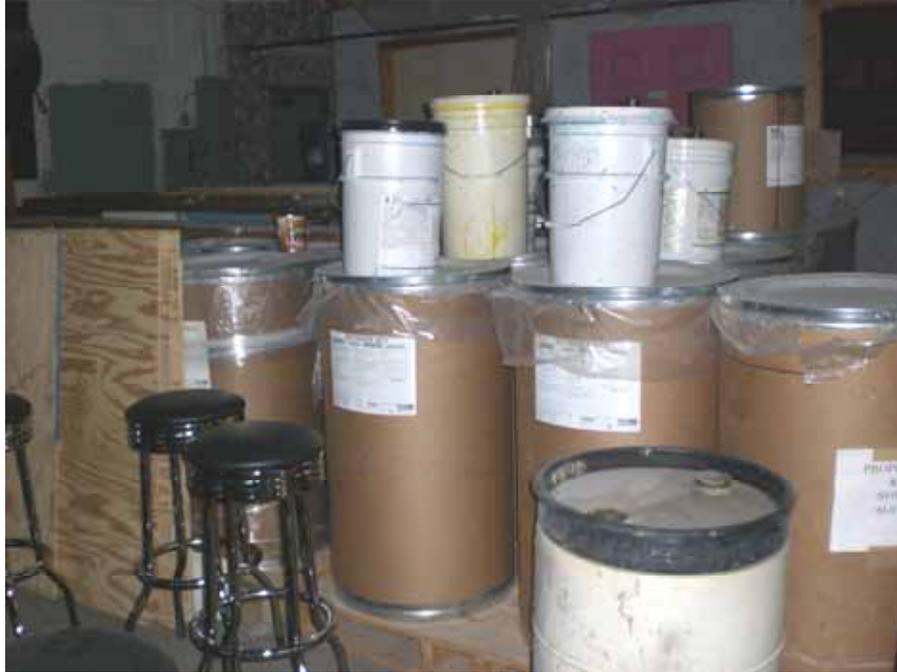
Photograph 13: Numerous containers in paint recycling business' area

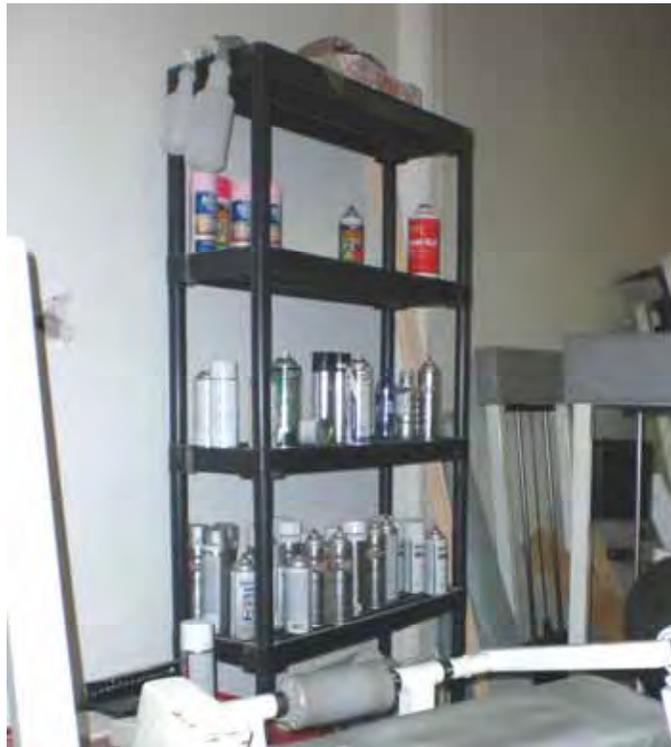
Photograph 14: Spray paint storage in Peak Fitness' area

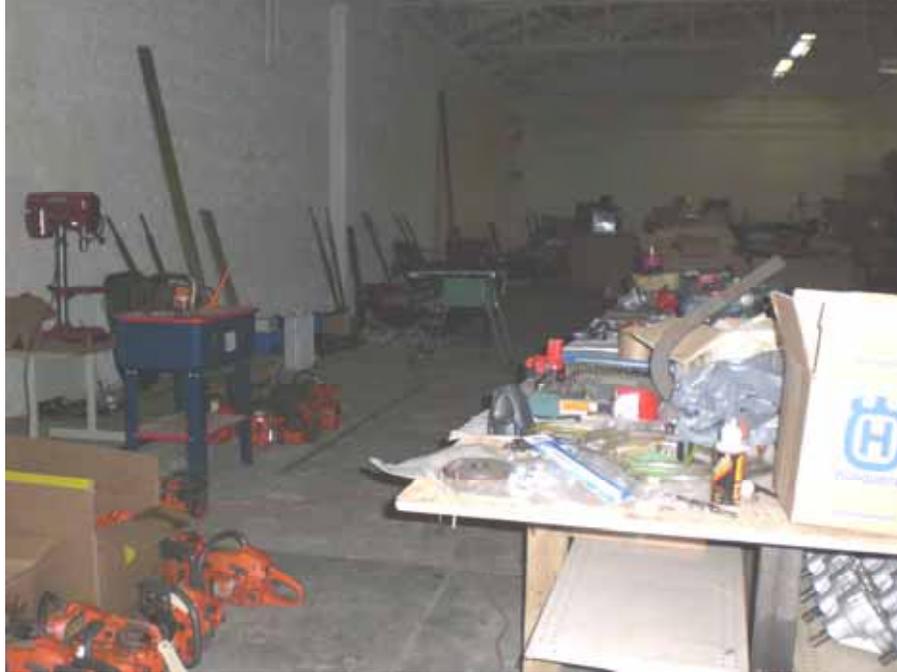
Photograph 15: Typical storage space in eastern warehouse

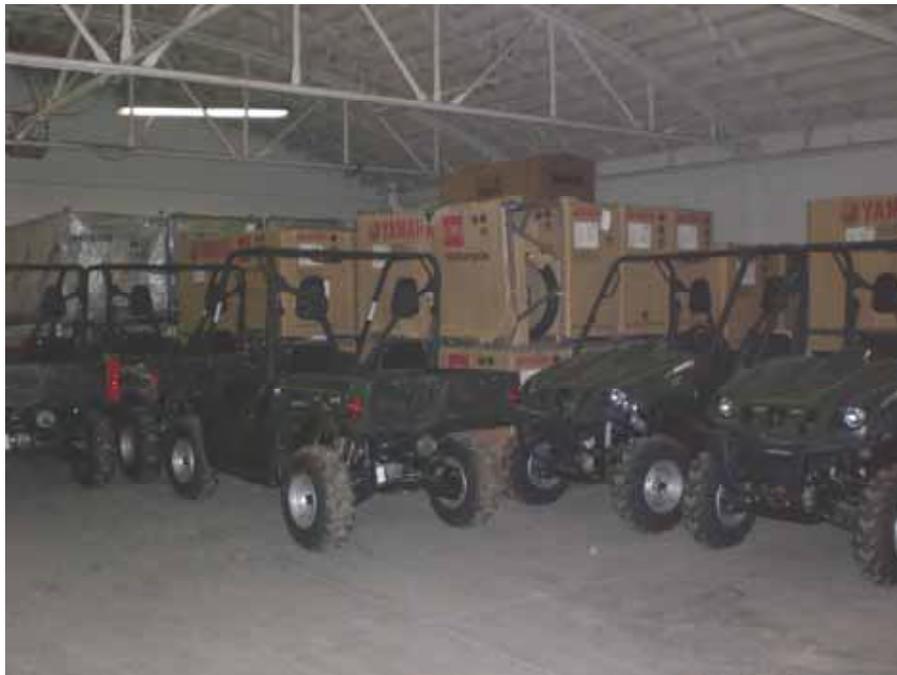
Photograph 16: Typical storage space in eastern warehouse
