ABF Project Number: ABF-14-1547

RE: February 2016 Quarterly Inspection Report
Old Fort Landfill, Old Fort Township, McDowell County, North Carolina
Permit# 56-03

Table 1 - Landfill Inspection Record - IAC Industrial Landfill

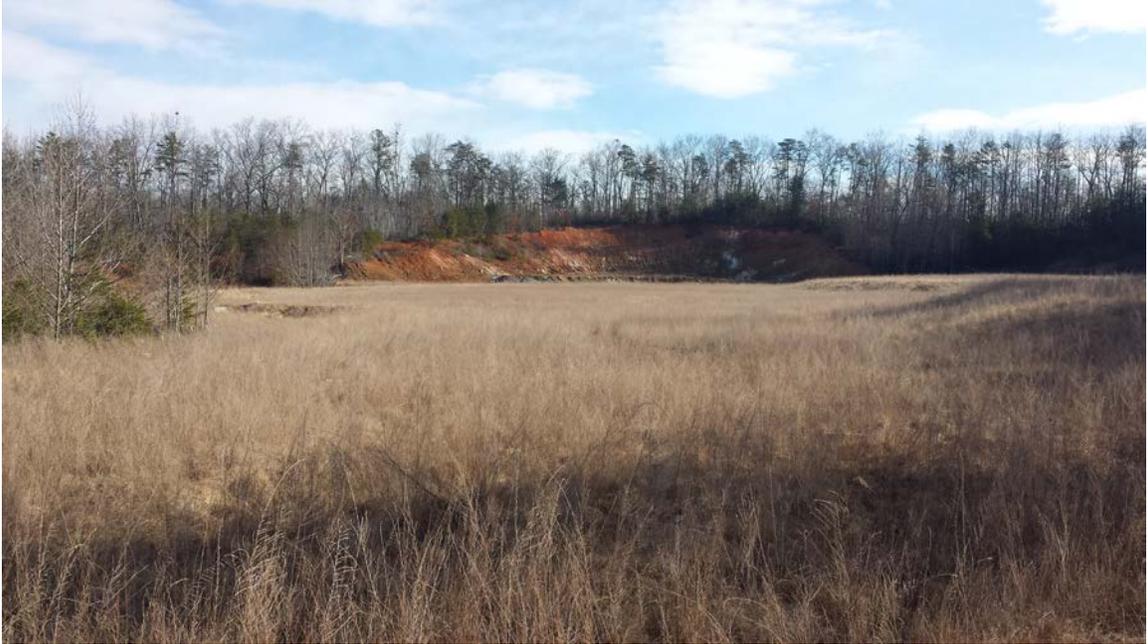
Photo A – View of landfill looking northeast

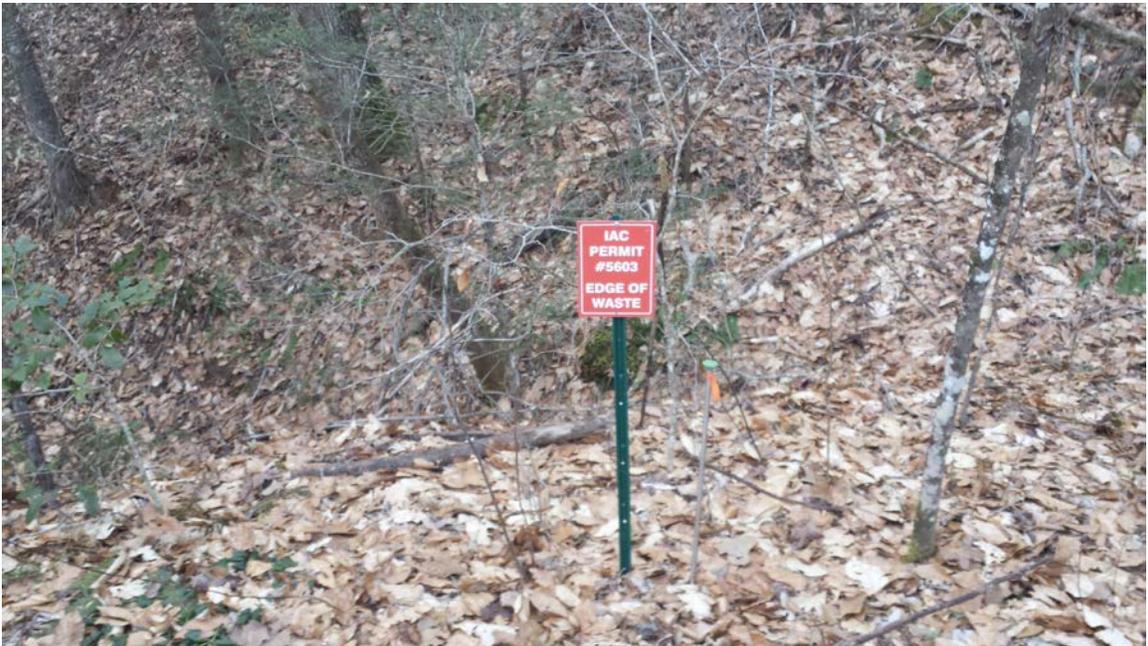
Photo B – Typical Edge-Of-Waste signage around landfill

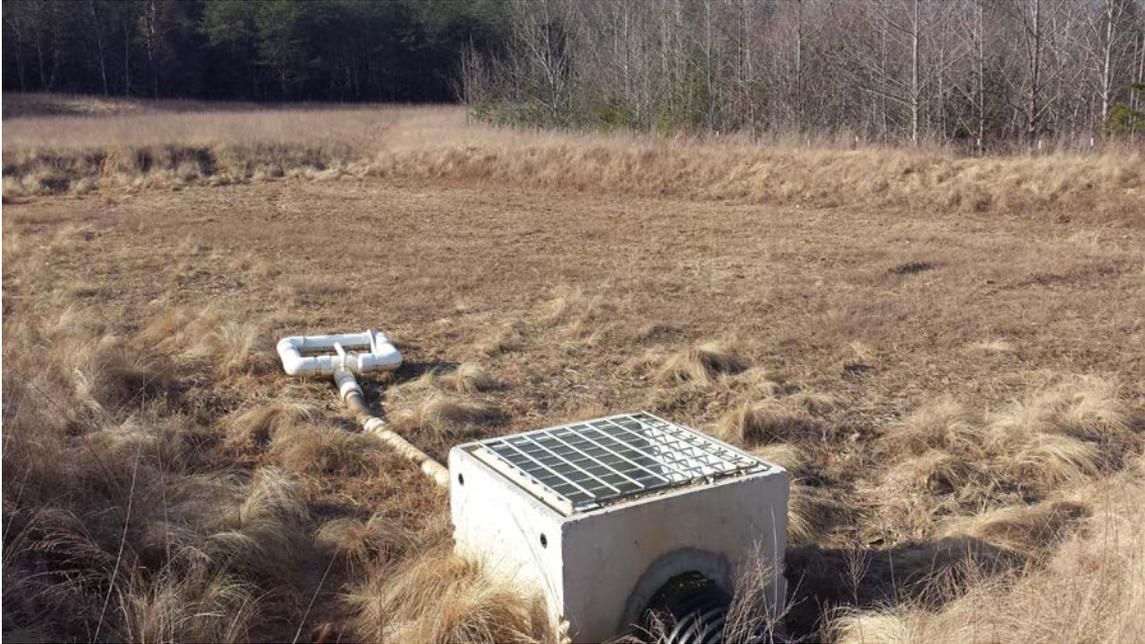
Photo C – View of Detention Basin 2.1 with outlet structure 5.5

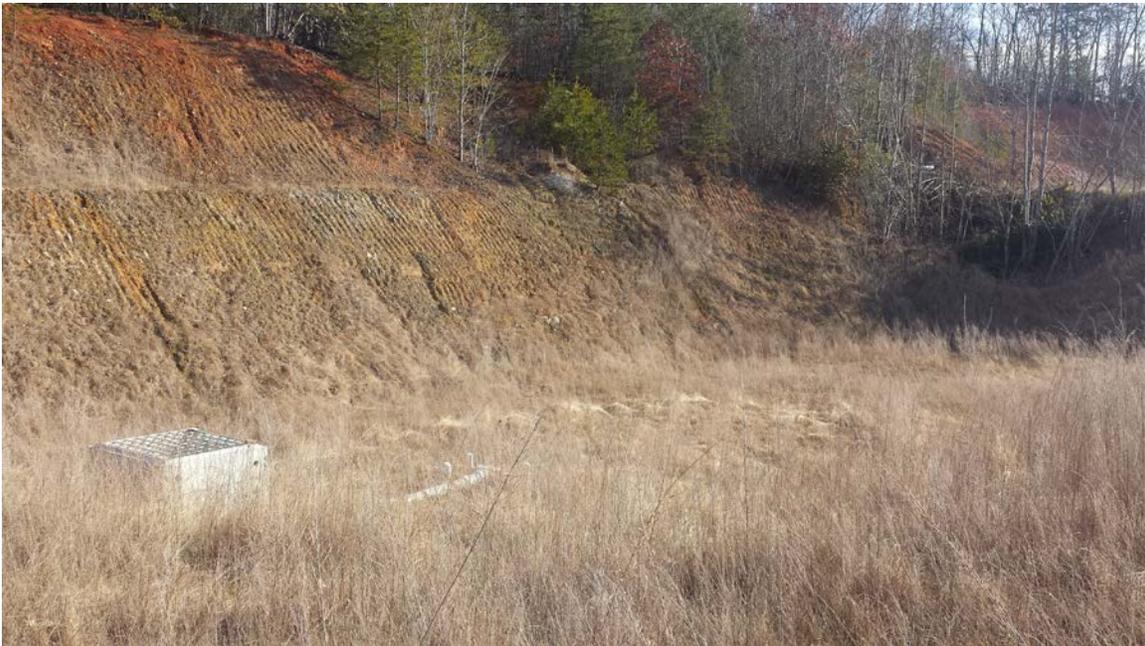
Photo D – View of Detention Basin 2.3
