Site Name (Subject):	THOMASVILLE FURNITURE INDS/LENOIR
Site ID (Document ID):	NCD054290770
Document Name (DocType):	Contractor Report (CONTR)
Report Segment:	
Description:	Remedial Operations Summary
Date of Document:	6/9/1993
Date Received:	
Box: <i>Enter SF and # with no spaces</i>	SF10,631
Access Level:	PUBLIC
Division:	WASTE MANAGEMENT
Section:	SUPERFUND
Program (Document Group):	SERB (SERB)
Document Category:	FACILITY

RE: Remedial Operations Summary, Thomasville Furniture Industries, Inc., Lenoir, North Carolina Facility

Subject: Site Inspection Prioritization
Thomasville Furniture Industries NCD 054 290 770
Lenoir, Caldwell County, NC

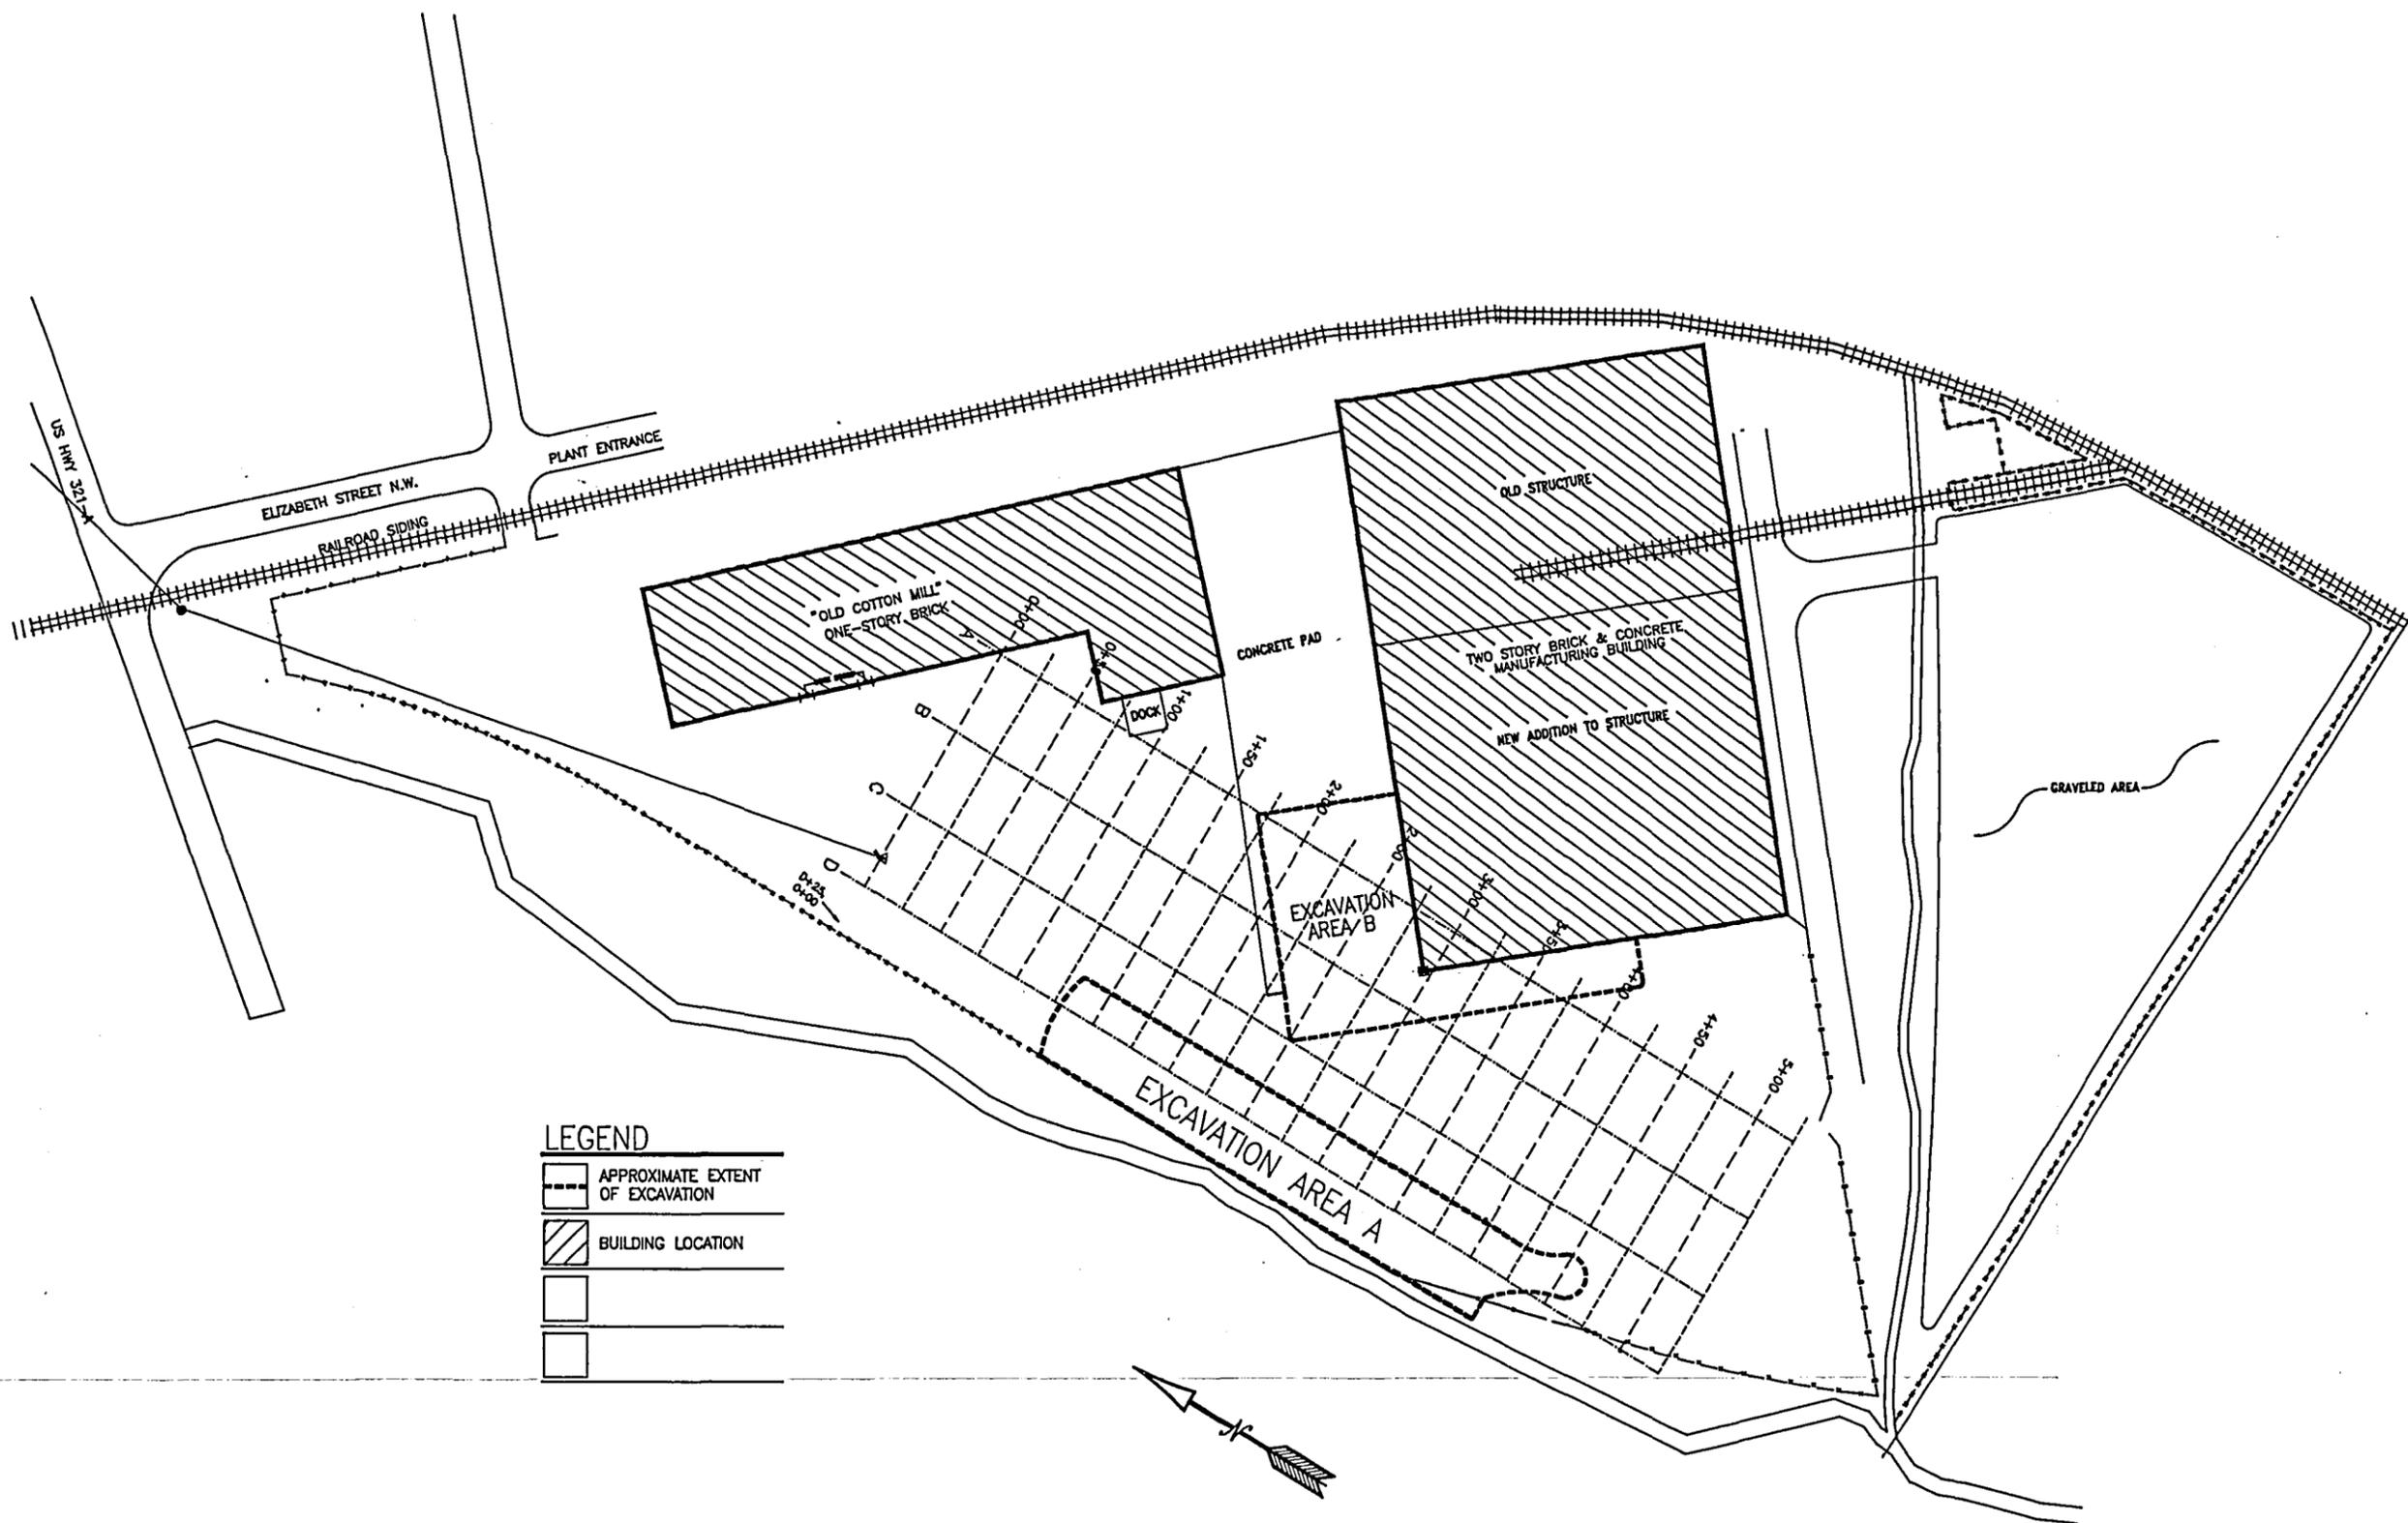
During the excavation operations, ENSCI excavated 153 buried drums at the subject facility. The drums were excavated from two areas of the facility identified as Area A and Area B (see Figure 1). Area A contained 97 drums and Area B contained 56 drums. There were a total of three liquids drums excavated and disposed from the facility, two from Area A and one from Area B. The balance of the excavated drums contained solid materials. The excavated drums of solid materials contained, for the most part, similar materials that included glue, trash, and assorted

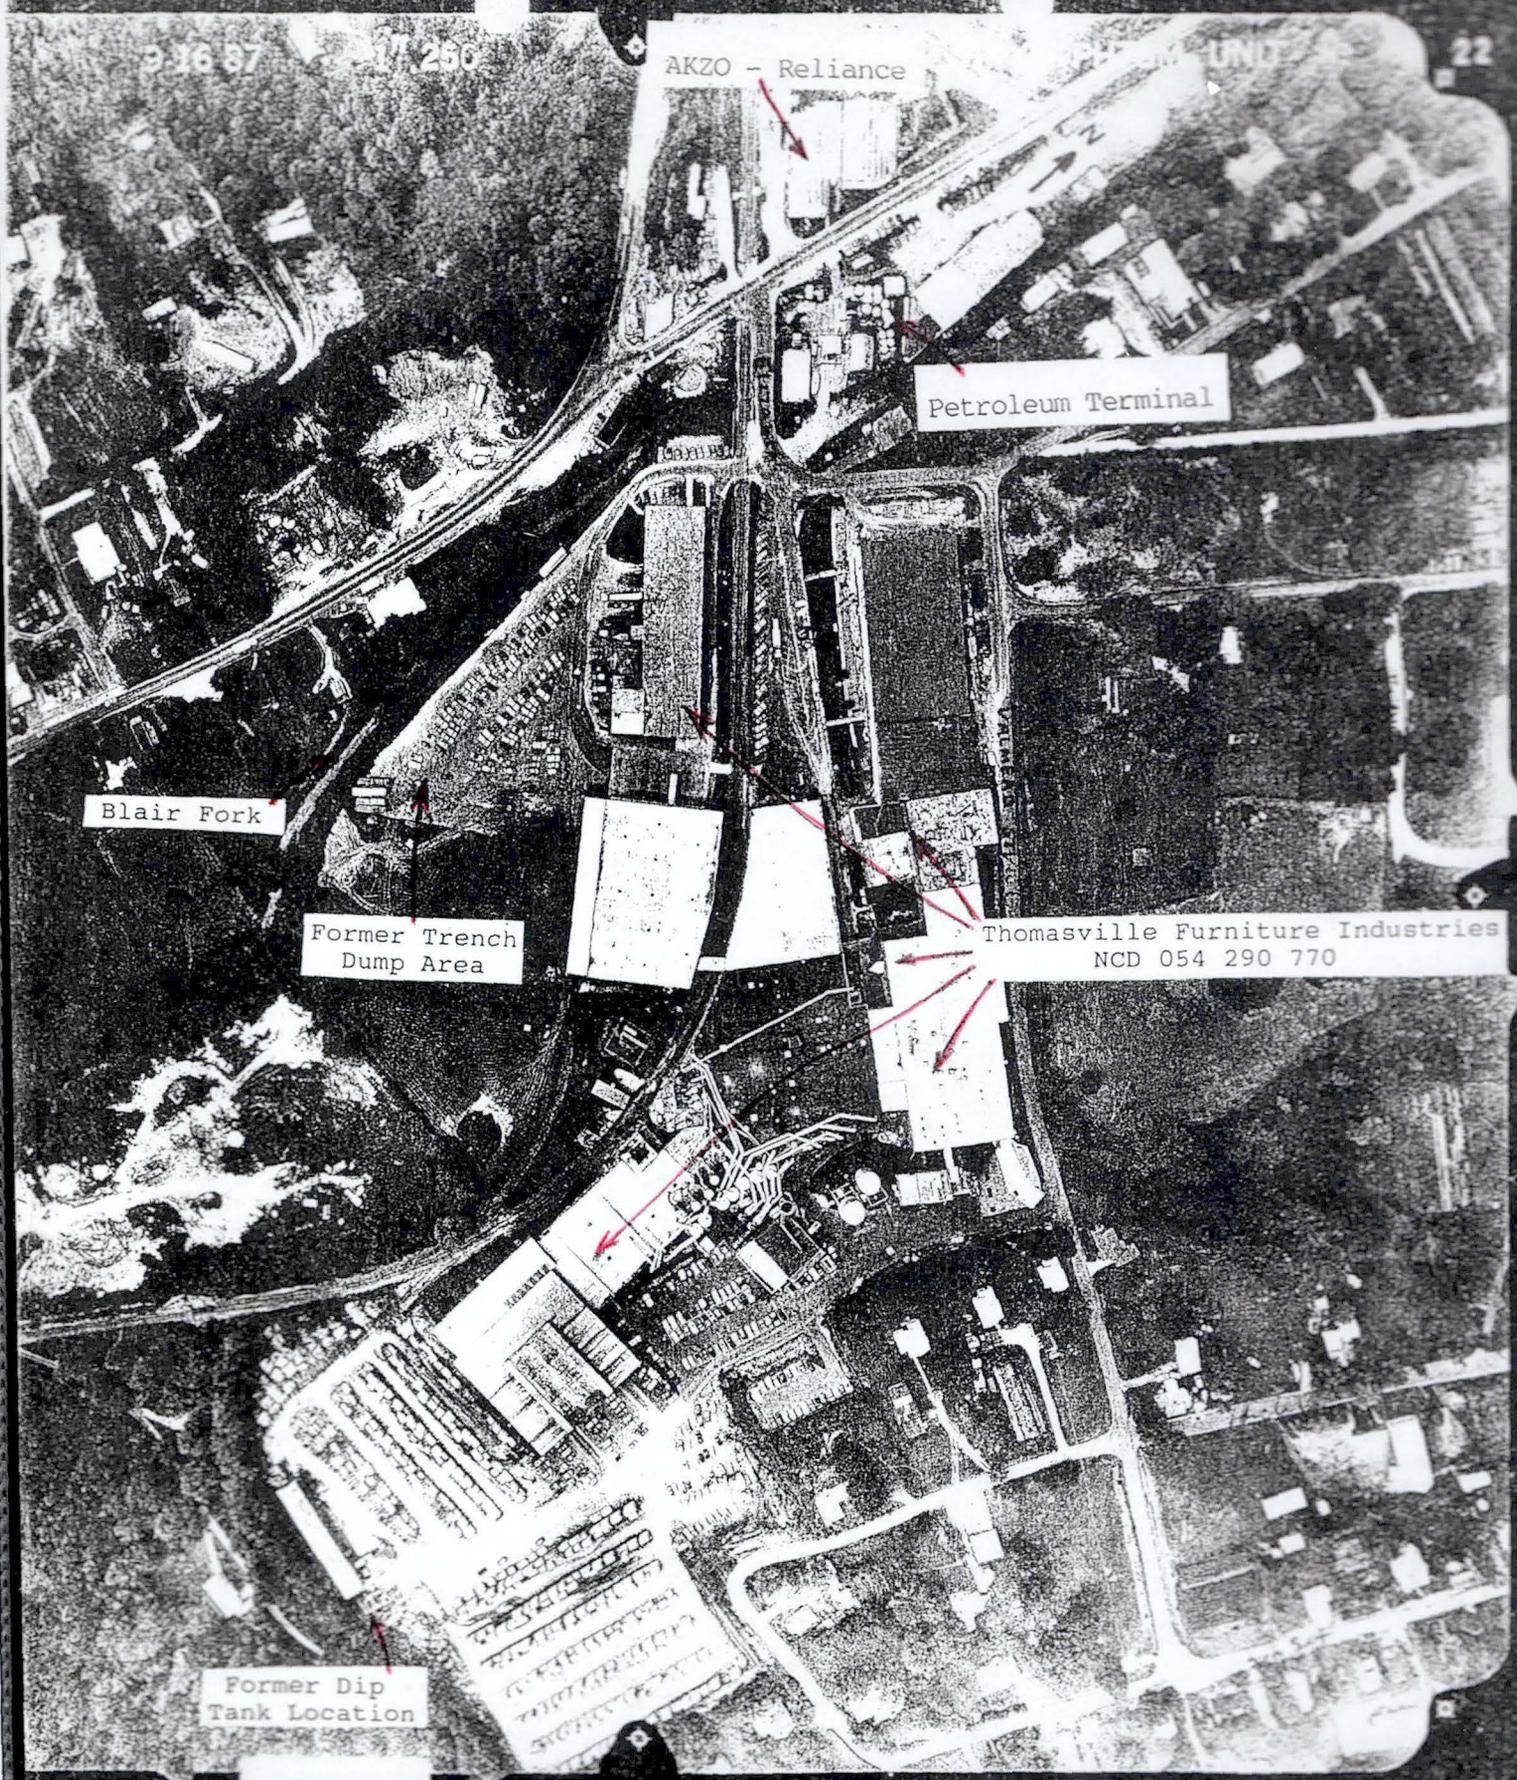
Figure 3. **FORMER TRENCH DUMP AREA**
N.C. DOT Aerial Photograph
1" = 250'

The location of the former wood preserving dip tank was also observed during the course of the site visit. The dip tank and any impacted soil associated with it had been removed in 1991. Inspection of this area did not reveal any visible signs of contamination. A monitoring well is present at the location previously occupied by the dip tank. However, soil and groundwater conditions downgradient of the former tank were not monitored at the time of removal (Ref. 10; 15; 30; Fig. 3).

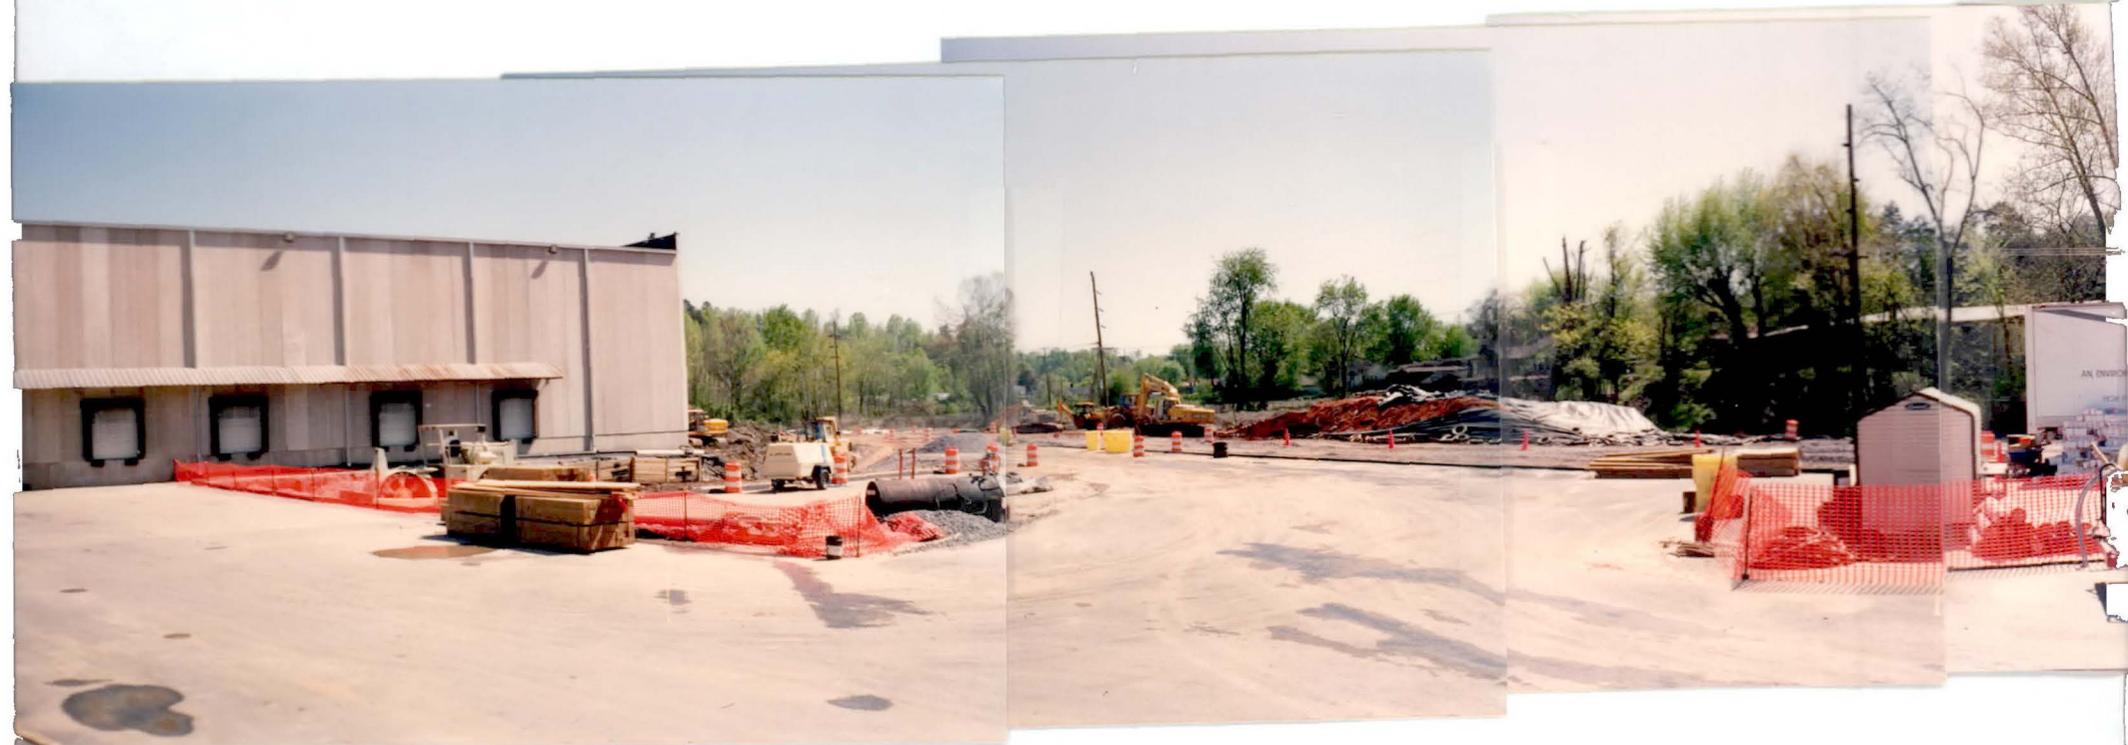
Photograph 1-5: Panoramic view of excavation area looking east.

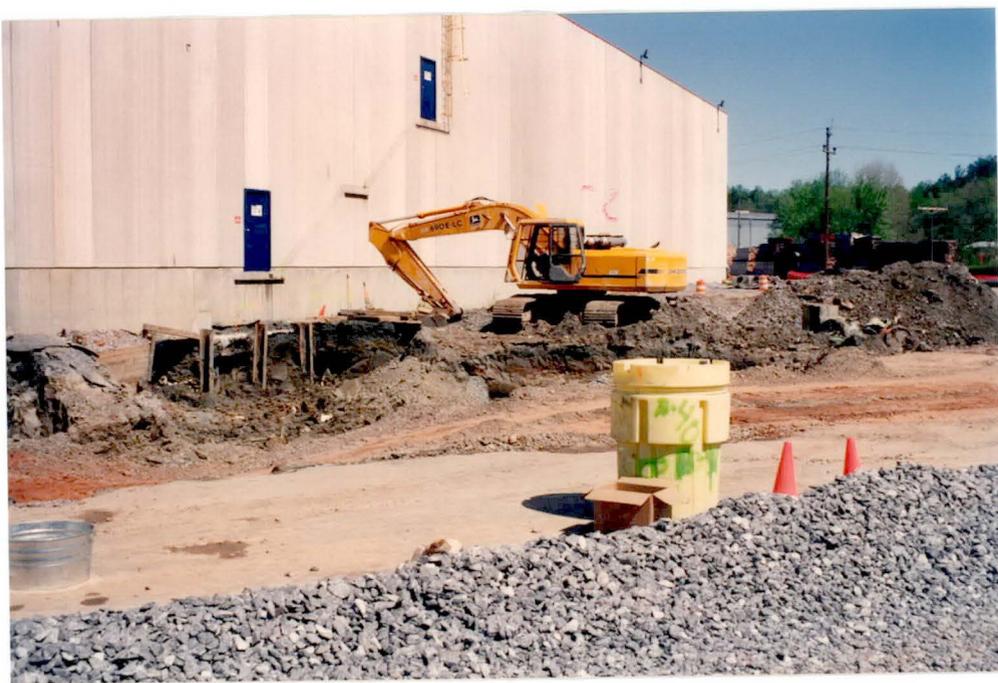
Photograph 6: Eastern view of excavation area at edge of new warehouse.

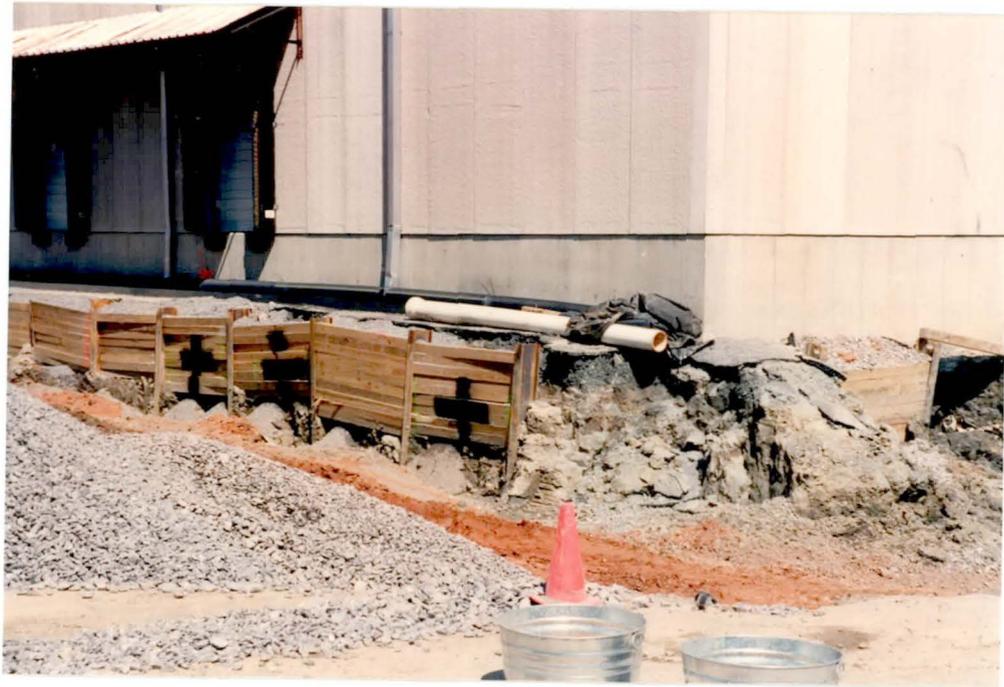
Photograph 7: Eastern view of excavation area at edge of new warehouse.

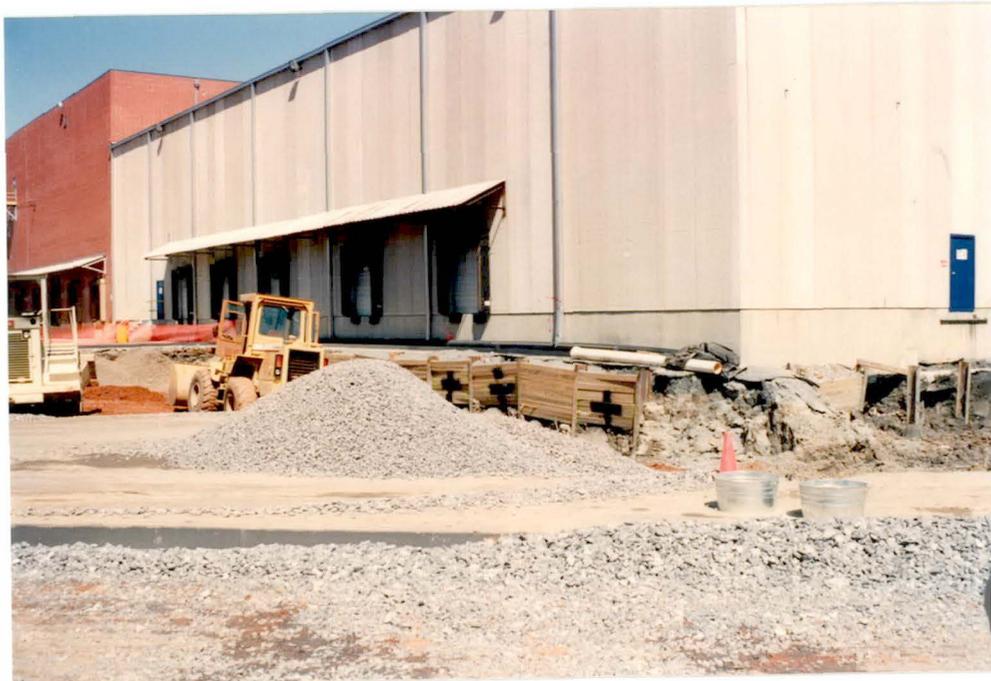
Photograph 8: Eastern view of excavation area at edge of new warehouse.

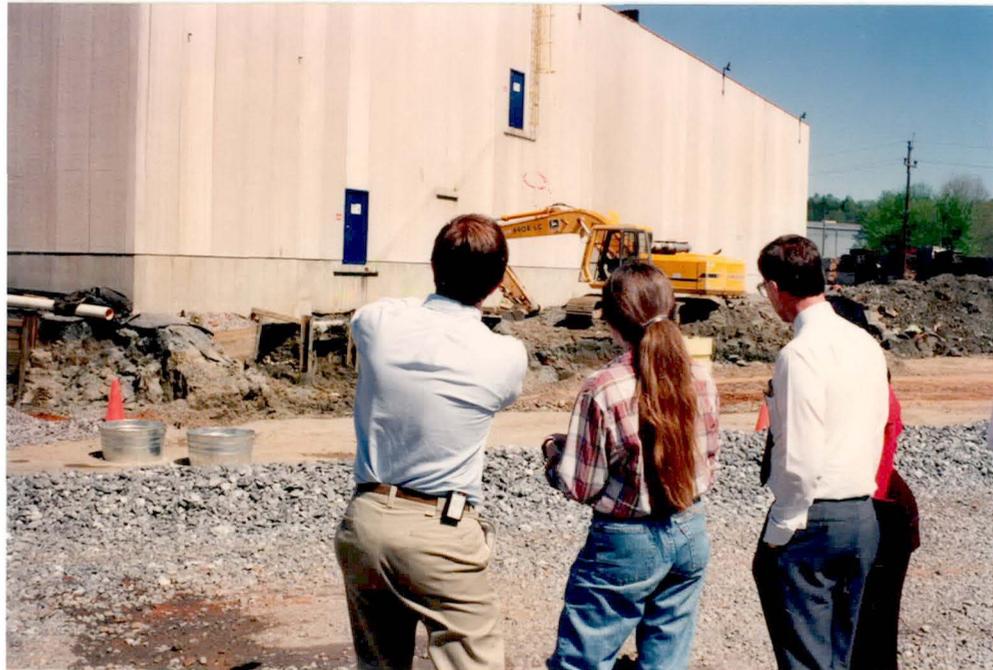
Photograph 9: Eastern view of excavation area at edge of new warehouse.

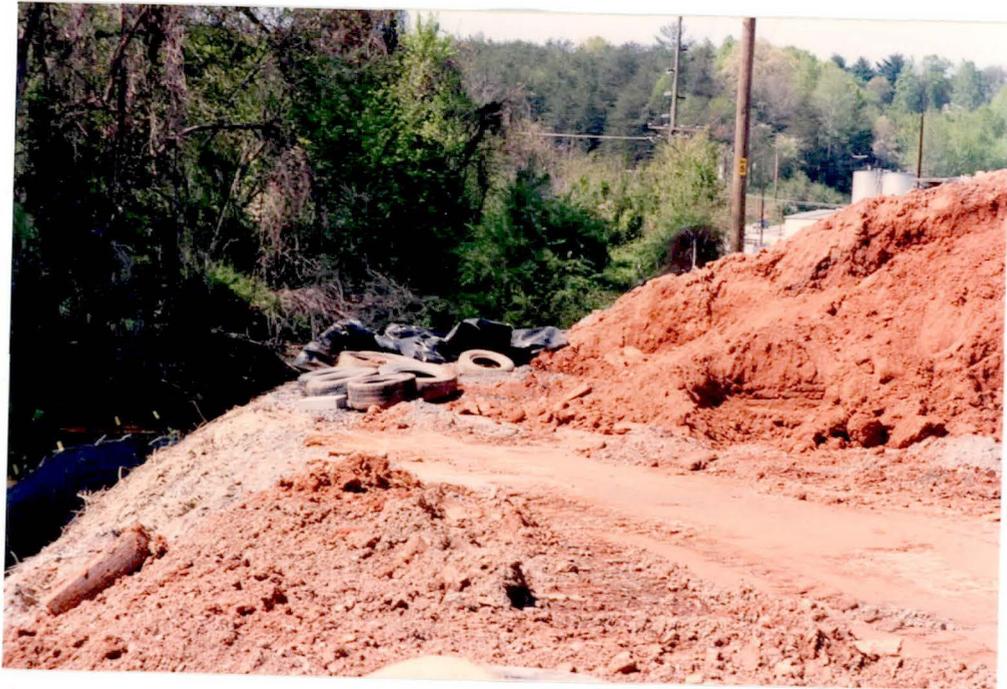
Photograph 10: Blair Fork looking upstream along stockpile of clean fill.

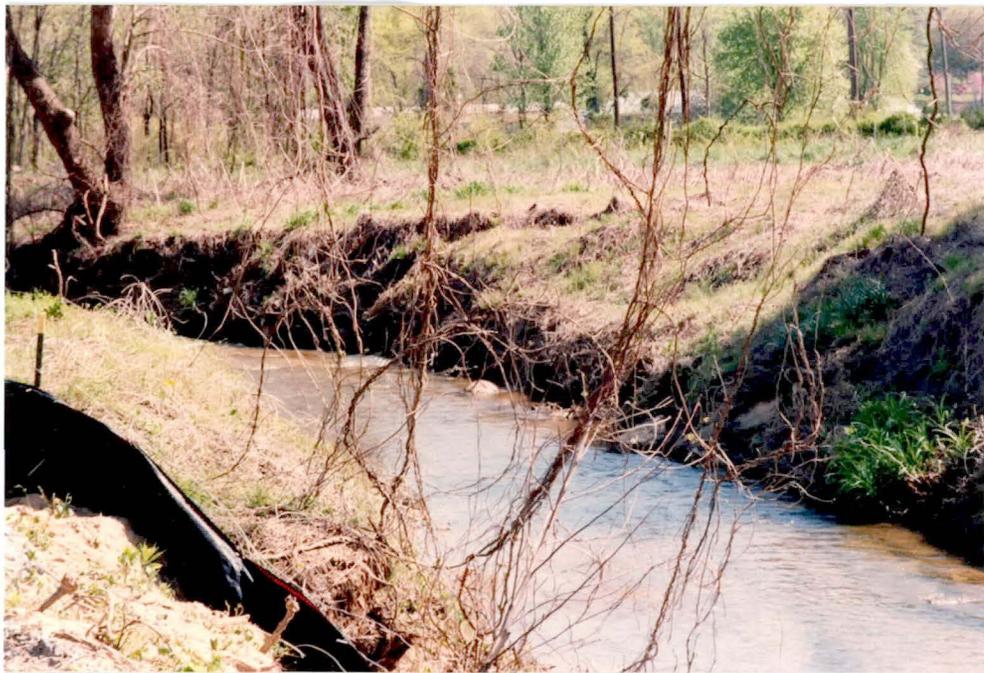
Photograph 11: Blair Fork looking downstream from excavation area.

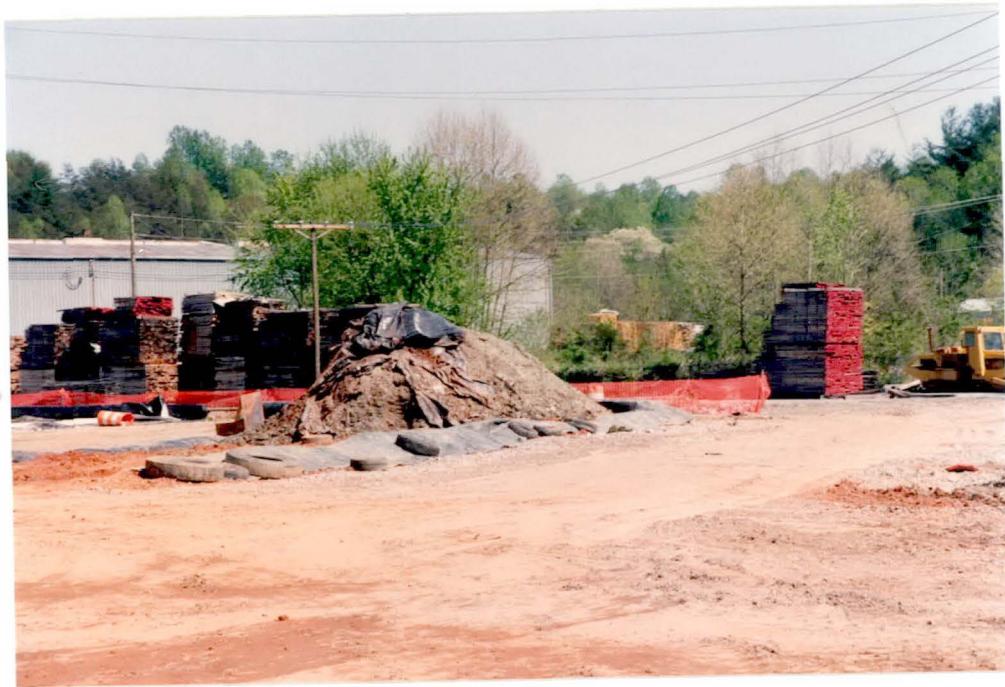
Photograph 12: Hazardous waste stockpile.

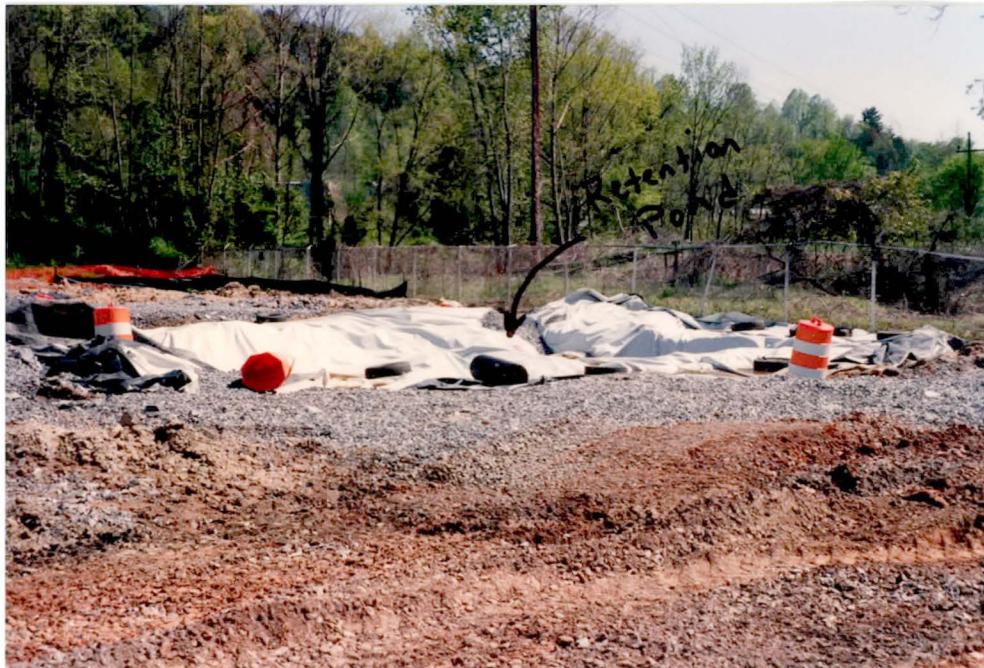
Photograph 13: Runoff retention pond.

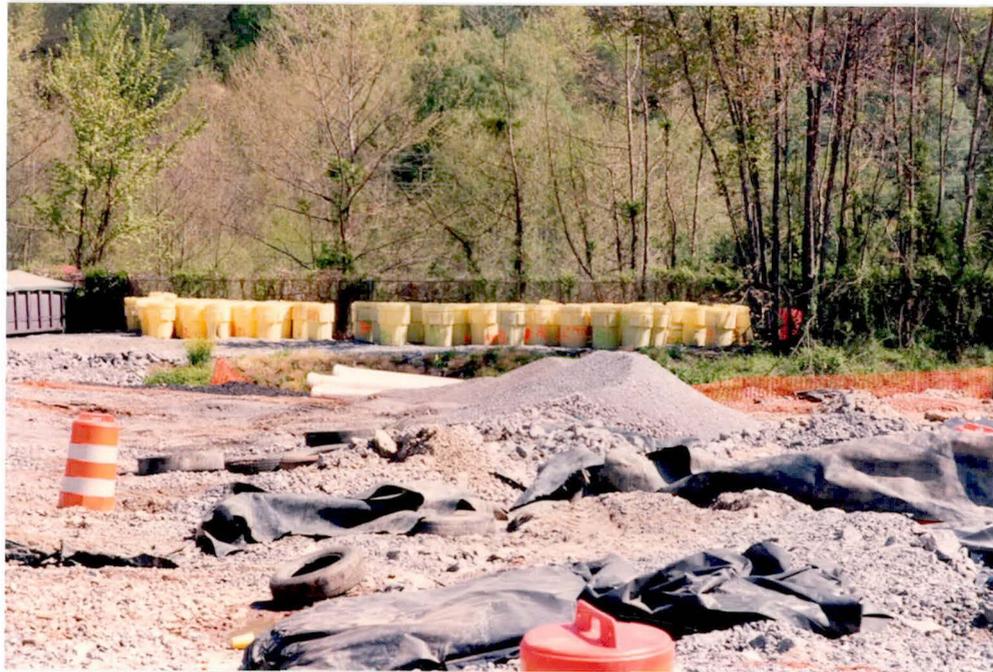
Photograph 14: Staging area for overpacked drums; 127 overpacks present.

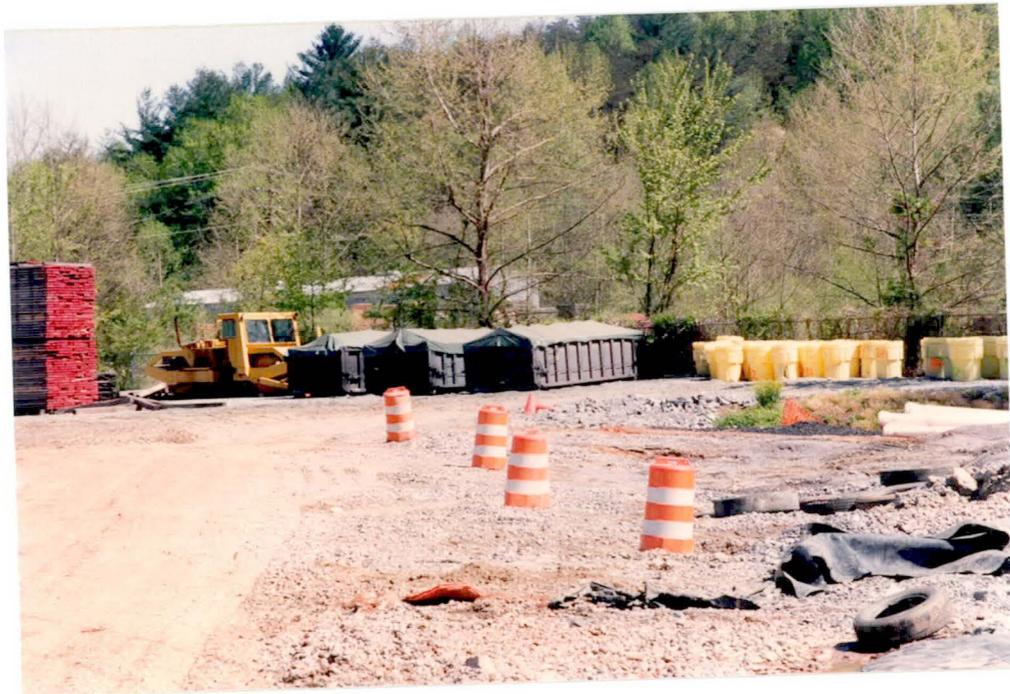
Photograph 15: Empty rolloff boxes.

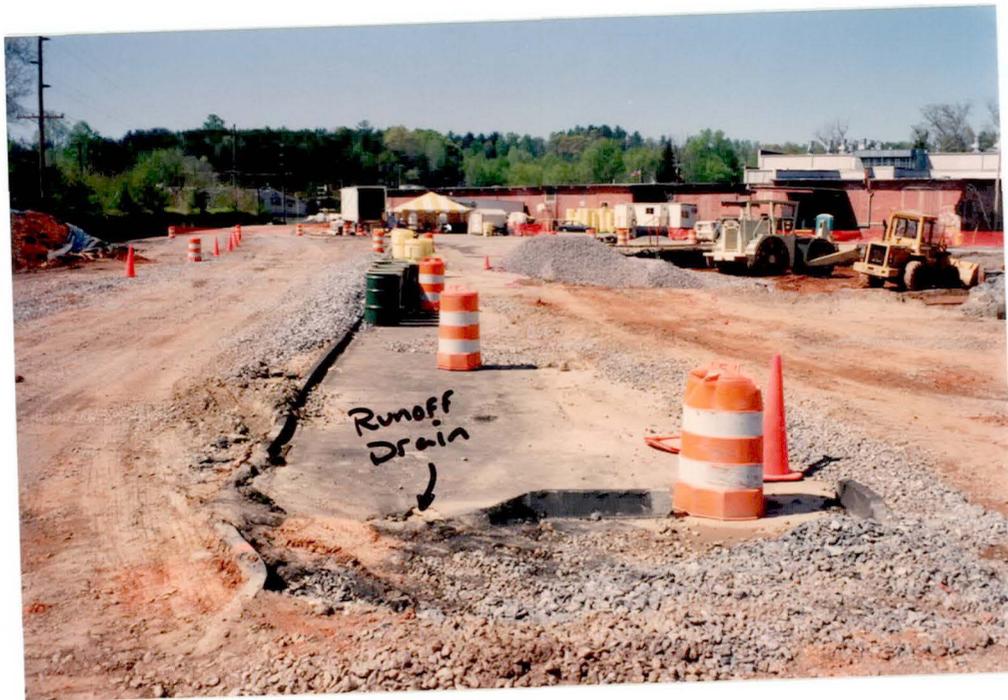
Photograph 16: Runoff to retention pond drain: west view.

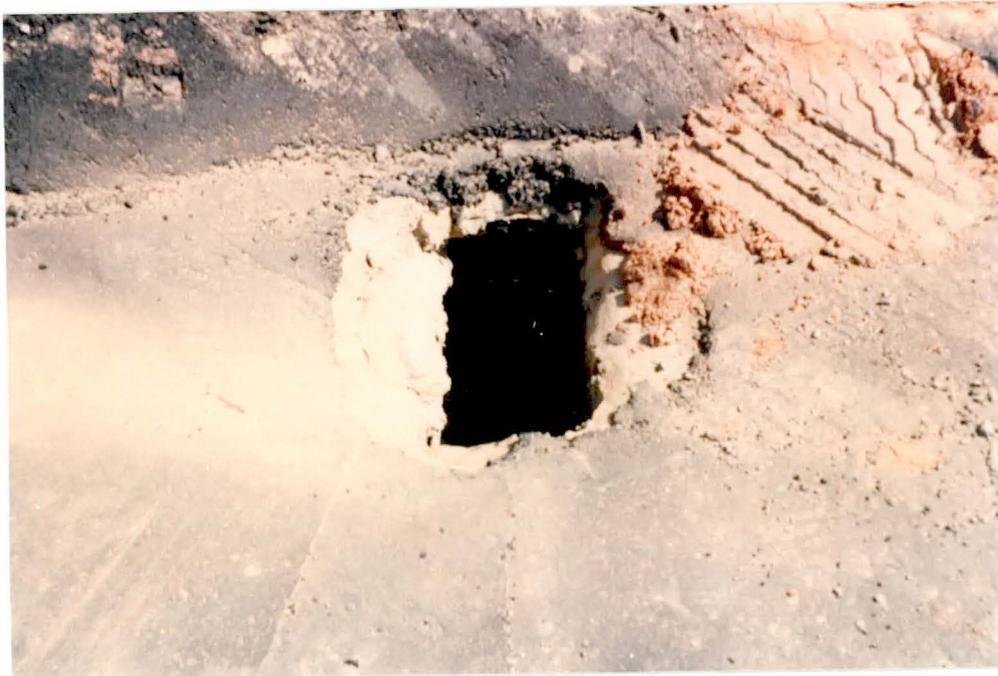
Photograph 17: Runoff to retention pond drain: east view.

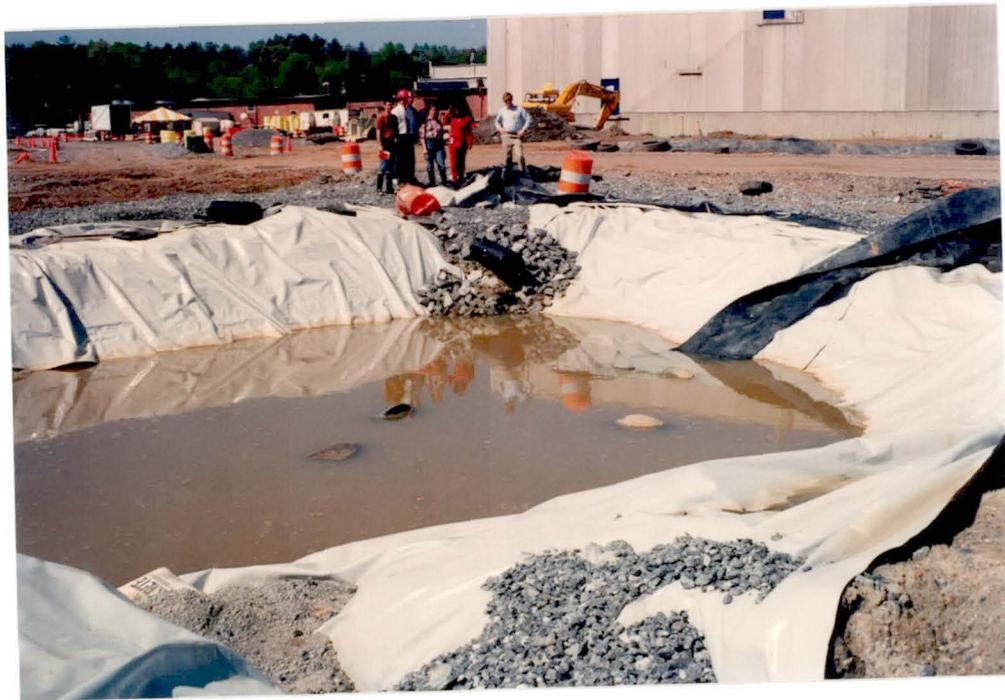
Photograph 18: Retention pond: north view.

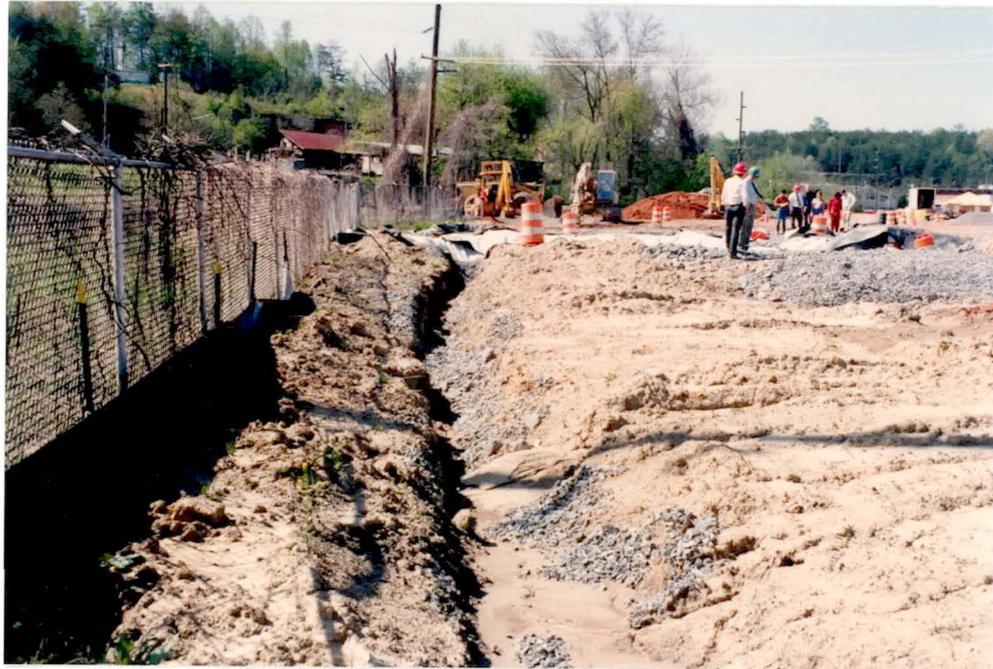
Photograph 19: Retention pond overflow to site drainage.

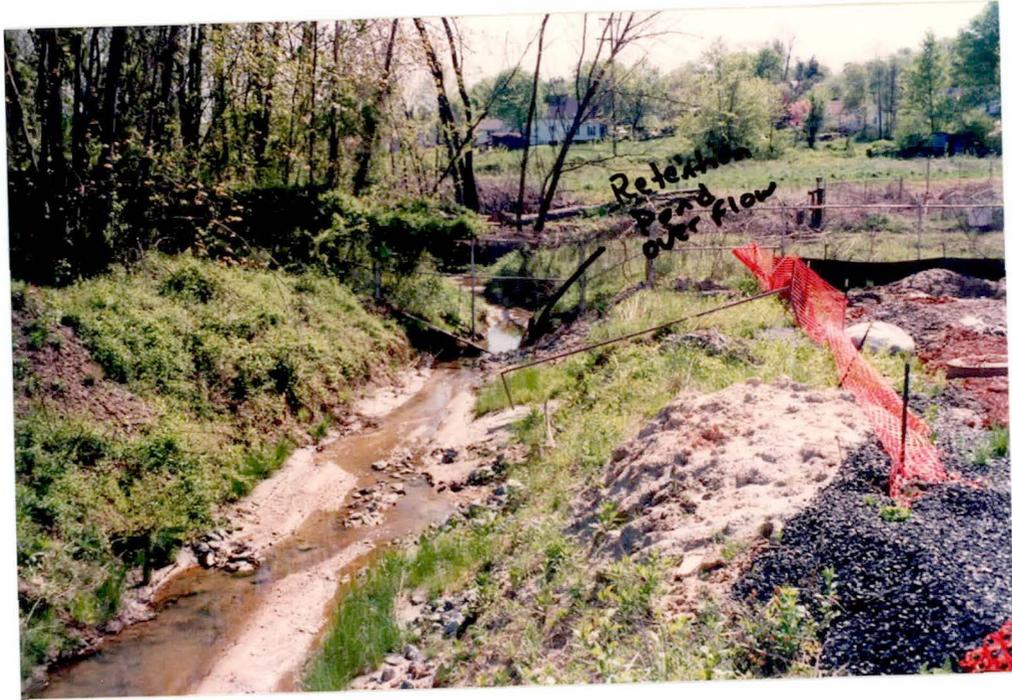
Photograph 20: Site drainage to Blair Fork: south view.

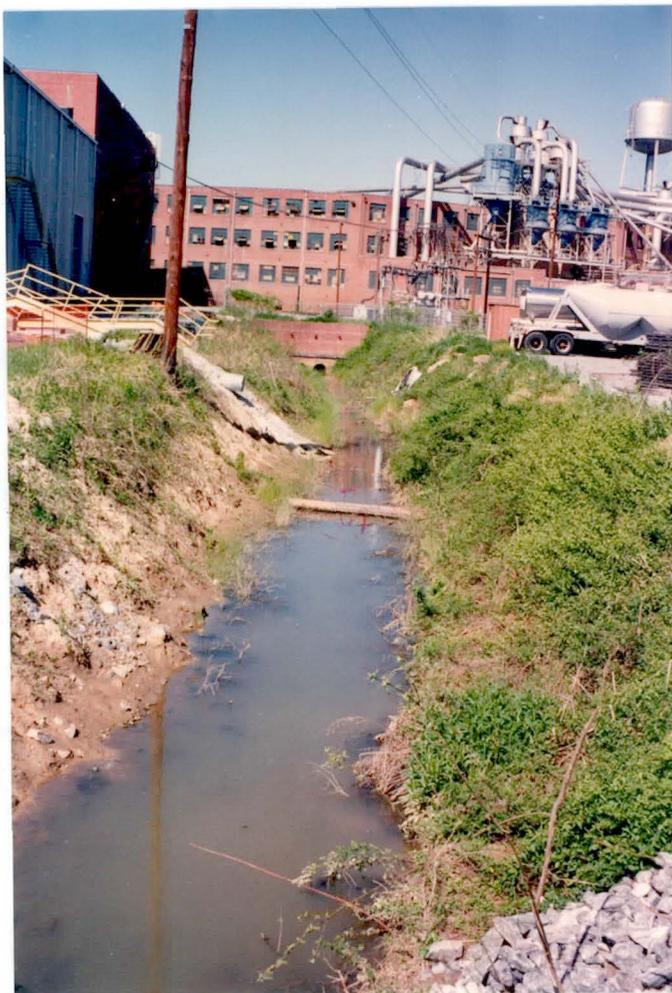
Photograph 21: Site draingage to Blair Fork: north view.

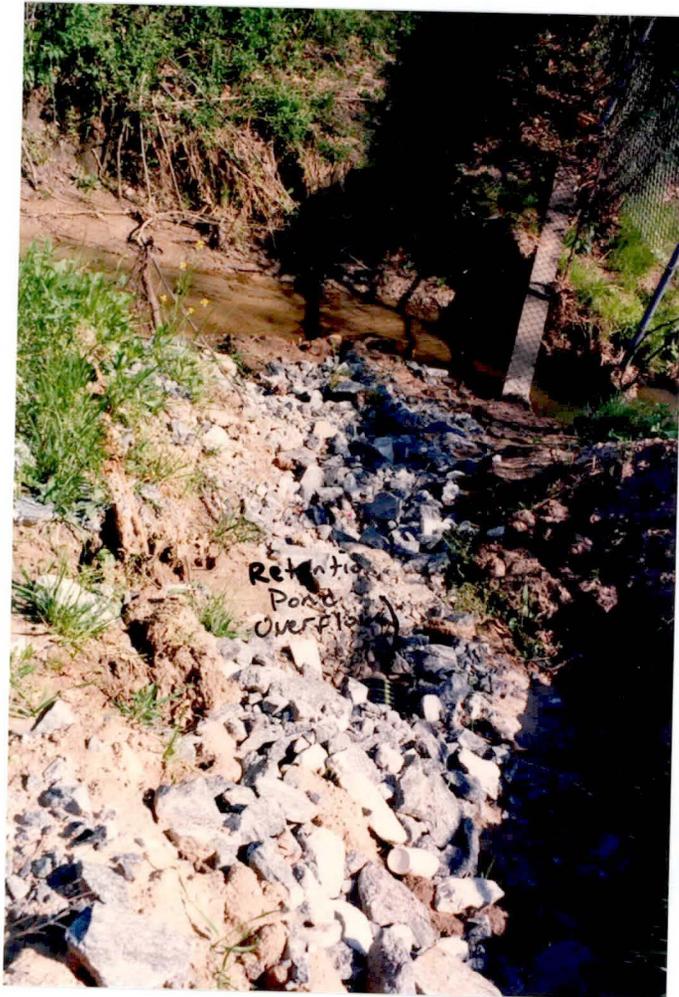
Photograph 22: Retention pond overflow into site drainage to Blair Fork.

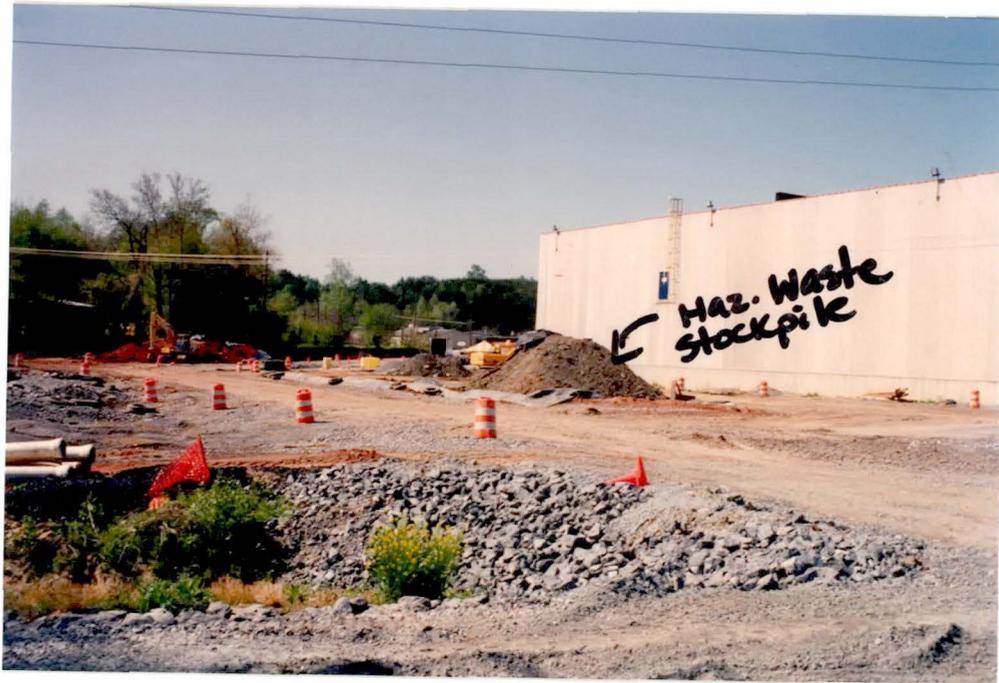
Photograph 23: East view of excavation.

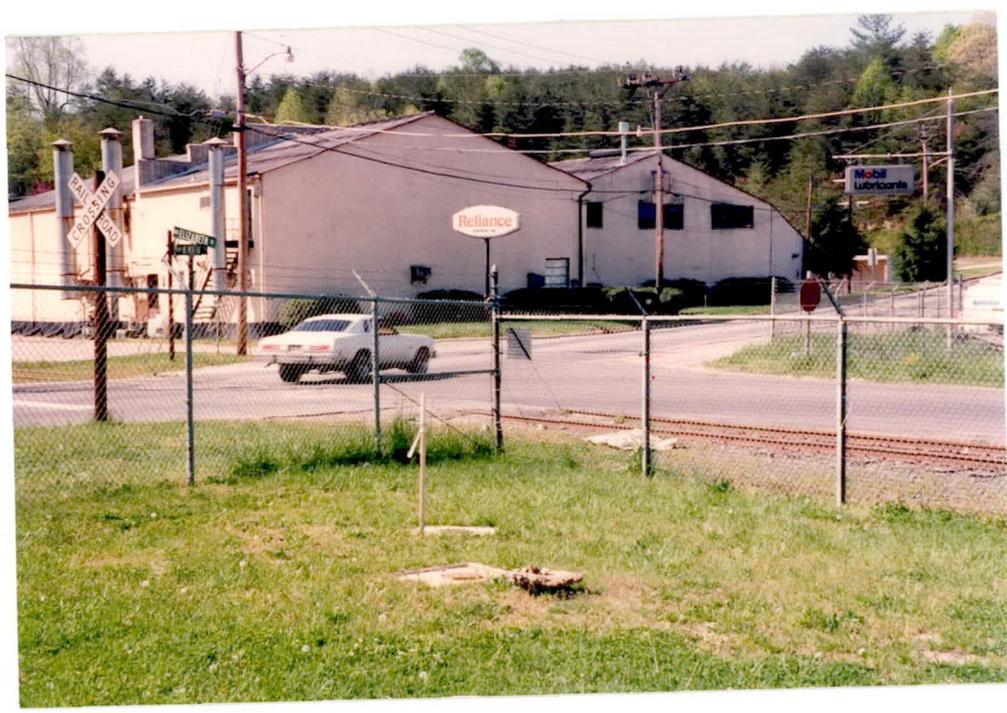
Photograph 24: Monitor wells MW-12 & MW-13 facing east.

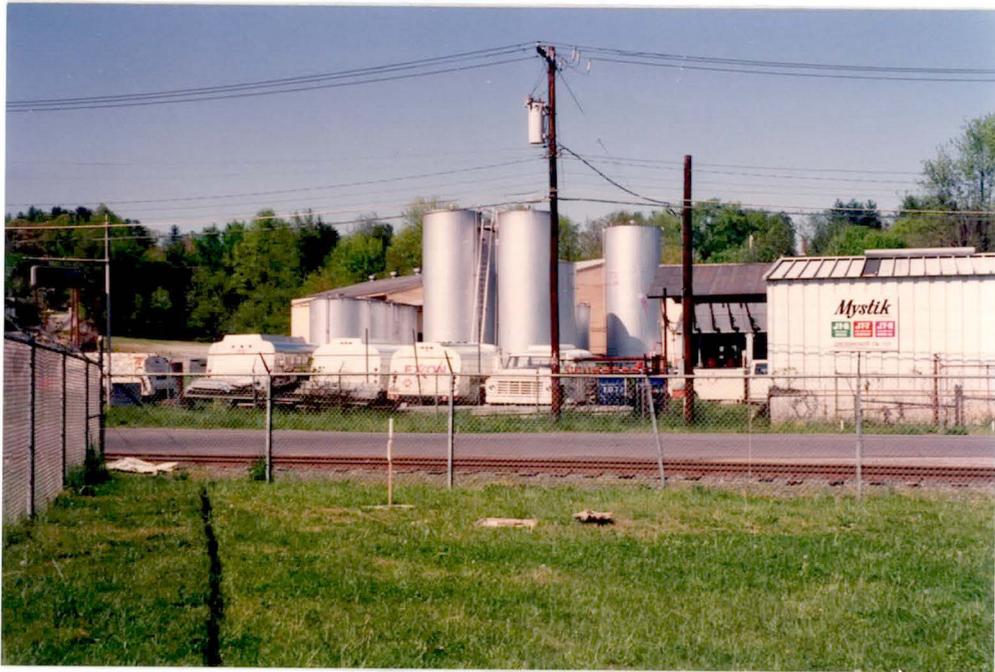
Photograph 25: Monitor wells MW-12 & MW-13 facing north.

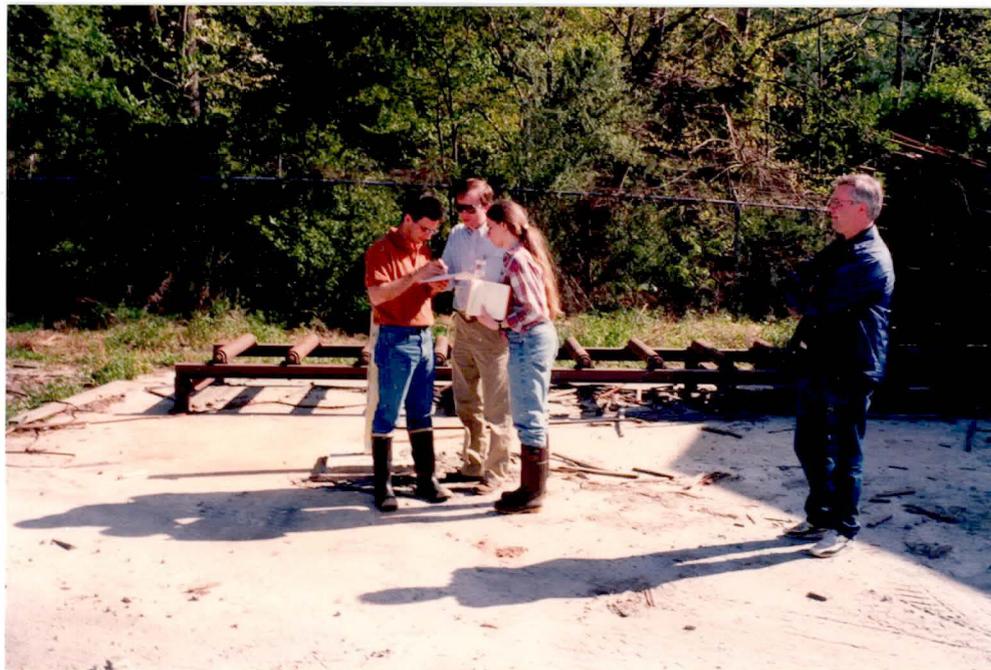
Photograph 1: Monitor well at former dip tank location: south view, Lower Creek below fence line.
