Site Name (Subject):	THOMASVILLE FURNITURE INDS/LENOIR
Site ID (Document ID):	NCD054290770
Document Name (DocType):	Contractor Report (CONTR)
Report Segment:	
Description:	Remedial Operations Summary
Date of Document:	6/9/1993
Date Received:	
Box: <i>Enter SF and # with no spaces</i>	SF10,631
Access Level:	PUBLIC
Division:	WASTE MANAGEMENT
Section:	SUPERFUND
Program (Document Group):	SERB (SERB)
Document Category:	FACILITY

RE: Remedial Operations Summary, Thomasville Furniture Industries, Inc., Lenoir, North Carolina Facility

Subject: Site Inspection Prioritization
Thomasville Furniture Industries NCD 054 290 770
Lenoir, Caldwell County, NC

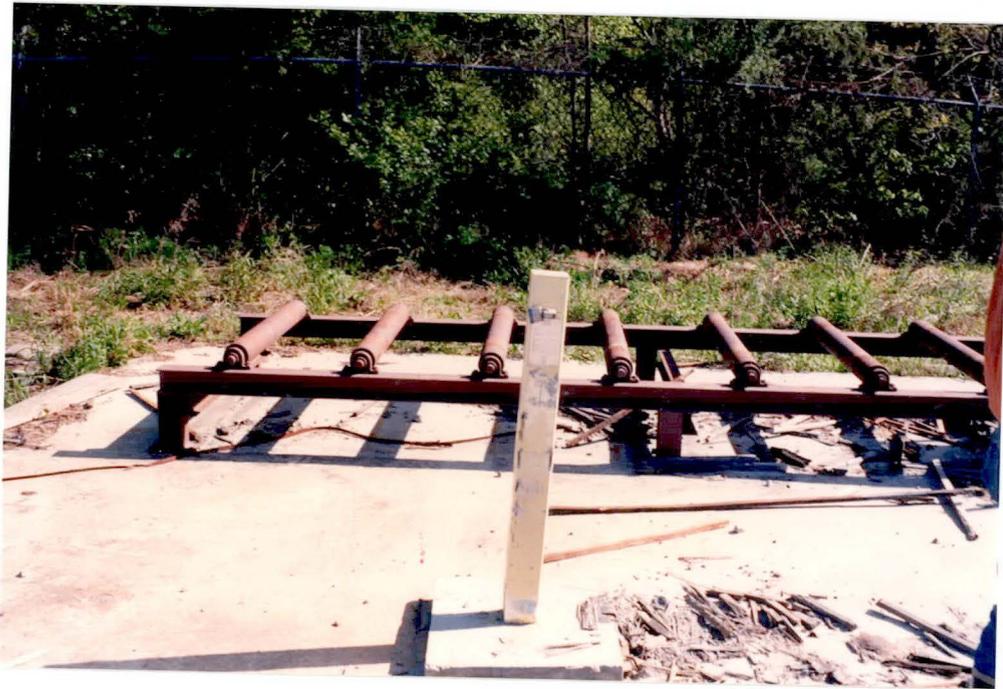
Photograph 2: Monitor well at former dip tank location: south view, Lower Creek below fence line.

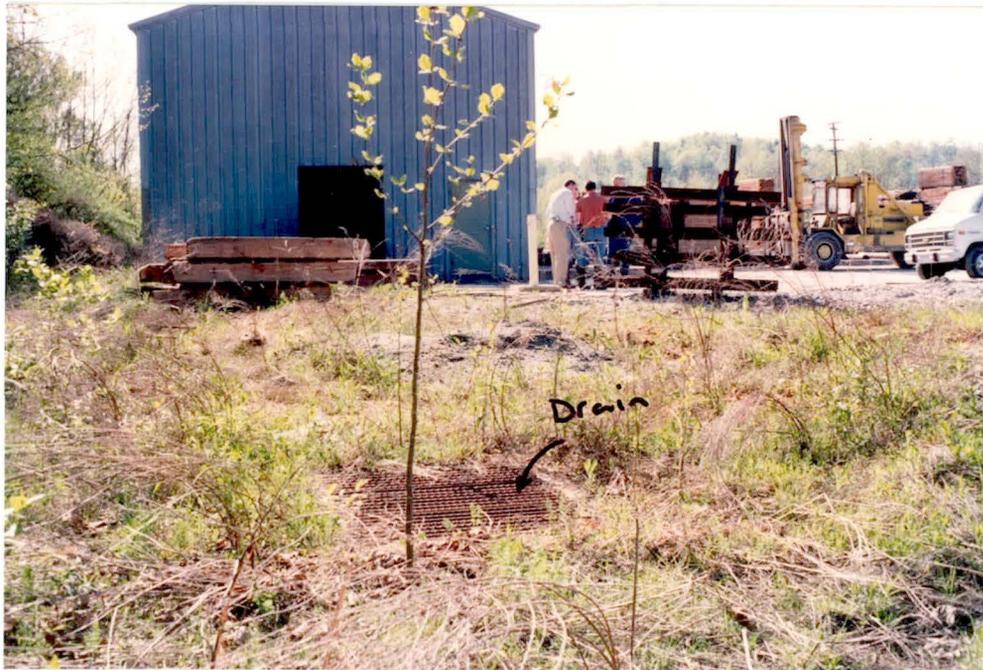
Photograph 3: Drain for area runoff to Lower Creek.

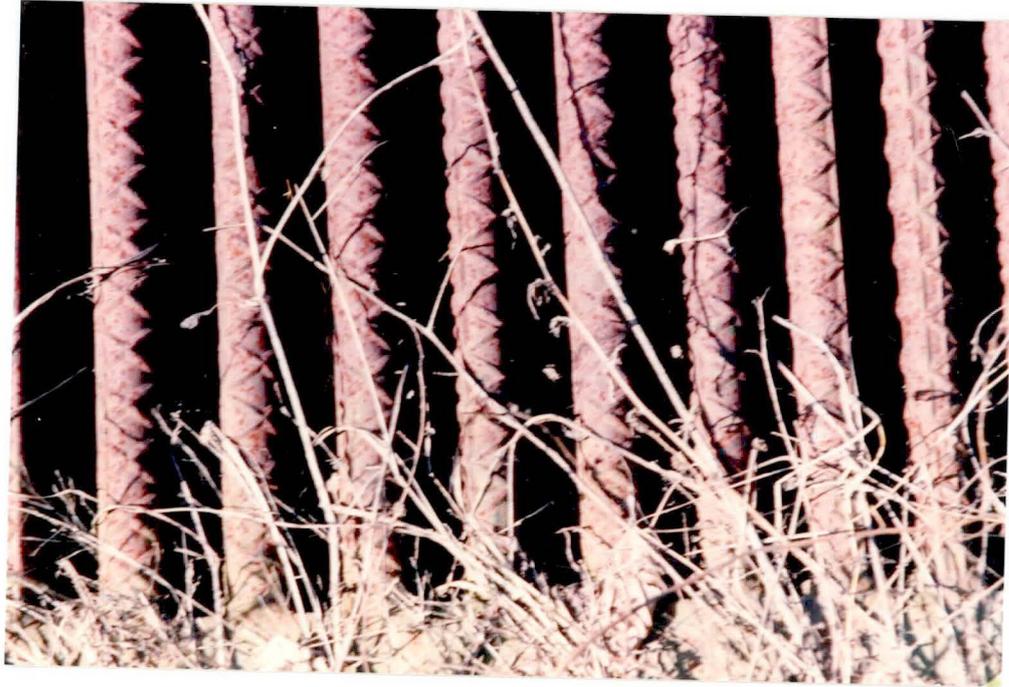
Photograph 4: Drain for area runoff to Lower Creek.

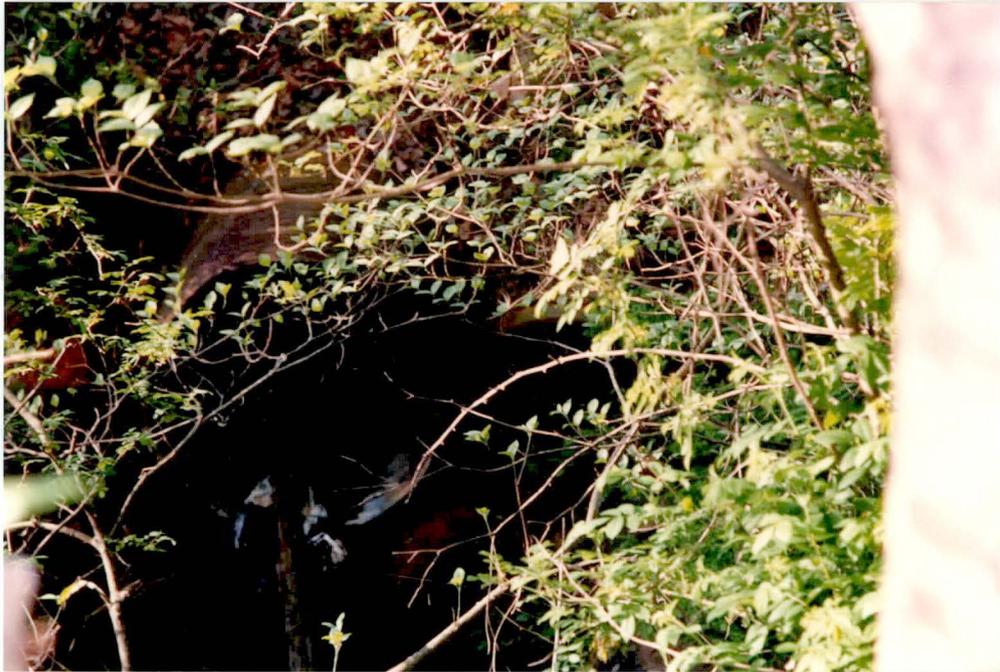
Photograph 5: Drain pipe to Lower Creek for runoff from area around former dip tank.

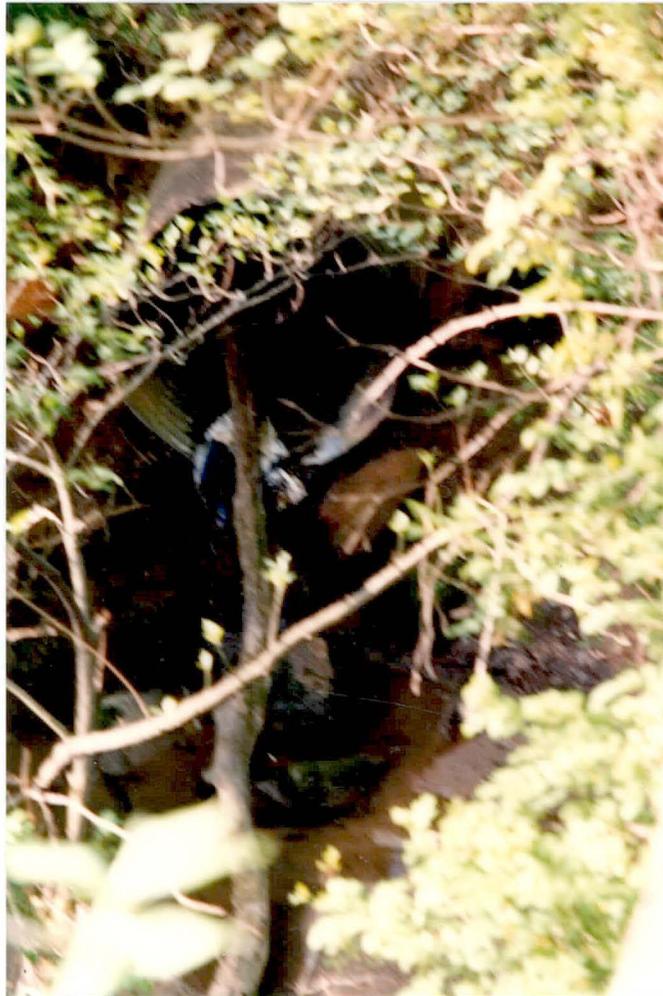
Photograph 6:
Drain pipe to Lower Creek for runoff from area around former dip tank.
