FACILITY COMPLIANCE INSPECTION REPORT
Division of Waste Management
Solid Waste Section

Date of Site Inspection: 10/17/2016 Date of Last Inspection: 08/17/2016

Davidson County Integrated Solid Waste Management Facility
220 Davidson County Landfill Road
Lexington, NC 27292

Partial Inspection

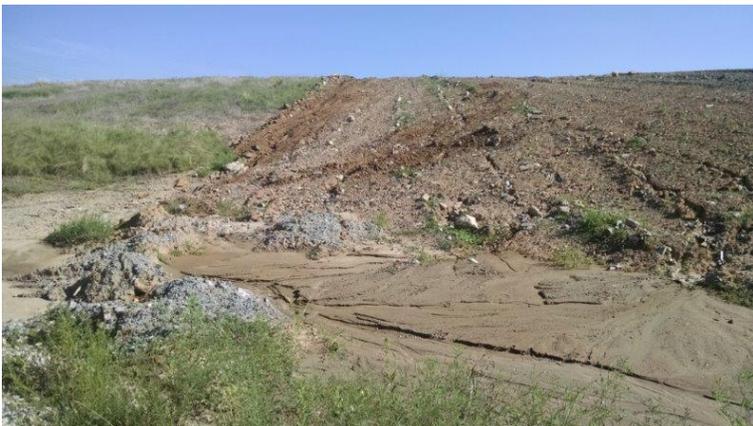
- 1. RESOLVED: 15A NCAC 13B .0542(f)(1) cited for failure to apply adequate cover to waste at the C&D landfill. The top and all side slopes of the C&D landfill were observed to have an established vegetative cover, and no waste was visible on the site. A small area where erosion appeared to have begun as a result of the rains associated with Hurricane Matthew was observed to be under repair; however, additional seeding should not be necessary after the repairs are complete.
2. RESOLVED: 15A NCAC 13B .1626(2)(a) cited for failure to adequately cover waste at the MSW landfill. No waste was visible on the top or any of the side slopes of the MSW landfill. Soil cover was observed to be in place, with new vegetative cover beginning to emerge on the side slopes.

*Toe of C&D landfill with silt and runoff ponded at temporary berm. Note uneven grade with some uncovered waste resulting from the rocky cover soil. (Photo taken 8-17-2016)*

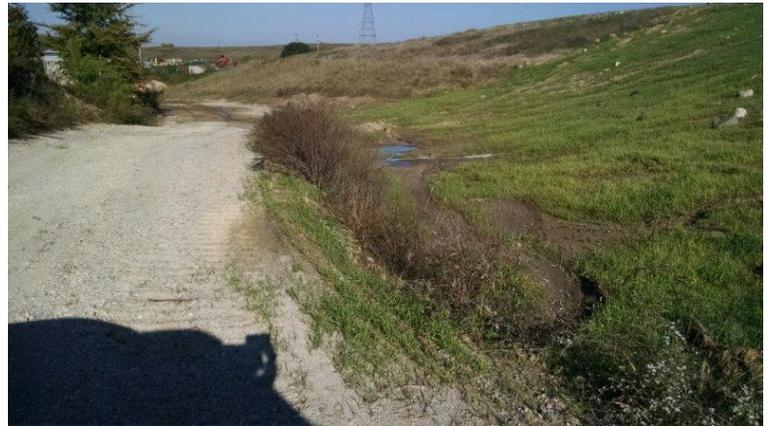
*Toe of C&D landfill with runoff ponded at temporary berm. Note well established vegetative cover with no waste visible. (Photo taken 10-17-2017)*

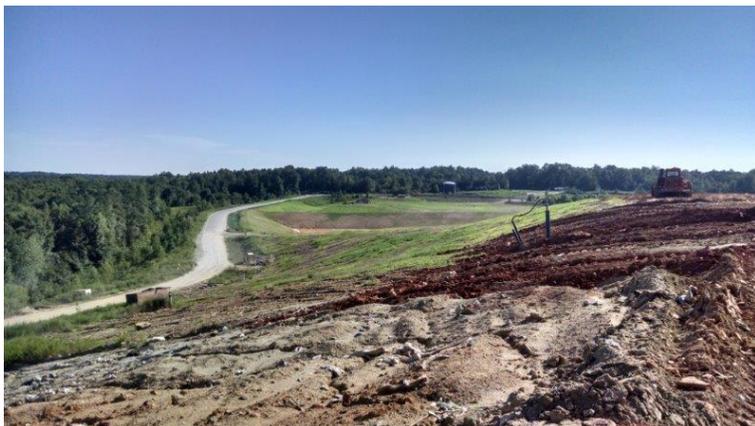
4. **CORRECTIVE MEASURES IN PROGRESS:** 15A NCAC 13B. 1626(7)(b) cited for failure to prevent on-site erosion. Although Mr. Sink stated that all repairs, regrading and reseeding had taken place as planned in August/September, some small areas of erosion and slope repair were observed on the side slopes of Phase 2 that were the result of the heavy rain event associated with Hurricane Matthew. Mr. Sink stated that spot seeding would be undertaken as quickly as possible to re-establish the vegetative cover that had begun to sprout before the storm occurred.

*Eroded areas and repaired areas along northern slope with new cell in the background. (Photo taken 8-17-2016)*

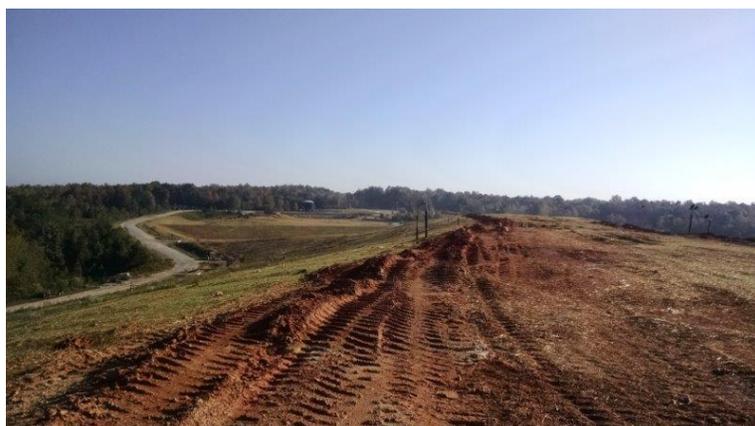
5. **CORRECTIVE MEASURES IN PROGRESS:** 15A NCAC 13B. 1626(7)(c) cited for failure to provide for a vegetative cover sufficient to restrain erosion within 30 working days or 120 calendar days of completion of any phase of MSWLF development. Although slope repairs and reseeding had again taken place, vegetative cover at the MSW landfill has not yet become established due to the rain event associated with Hurricane Matthew. Final repairs were observed to be in progress during this inspection, and Mr. Sink stated that spot seeding will take place once repairs are complete.

*Repaired north slope with emerging vegetative cover and new cell in the background. (Photo taken 10-17-2016)*

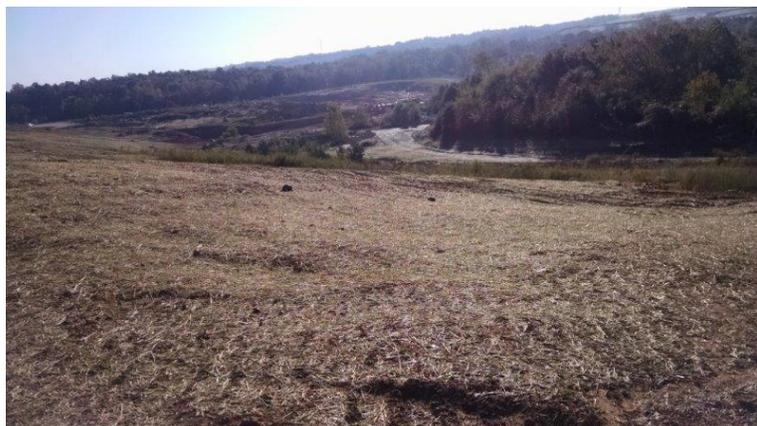
*Repaired south slope of active MSW landfill with emerging vegetative cover. (Photo taken 10-17-2016).*
