**RE: REACHES 1 TO 3 2015 VISUAL AND VEGETATION MONITORING
WARD TRANSFORMER SUPERFUND SITE, RALEIGH, NORTH CAROLINA**

On behalf of the Ward Transformer Site Trust (Trust), Golder Associates NC, Inc. (Golder) submits the results of the visual and vegetation monitoring of the riparian vegetation for Reaches 1 to 3 for the Phase 2 Removal Action (RA) at the Ward Transformer Superfund Site, Raleigh, North Carolina.

**ATTACHMENT 1
AS-BUILT SURVEY FOR
PHASE 2 REMOVAL ACTION REPAIRS**

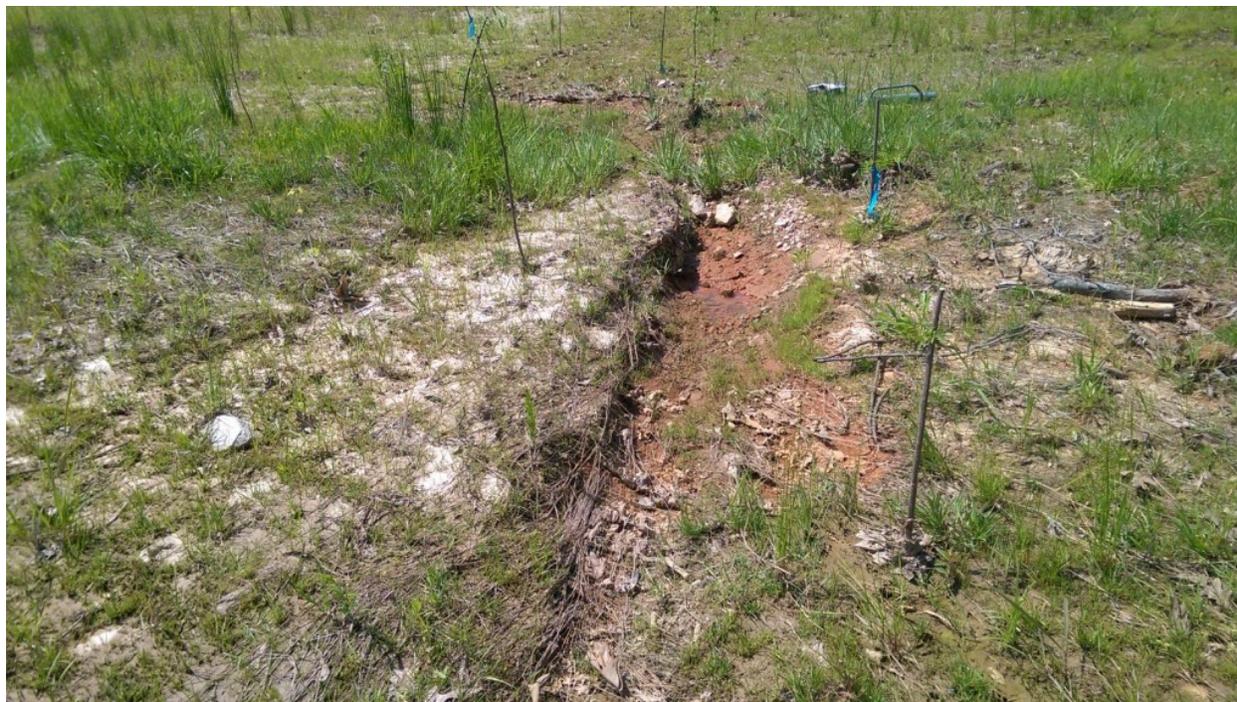
In the Reach 1 area, erosion was observed south and downstream of the riprap stormwater channels near the edge of the 'wet area.' The erosion channel was approximately 20 feet long by 2-5 feet wide, and an average depth of 6-12" during the monitoring. This area is shown in Photo 14.

Photograph No. 14
Erosion Channel Upstream of Reach 1 'wet area'
Facing South

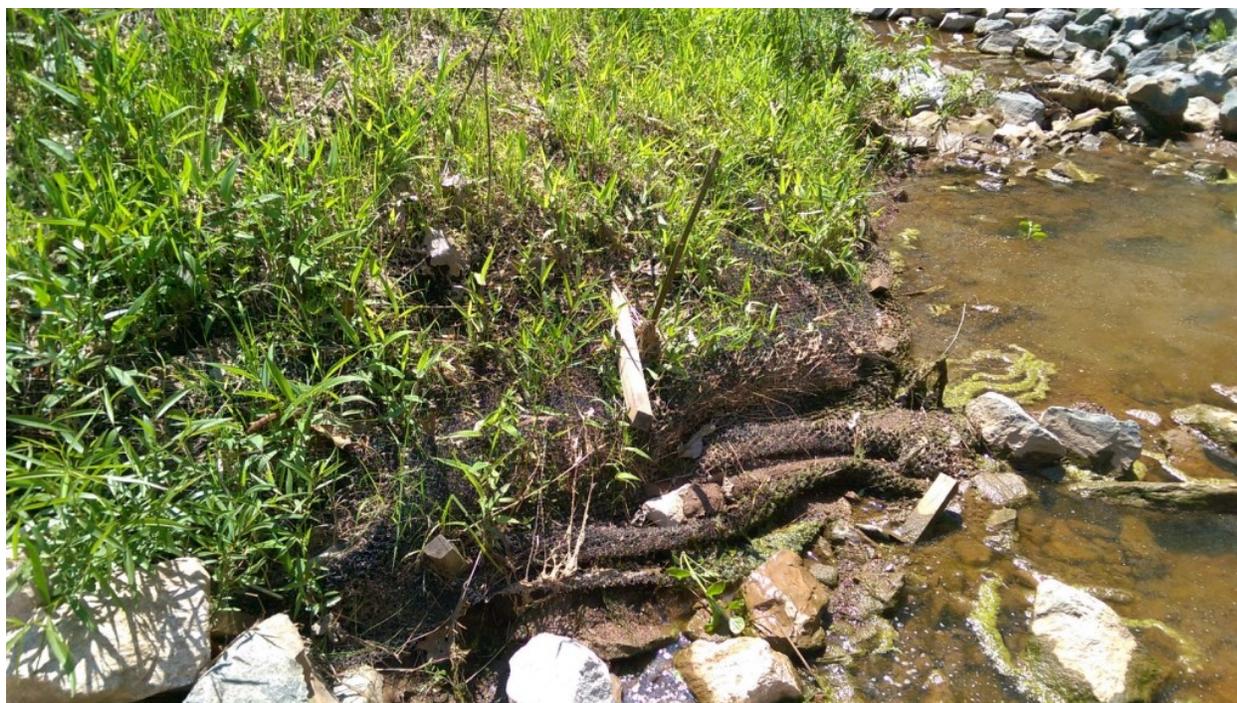
In Reach 2, two (2) erosion areas along the turf-reinforcement matting (TRM) were observed along the Reach 2 channel. The first area, shown in Photo 15, was approximately 10 feet long located along the south bank toe of Reach 2 at the end of the first riprap toe section. The TRM was loose and folded and the wooden stakes dislodged or loose.

Photograph No. 15
Loose/Displaced TRM at End of First Riprap Toe Protection Along South Side of Reach 2
Facing West

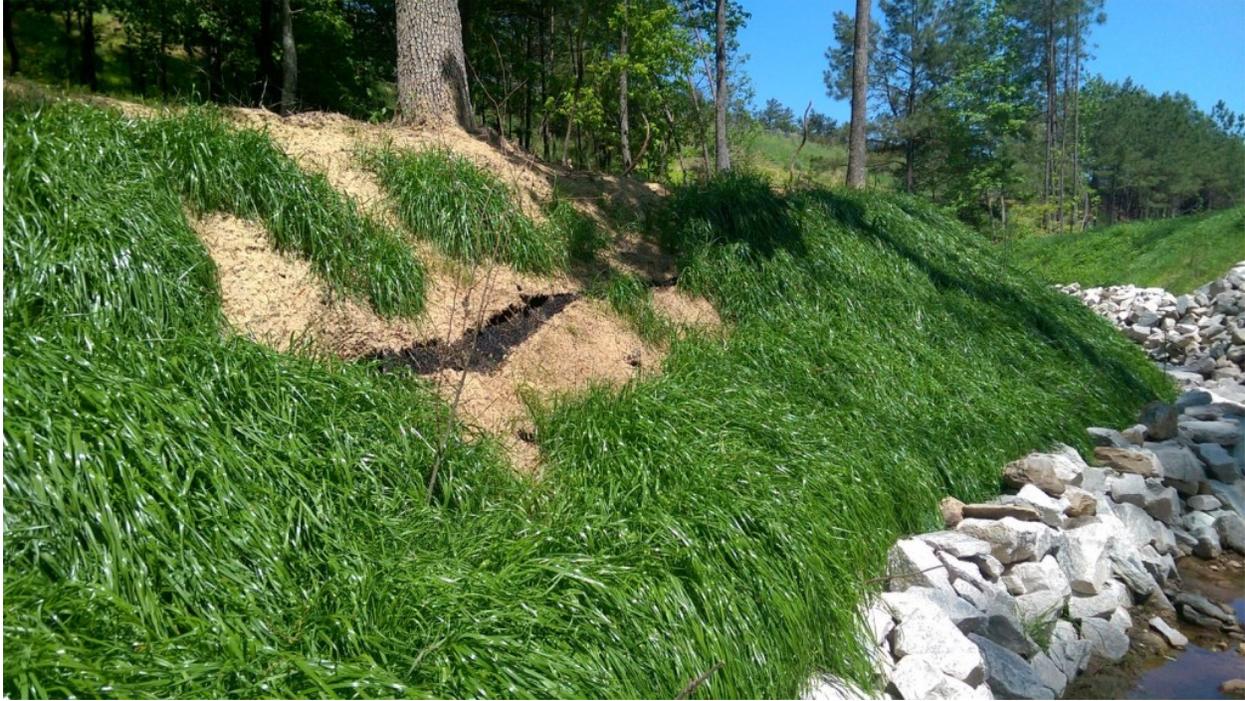
Photograph No. 16
Sloughed Soil and TRM Displacement Along North Bank in Reach 2 Channel
Facing Northeast

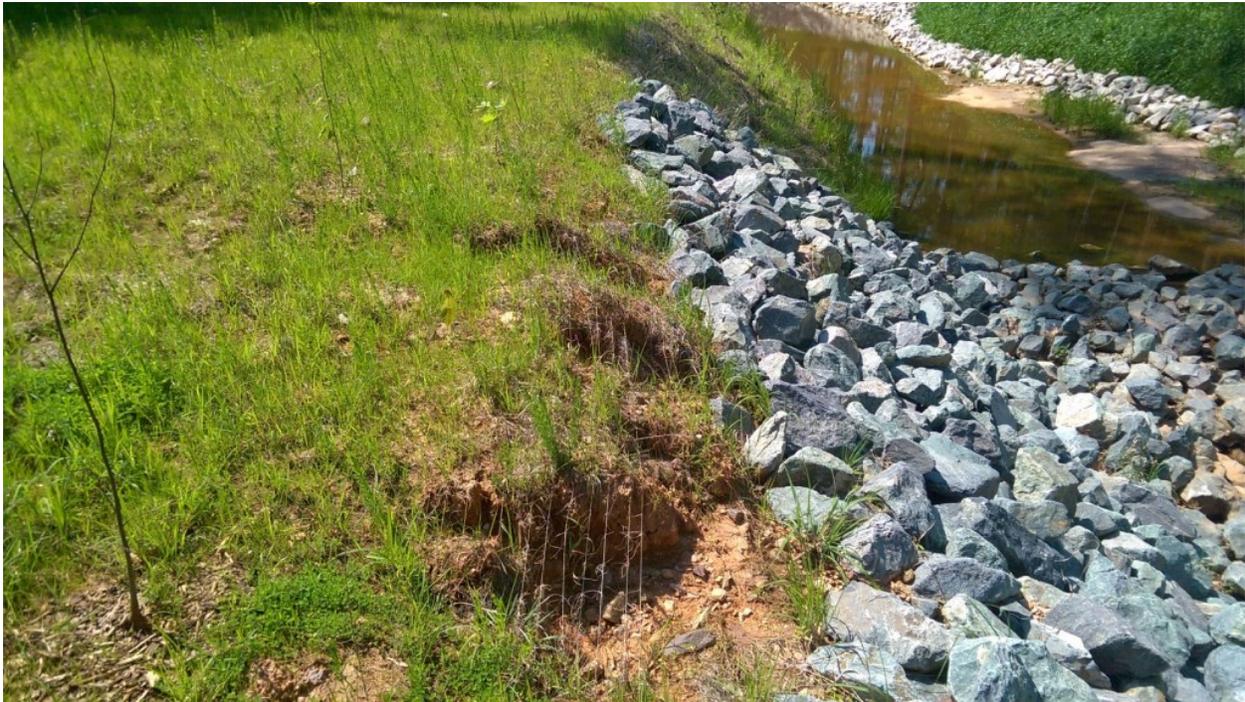
In Reach 3, two erosion areas were observed. The first area, shown in Photo 17, is located immediately above the upstream DOT riprap apron on the west side of the Reach 3 channel. A series of several small erosion channels are forming in an area approximately 10 feet long, 2-3 feet wide and 1-2 feet deep were observed above riprap.

Photograph No. 17
Erosion Channels Along Top of West Side of Upstream DOT NCDOT Riprap Apron at Reach 3
Facing North

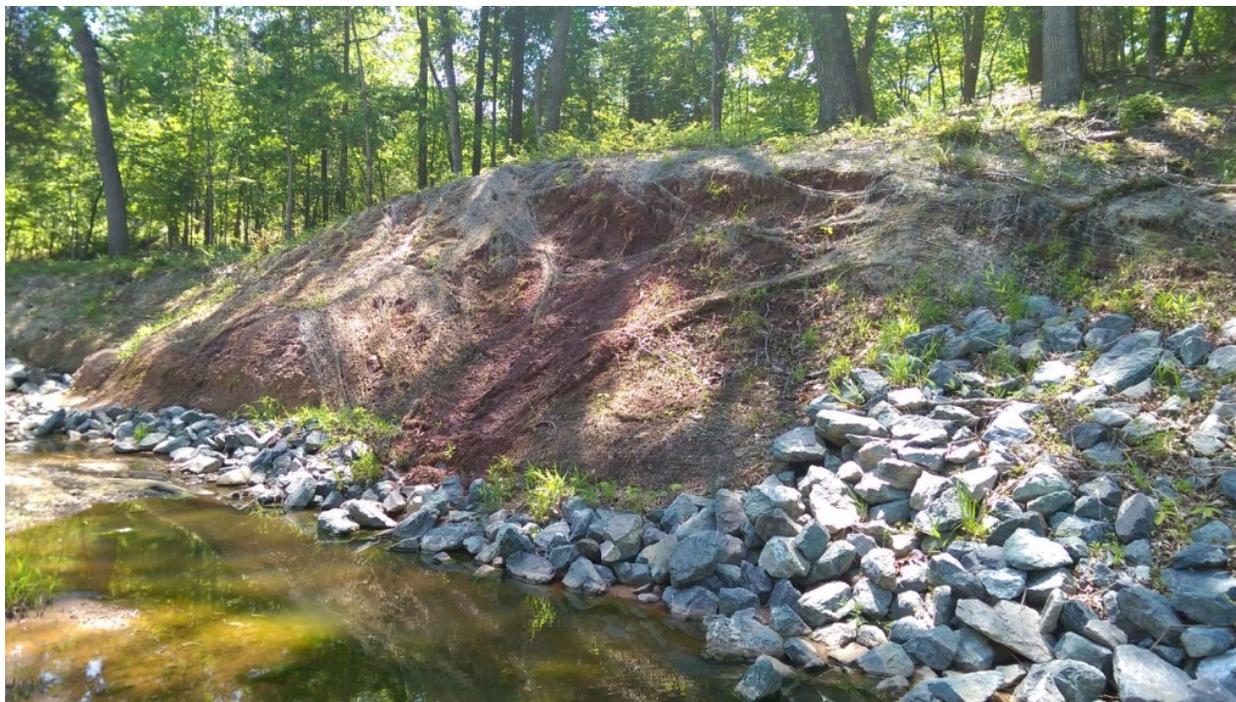
The second area shown in Photo 18, is located along the west side of the Reach 3 channel along the top of the stream bank cut. The soil is sloughing at the top of the stream bank cut above partially weathered rock and depositing sediment at the riprap toe and the straw matting is being pulled and torn as a result. The affected area measures approximately 25 feet long and 12 feet tall.

Photograph No. 18
Erosion Along Top of Stream Bank Cut on West Side of Reach 3 Channel
Facing Southwest

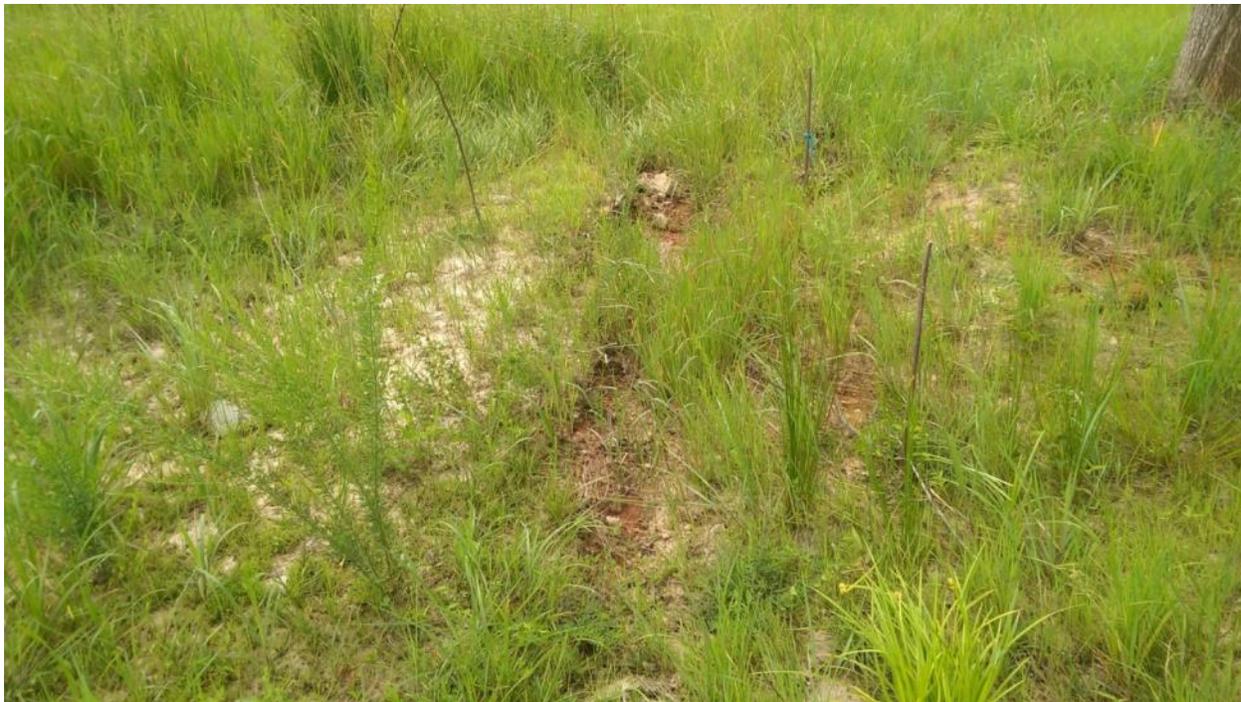
In the Reach 1 area, erosion was observed south and downstream of the riprap stormwater channels near the edge of the 'wet area.' The erosion channel was approximately 15 feet long by 2-3 feet wide, and an average depth of 6-8" during the monitoring. This area has partially filled in with sediment and has somewhat improved since the May 2015 monitoring. This area is shown in Photo 14.

Photograph No. 14
Erosion Channel Upstream of Reach 1 'wet area'
Facing South

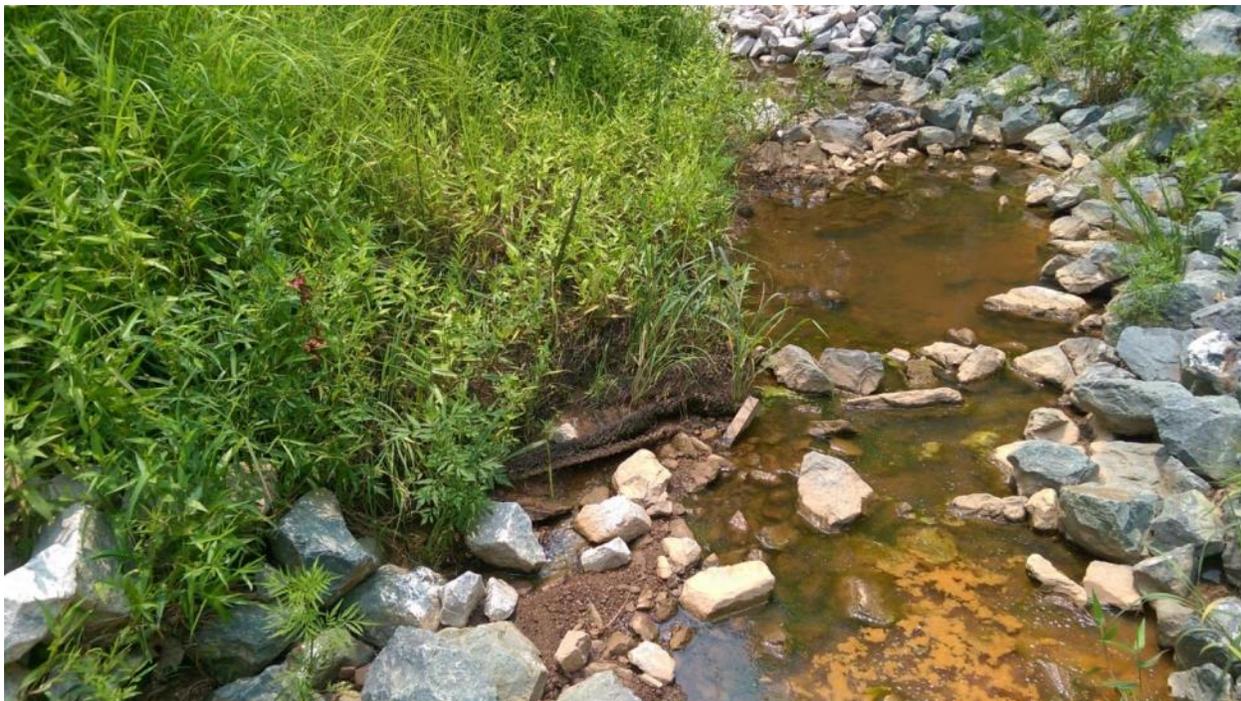
In Reach 2, the two (2) erosion areas along the turf-reinforcement matting (TRM) previously identified in May 2015 were observed along the Reach 2 channel. The first area, shown in Photo 15, was approximately 10 feet long located along the south bank toe of Reach 2 at the end of the first riprap toe section. The density of vegetation in this area has increased and sediment load has filled in some of the TRM. The TRM remains folded and loose in spots and the wooden stakes dislodged or loose.

Photograph No. 15
Loose/Displaced TRM at End of First Riprap Toe Protection along South Side of Reach 2
Facing West

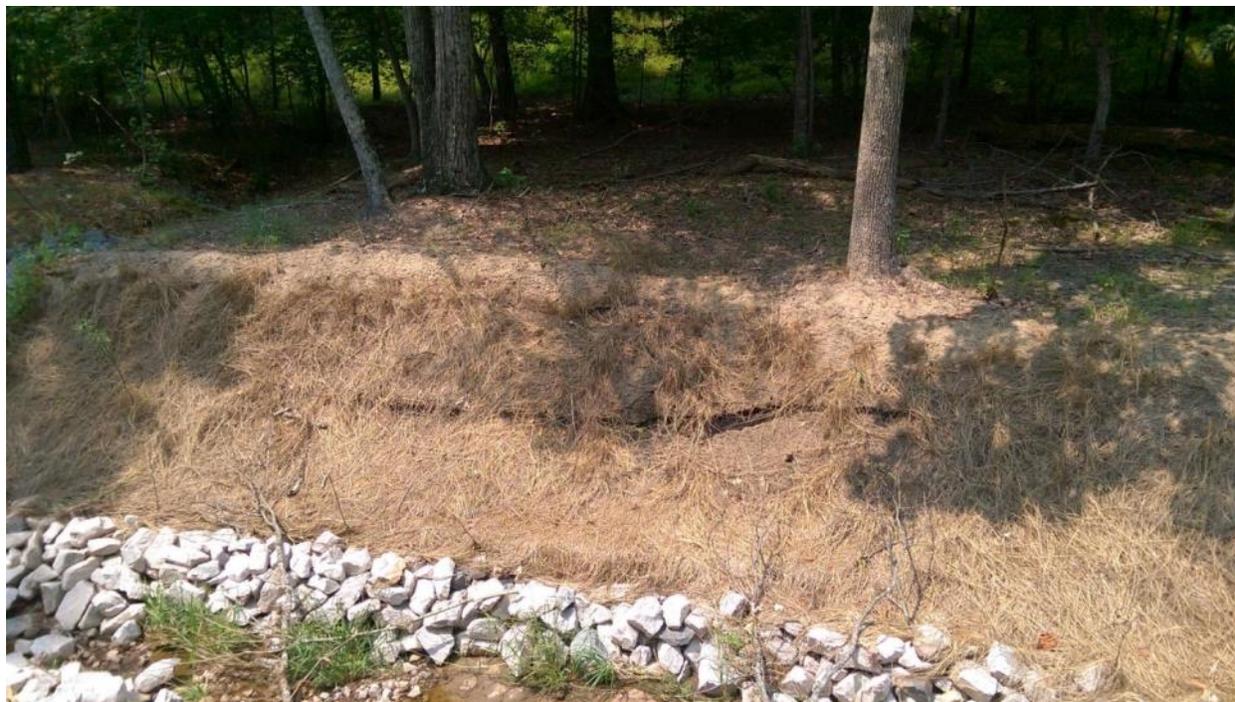
Photograph No. 16
Sloughed Soil and TRM Displacement at North Bank in Reach 2 Channel
Facing Northeast

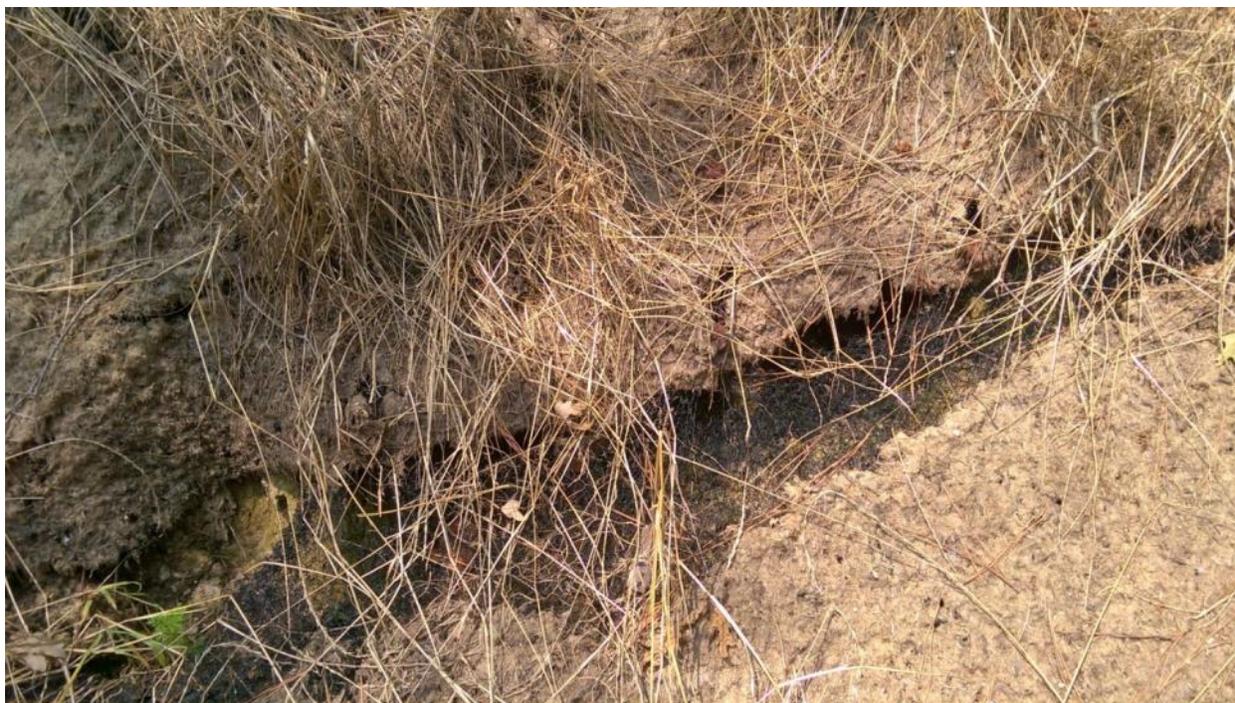
Photograph No. 17
Closeup of Sloughed Soil and TRM Displacement at North Bank in Reach 2 Channel
Facing Northeast

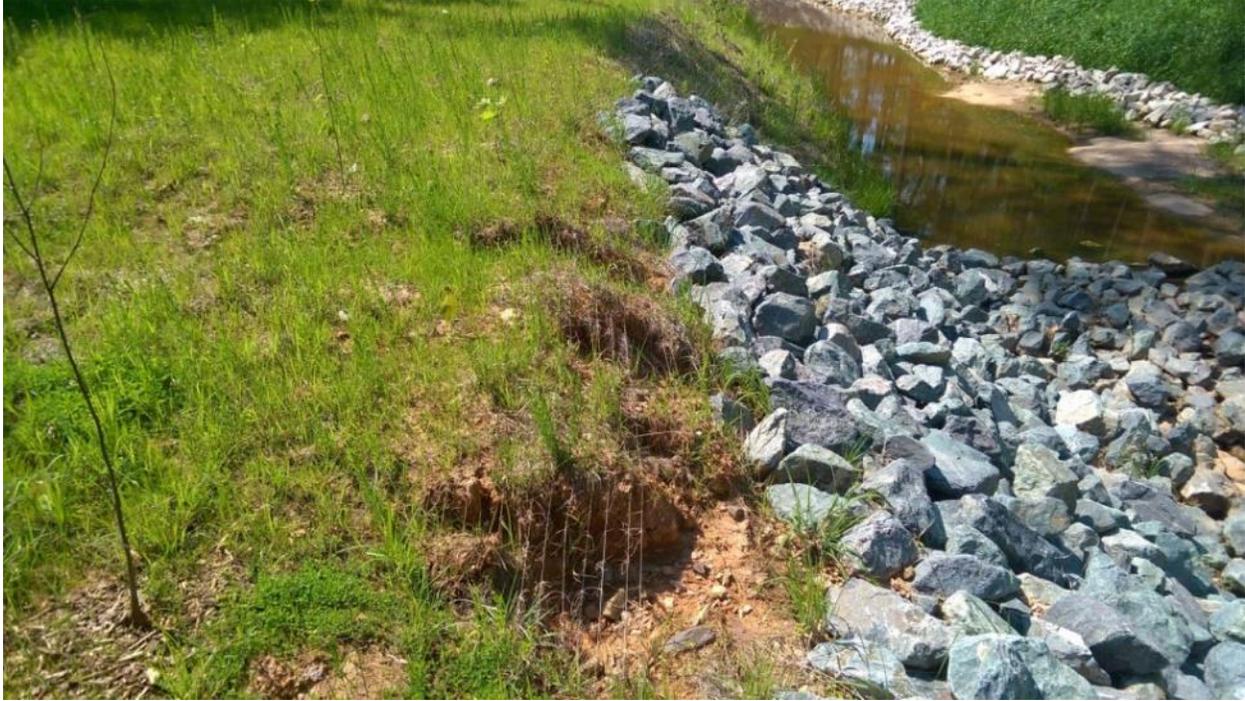
In Reach 3, two erosion areas were observed. The first area, shown in Photo 18, is located immediately above the upstream DOT riprap apron on the west side of the Reach 3 channel. A series of several small erosion channels are forming in an area approximately 10 feet long, 2-3 feet wide and 1-2 feet deep were observed above riprap. These erosion features did not show any significant change from May 2015.

Photograph No. 18
Erosion Rills above NCDOT Riprap Apron on West Side of Reach 3 Channel
Facing North (photo from May 2015, no change in conditions)

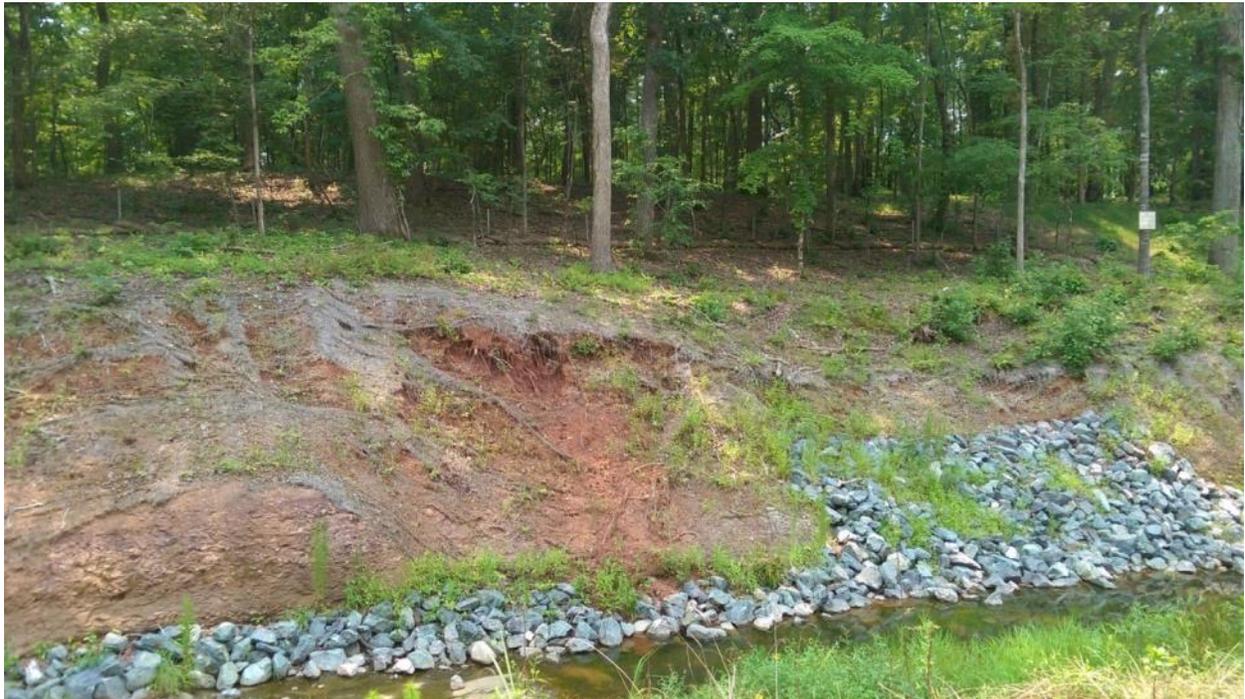
The second area shown in Photo 19, is located along the west side of the Reach 3 channel along the top of the stream bank cut. The soil is sloughing at the top of the stream bank cut above partially weathered rock and depositing sediment at the riprap toe and the straw matting is being pulled and torn as a result. The affected area measures approximately 25 feet long and 12 feet tall. This erosion feature did not show any significant change from May 2015. Plots and photograph locations are shown on the site map in Attachment A.

Photograph No. 19
Erosion at Top of Bank on West Side of Reach 3 Channel
Facing Southwest

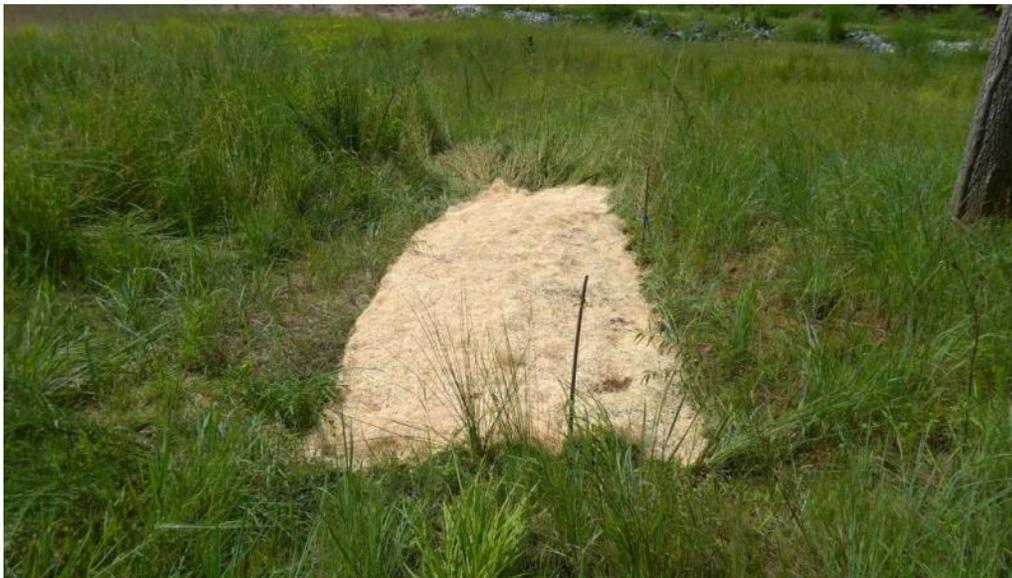
Photograph No. 1
Repair of Erosion Channel Upstream of Reach 1 'wet area'
Facing South

Seneca repaired the eroded channel on Reach 1 upstream of the 'wet area'.

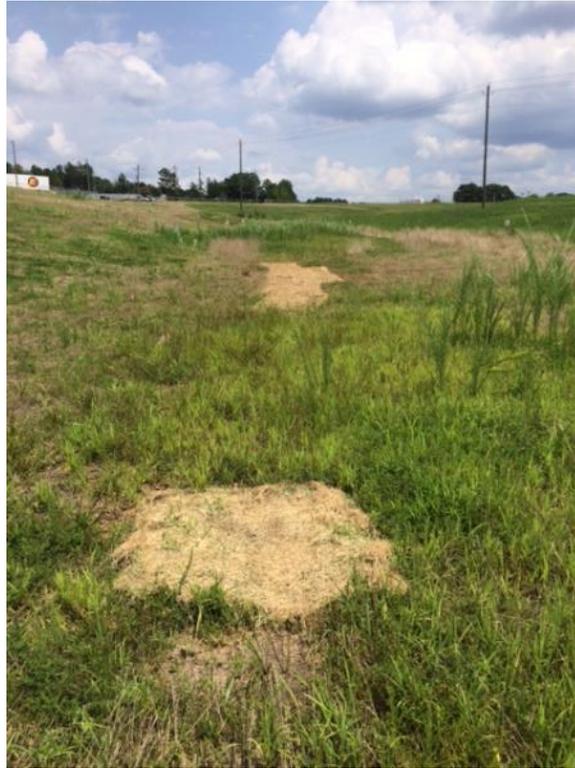
Photograph No. 2
Repair of Reach 1 Channel (taken 7/28/2015)
Facing Southeast

Seneca also repaired minor erosions on the Reach 1 channel.

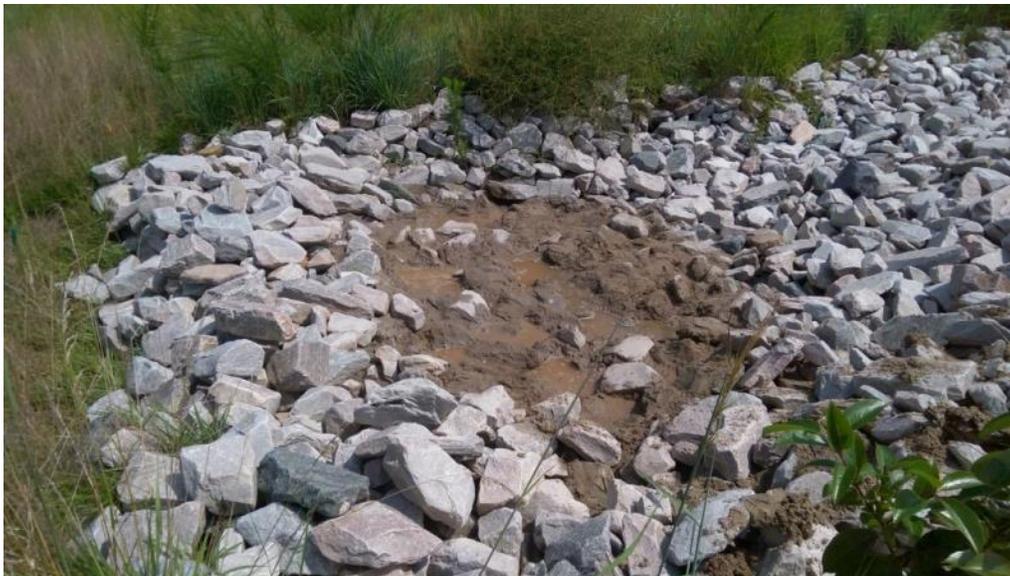
Photograph No. 3
Repair of Reach 1 Channel
Facing Northwest

In addition, Seneca cleaned the accumulated sediment on rip rap apron at the east channel at Estes southwest corner east channel.

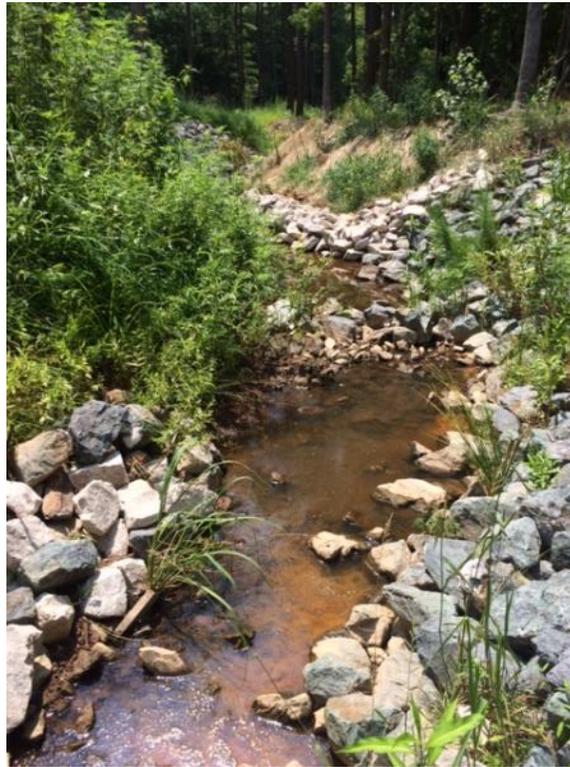
Photograph No. 4 (taken 7/28/2015)

Repaired Loose/Displaced TRM at End of First Riprap Toe Protection along South Side of Reach 2 Facing West

In Reach 2, Seneca repaired the two erosion areas along the turf-reinforcement matting (TRM).

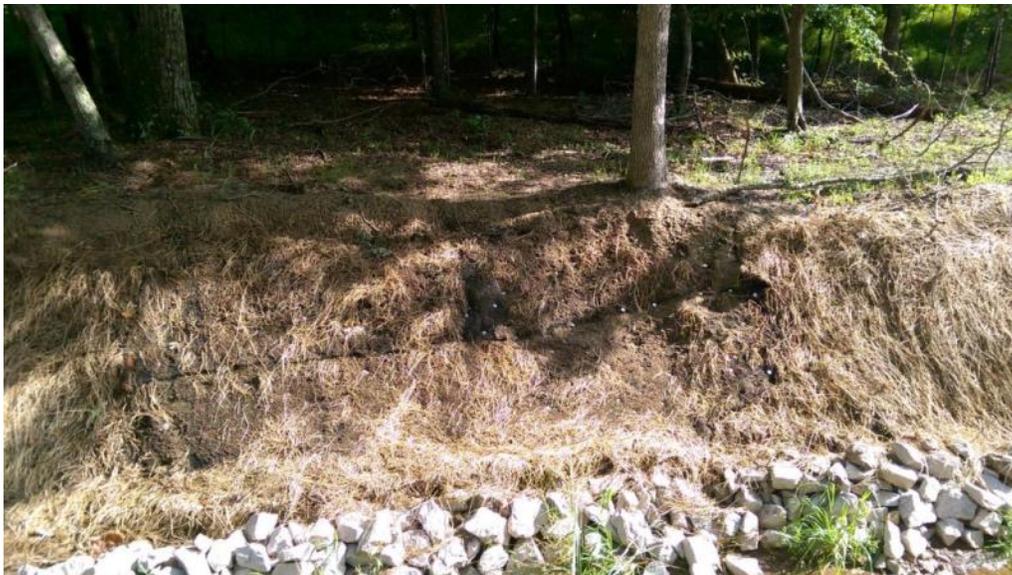
Photograph No. 5

Repaired Sloughed Soil and TRM Displacement at North Bank in Reach 2 Channel Facing Northeast

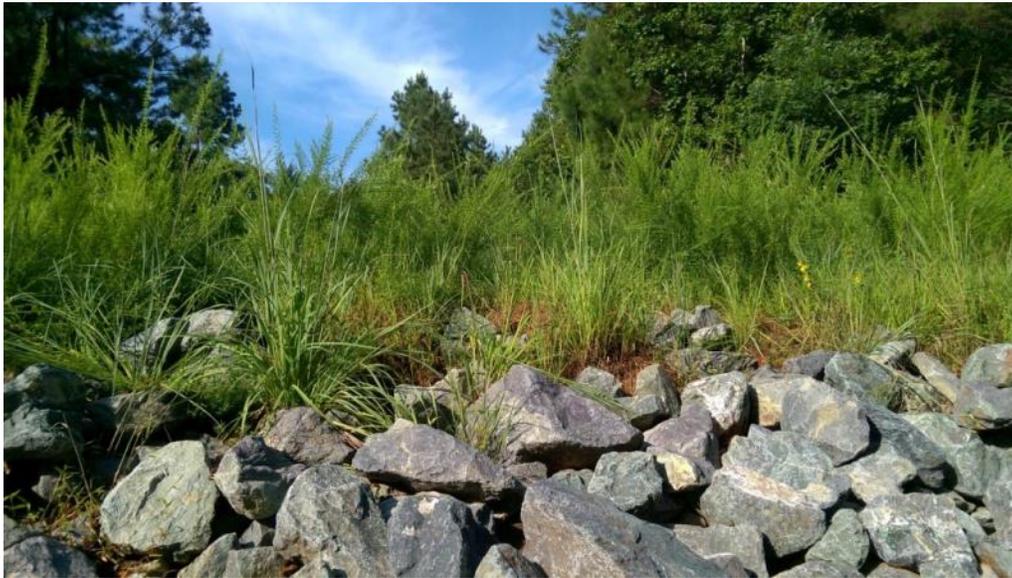
Photograph No. 6

Repaired Erosion Rills above NCDOT Riprap Apron on West Side of Reach 3 Channel Facing West

In Reach 3, Seneca repaired two erosion areas.

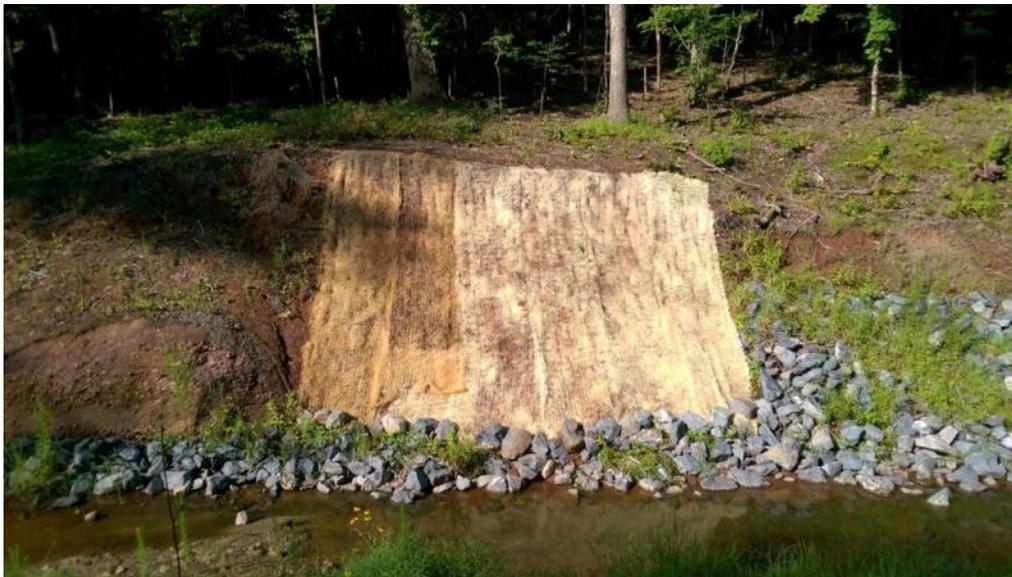
Photograph No. 7

Repaired Erosion at Top of Bank on West Side of Reach 3 Channel Facing Southwest
