**RE: WARD TRANSFORMER SITE REMOVAL ACTION
PROGRESS REPORT FOR MARCH 2016**

REACHES 1 TO 3 VISUAL MONITORING REPORT

PROJECT NAME: WARD TRANSFORMER SUPERFUND SITE, RALEIGH, NC.

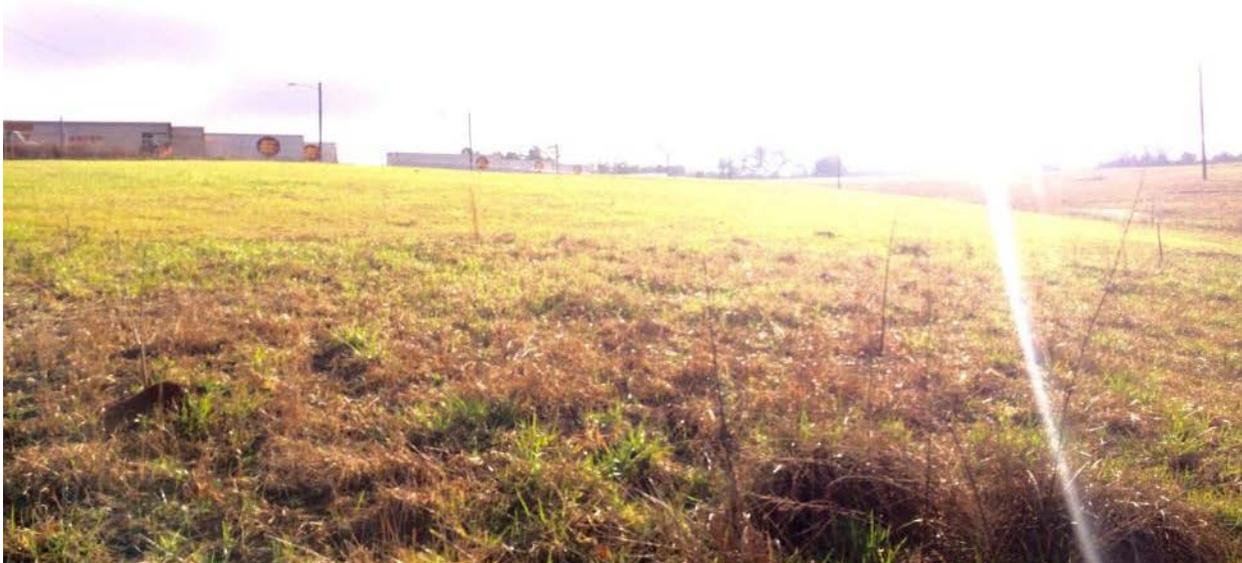
Photograph No. 1
Reach 1 RDU Slope and Channel
Facing Northeast

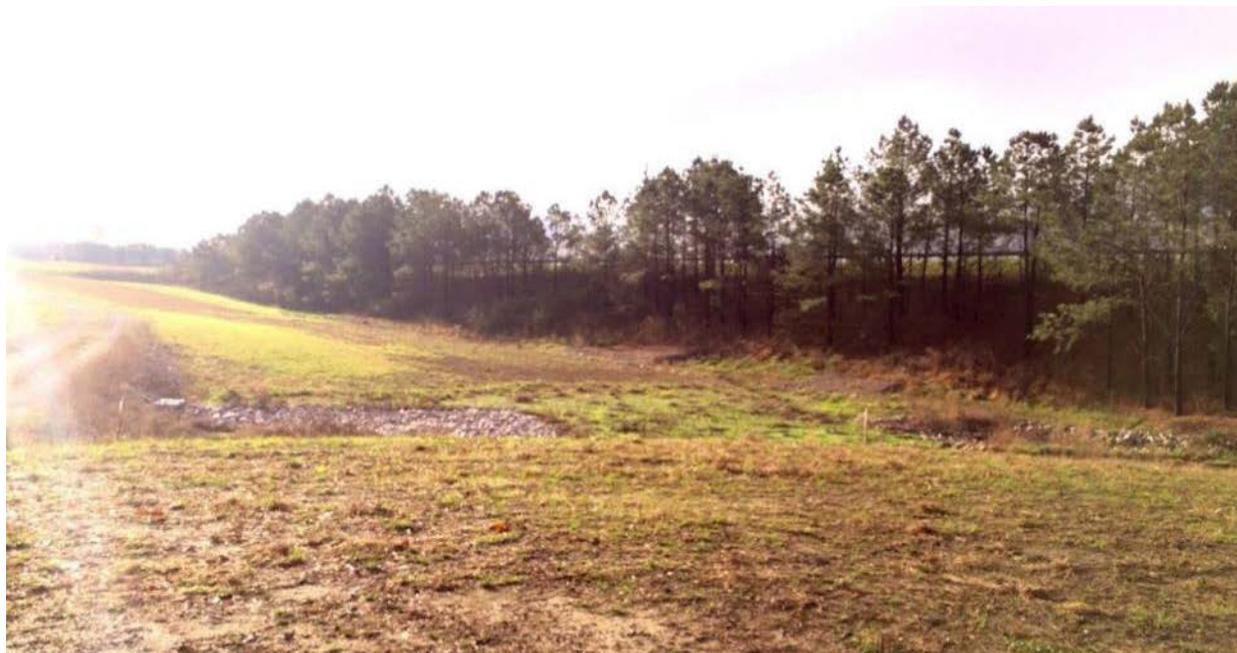
Photograph No. 2
Reach 1 Channel South of Access Path
Facing Southeast

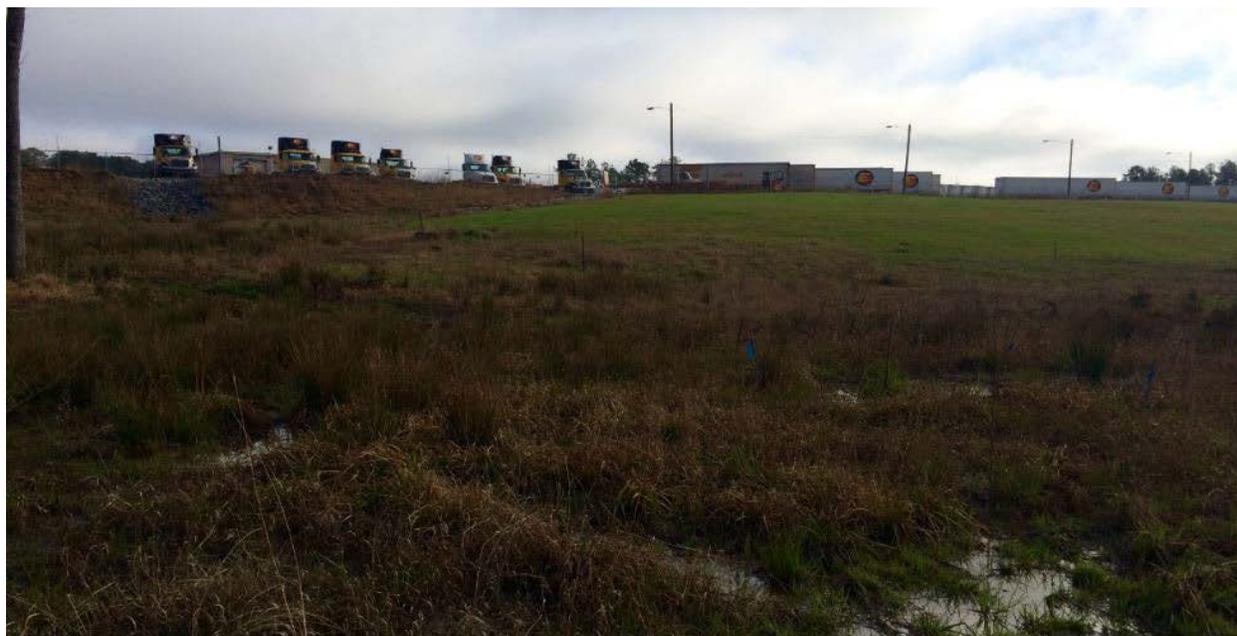
Photograph No. 3
Reach 1 Estes Southwest Corner and RDU Slope
Facing North

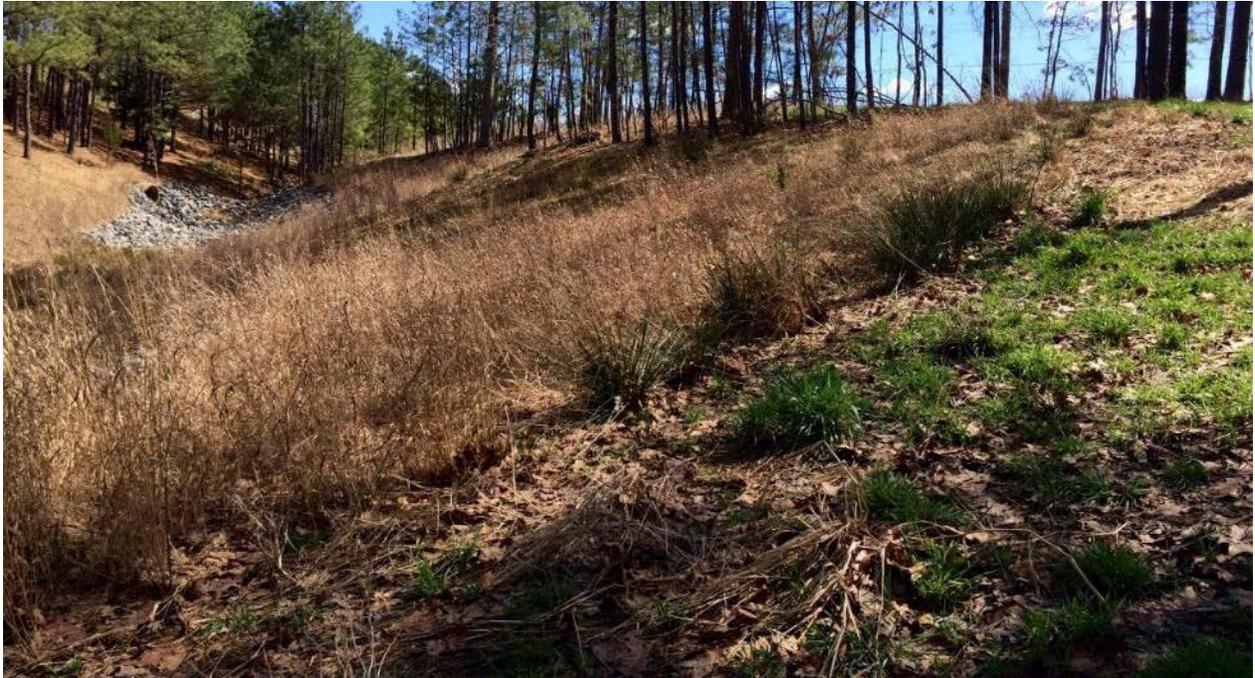
Photograph No. 4
Reach 2 Channel at Former NCDOT Sedimentation Pond
Facing East

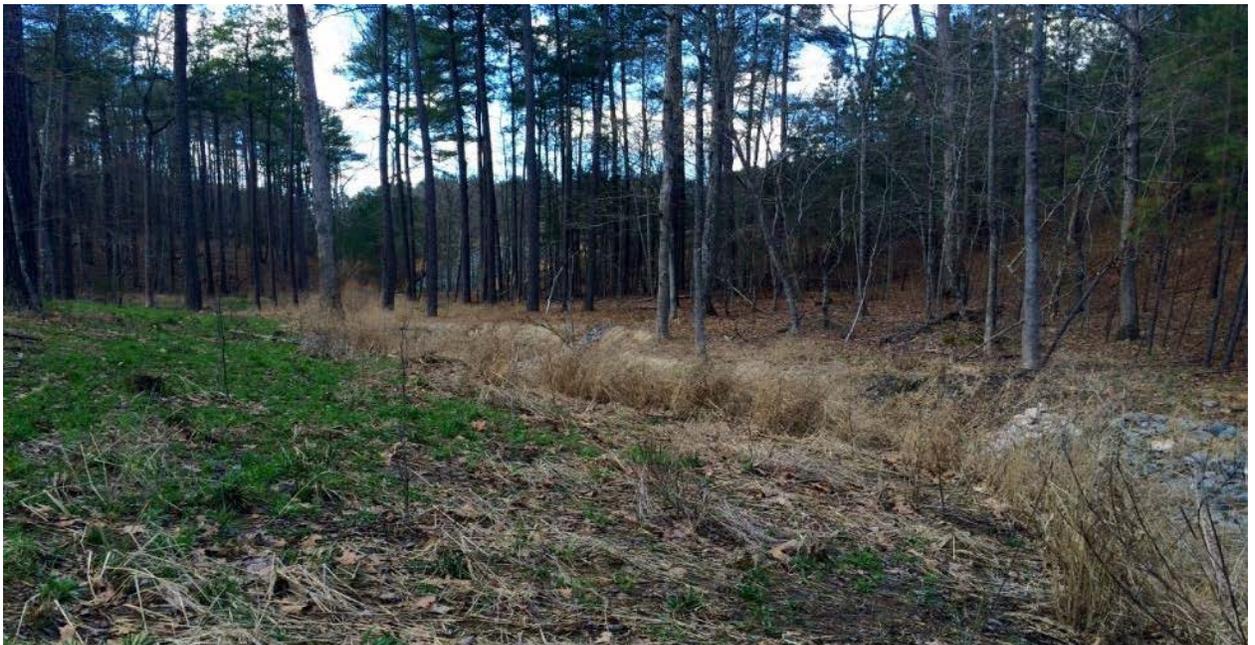
Photograph No. 5
Reach 2 Channel Upstream of First RDU Confluence
Facing West

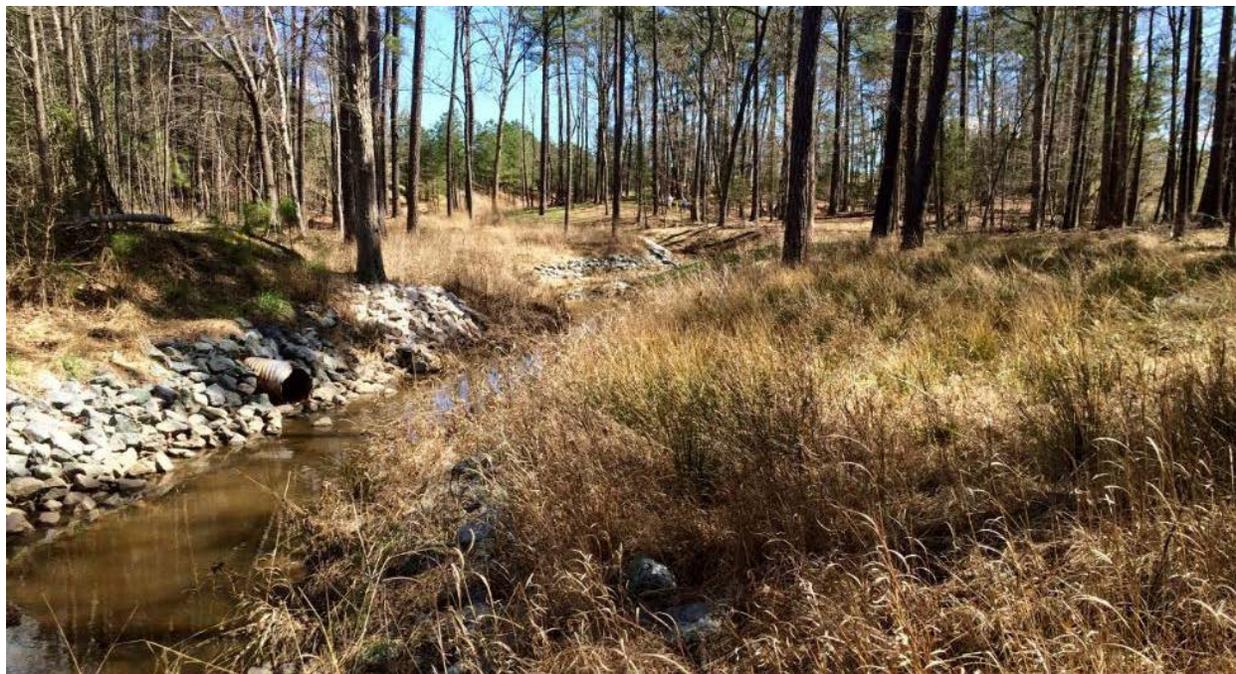
Photograph No. 6
End of Reach 2 Channel
Facing East

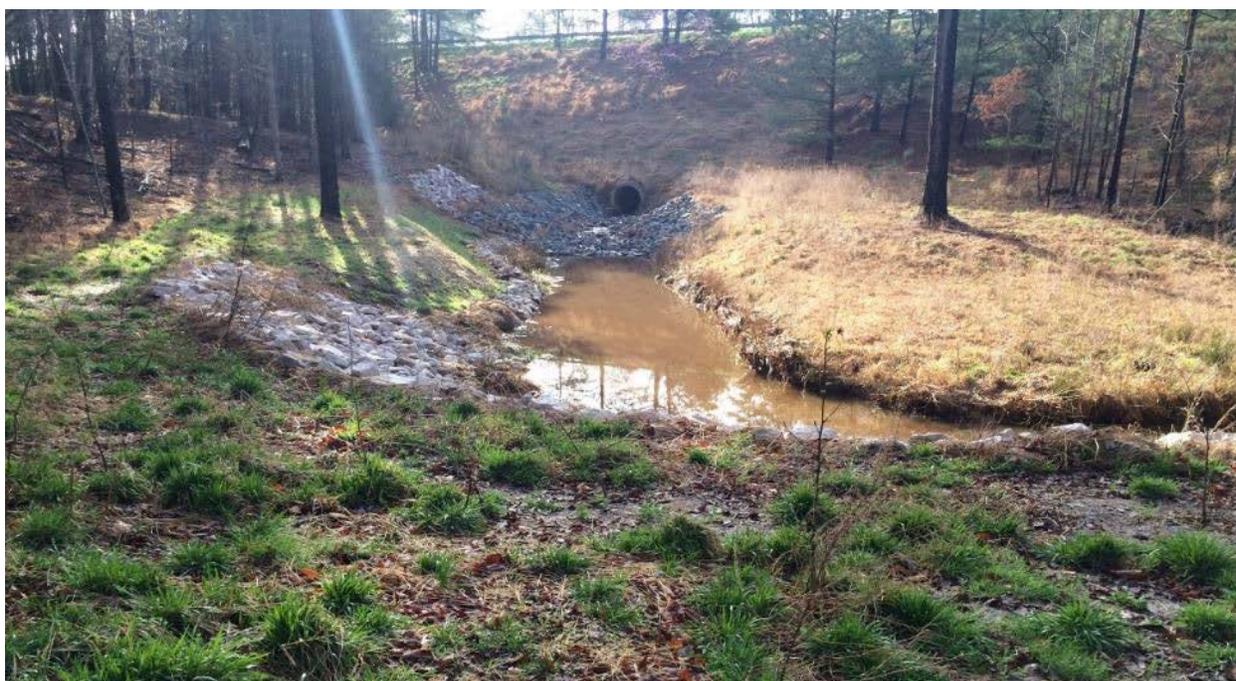
Photograph No. 7
Beginning of Reach 3 Channel
Facing Southeast

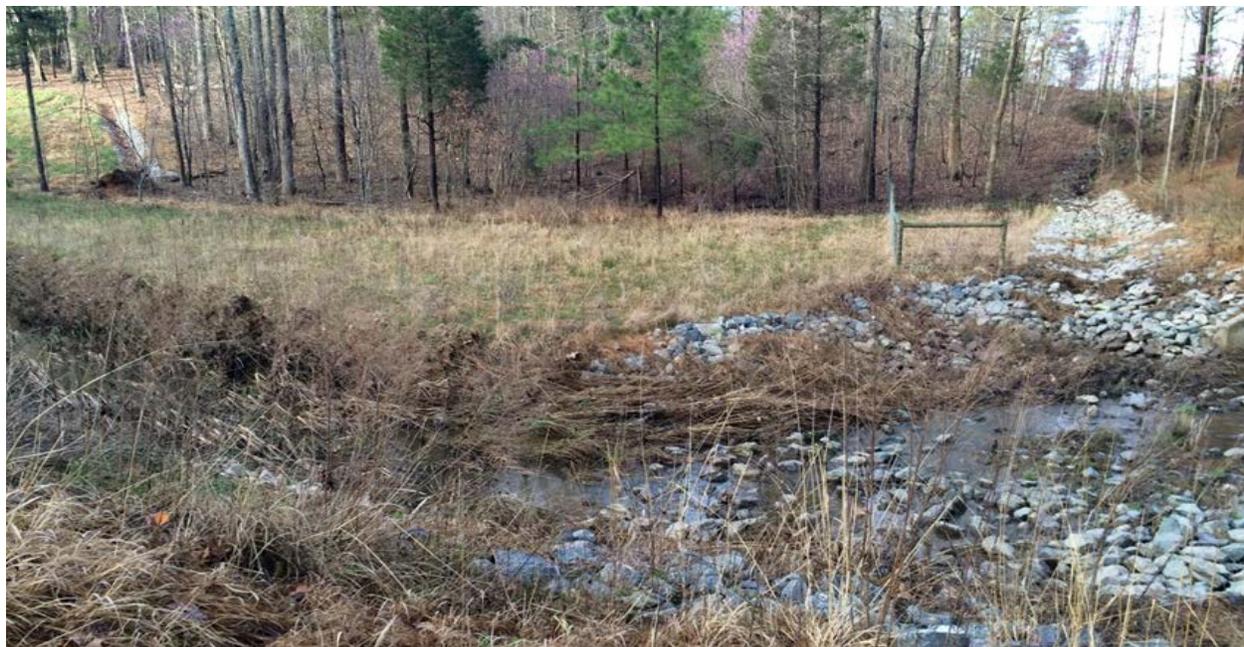
Photograph No. 8
End of Reach 3 Channel
Facing West

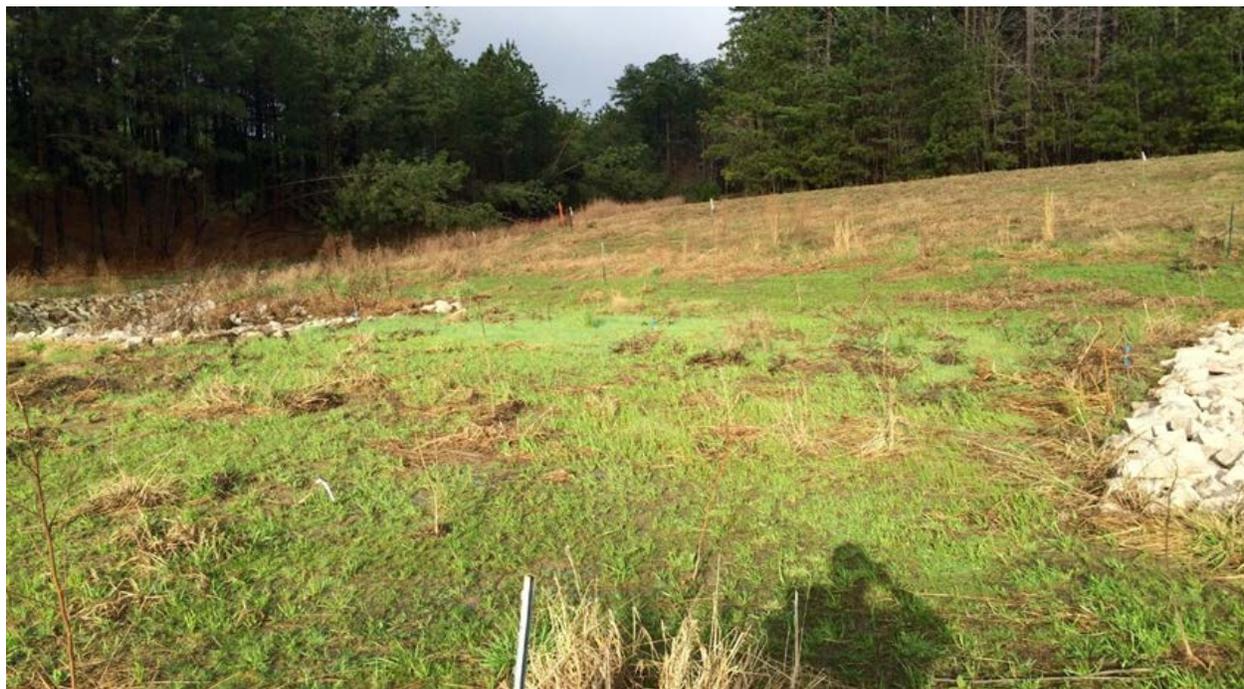
Photograph No. 9
View of Vegetation Plot 1
Facing Southwest from Northeast Corner

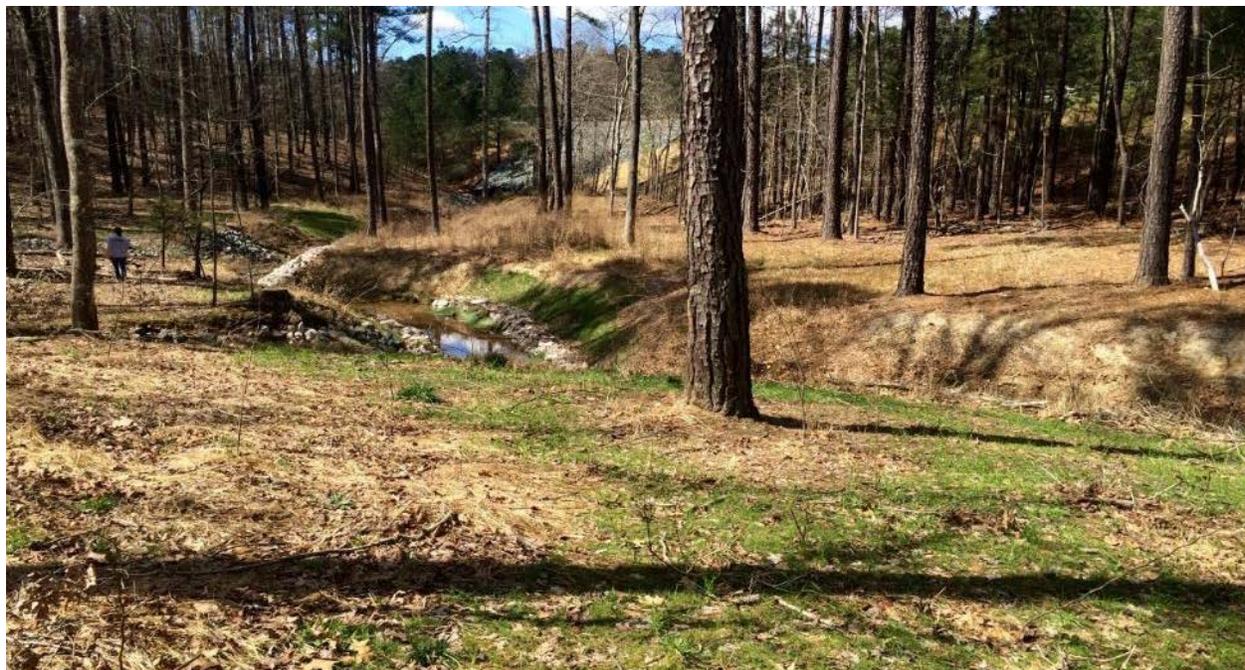
Photograph No. 10
View of Vegetation Plot 2
Facing Southwest from Northeast Corner

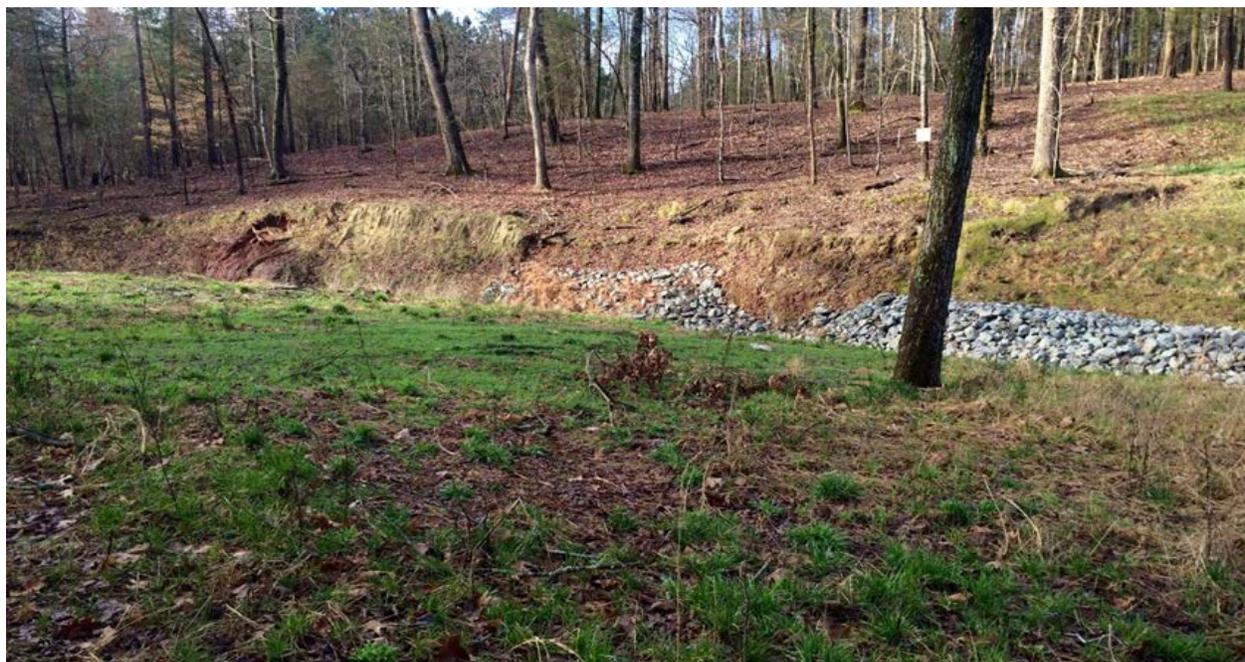
Photograph No. 11
View of Vegetation Plot 3
Facing Southwest from Northeast Corner

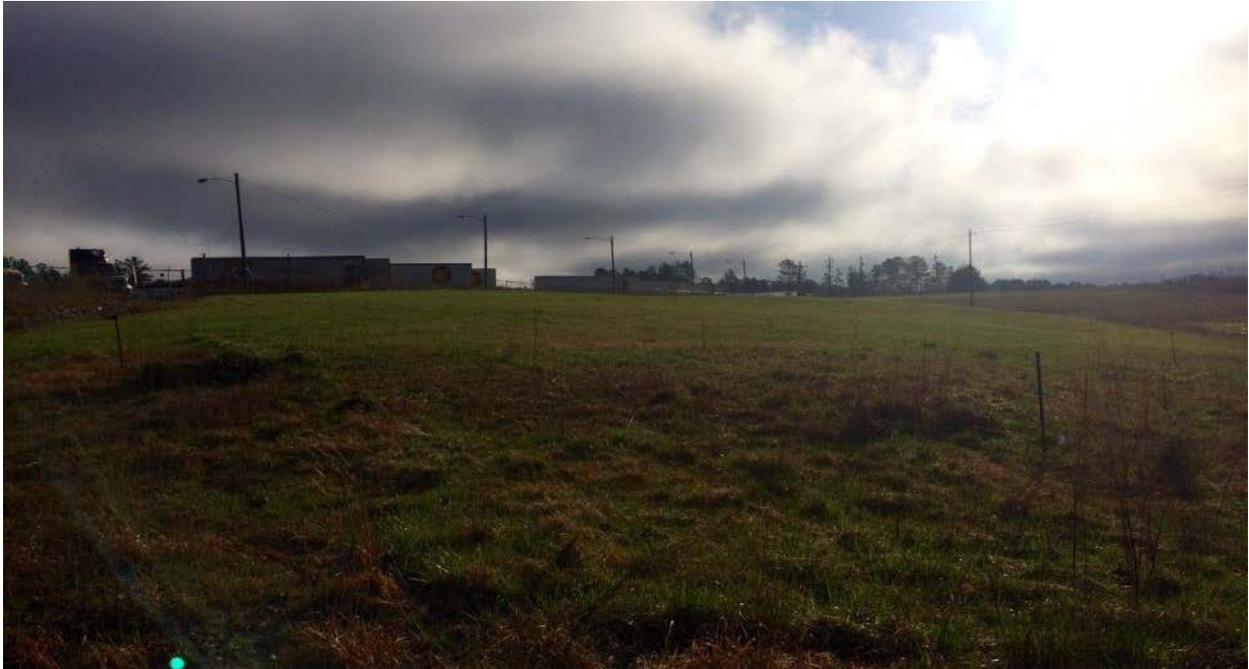
Photograph No. 12
View of Vegetation Plot 4
Facing Southwest from Northeast Corner

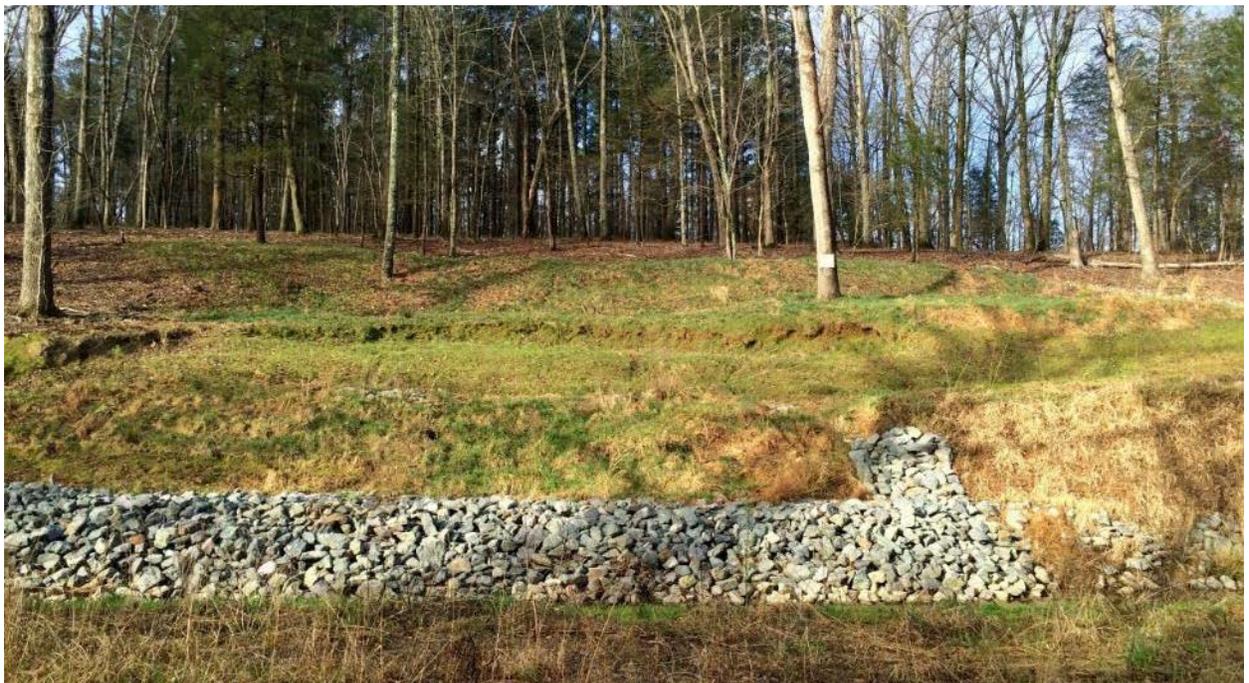
Photograph No. 13
Reach 3 Slide Repair Area
Facing West

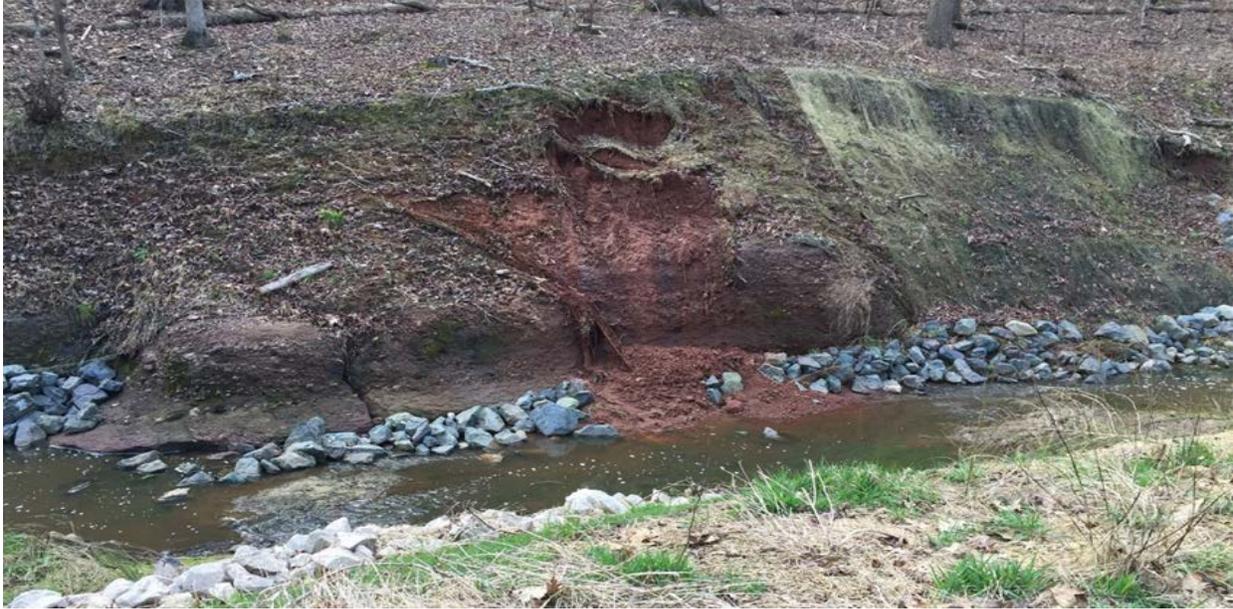
There is minor sloughing in Reach 3, as shown on Photograph 14, which appears to be caused by winter seepage. The sloughing is approximately 15' x 15'.

Photograph No. 14
Reach 3 Sloughing
Facing West
