Subject: 2015 Annual Monitoring Report – Operable Unit No. 1 (OU-1), Former No. 1 Landfill  
Domtar Paper Company, LLC (Domtar), Martin County, North Carolina

This letter report documents the 2015 annual inspection activities conducted at OU-1 – Former No. 1 Landfill area at the Domtar<sup>1</sup> (formerly Weyerhaeuser Company) mill in Plymouth, North Carolina.

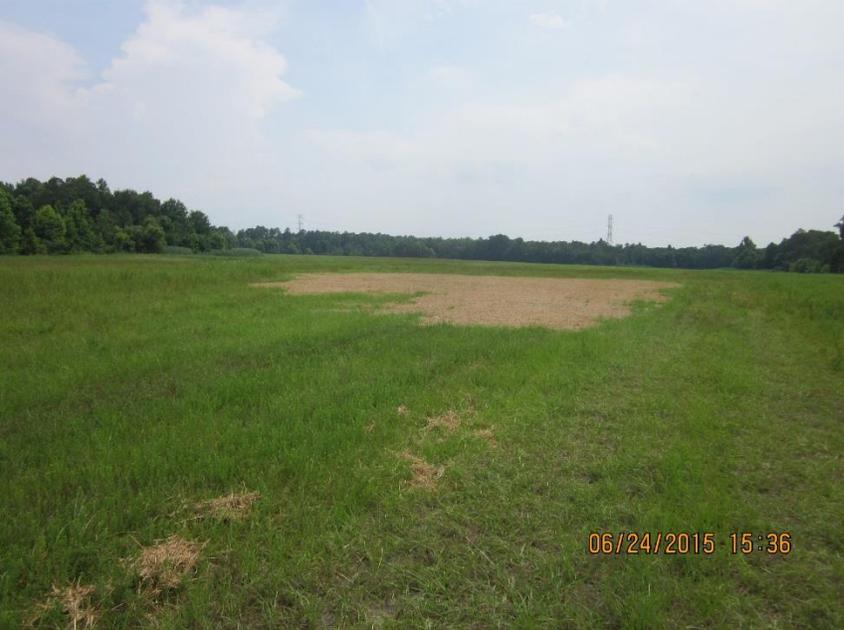
<b>Client Name:</b> Domtar Paper Company, LLC		<b>Site Location:</b> Plymouth, North Carolina	<b>Project No.:</b> 228189.0000.0000
<b>Photo No.</b> 1	<b>Date</b> 6/24/15

<b>Description</b> Central portion of landfill; looking southwest. Area recently filled and seeded (June 2015).

In May 2014, TRC contracted Spatial Data Consultants, Inc. to perform an aerial topographic survey of the Former Landfill No. 1 cover. TRC compared the baseline survey to the 2014 survey and created engineering drawings to identify areas of subsidence. Using these drawings, Domtar repaired the rutting and small depressions, and seeded the grass areas in June 2015. During the November inspection, TRC observed the repaired areas to be graded and covered with grass.

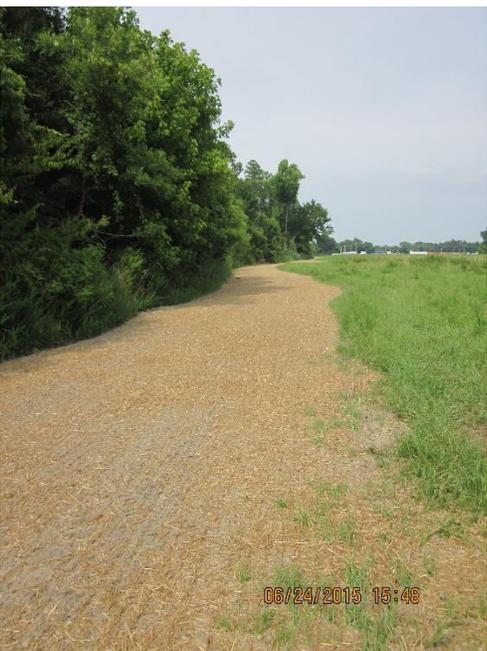
<b>Photo No.</b> 2	<b>Date</b> 6/24/15

<b>Description</b> Trail/road restoration in June 2015; looking northeast

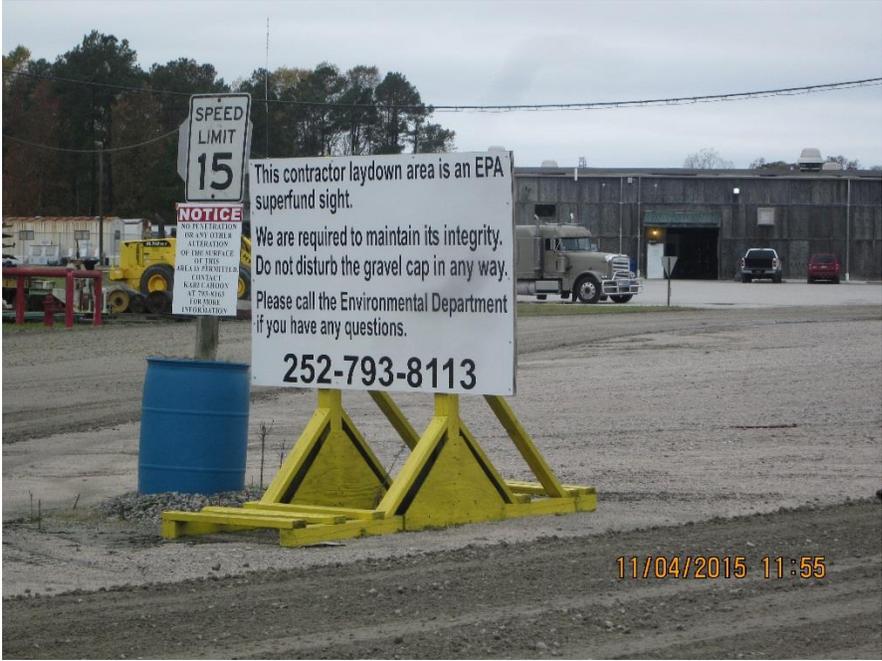
<b>Client Name:</b> Domtar Paper Company, LLC		<b>Site Location:</b> Plymouth, North Carolina	<b>Project No.:</b> 228189.0000.0000
<b>Photo No.</b> 3	<b>Date</b> 11/04/15

<p style="text-align: right; color: orange;">11/04/2015 11:55</p>	
<b>Description</b> Signage in front of gravel-covered portion of landfill.

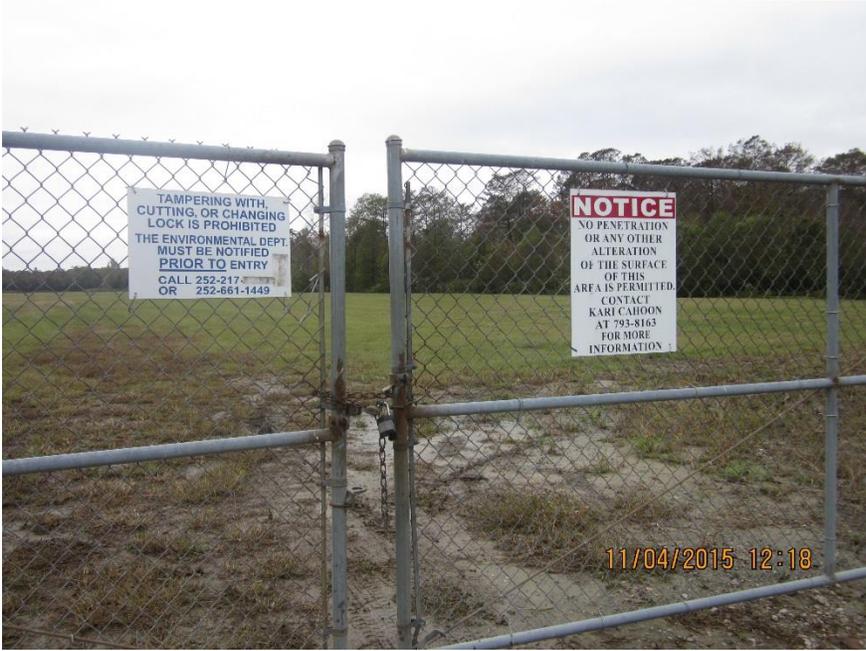
<b>Photo No.</b> 4	<b>Date</b> 11/04/15

<p style="text-align: right; color: orange;">11/04/2015 12:18</p>	
<b>Description</b> Signage in front of grass-covered portion of landfill.

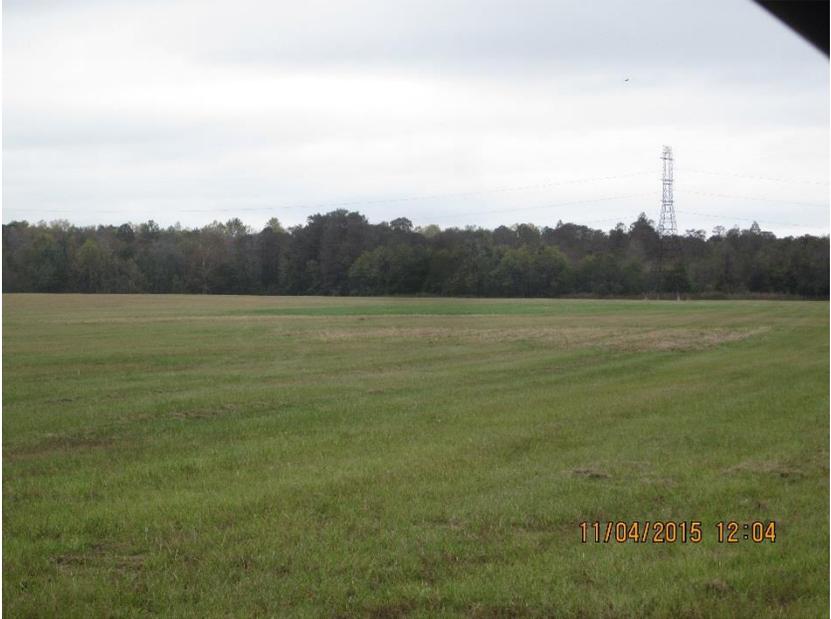
<b>Client Name:</b> Domtar Paper Company, LLC		<b>Site Location:</b> Plymouth, North Carolina	<b>Project No.:</b> 228189.0000.0000
<b>Photo No.</b> 5	<b>Date</b> 11/04/15

<b>Description</b> Central portion of landfill following seeding in June; looking northwest. Reference Photograph No. 1 for comparison.

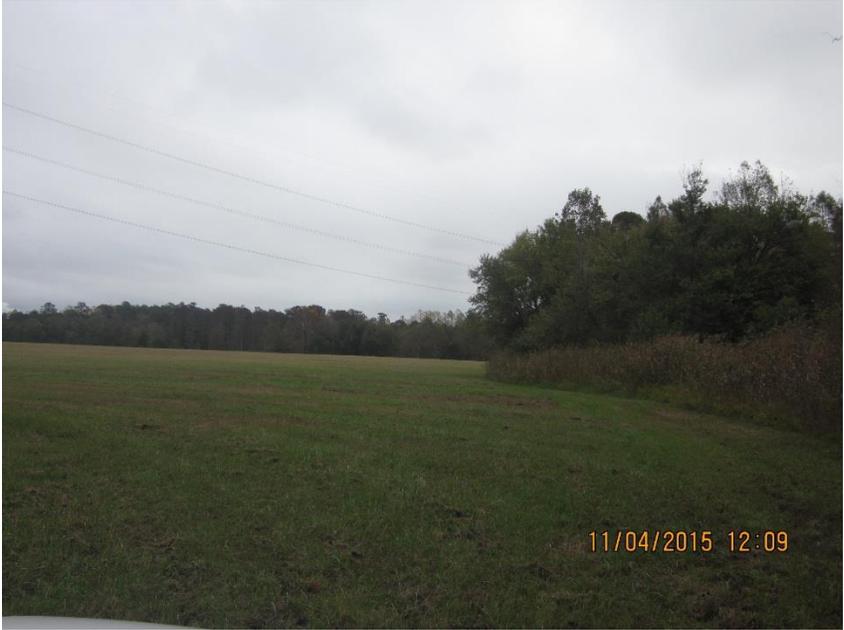
<b>Photo No.</b> 6	<b>Date</b> 11/04/15

<b>Description</b> Trail/road restoration in June 2015; looking southwest. Reference Photograph No. 2 for comparison.

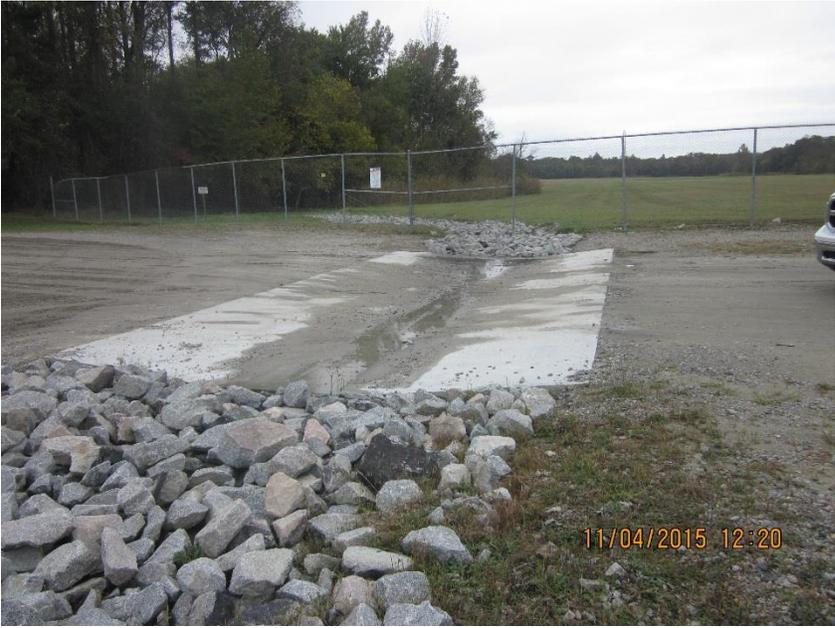
<b>Client Name:</b> Domtar Paper Company, LLC		<b>Site Location:</b> Plymouth, North Carolina	<b>Project No.:</b> 228189.0000.0000
<b>Photo No.</b> 7	<b>Date</b> 11/04/15

<b>Description</b> Newly constructed drain to outfall in order to prevent road wash out.

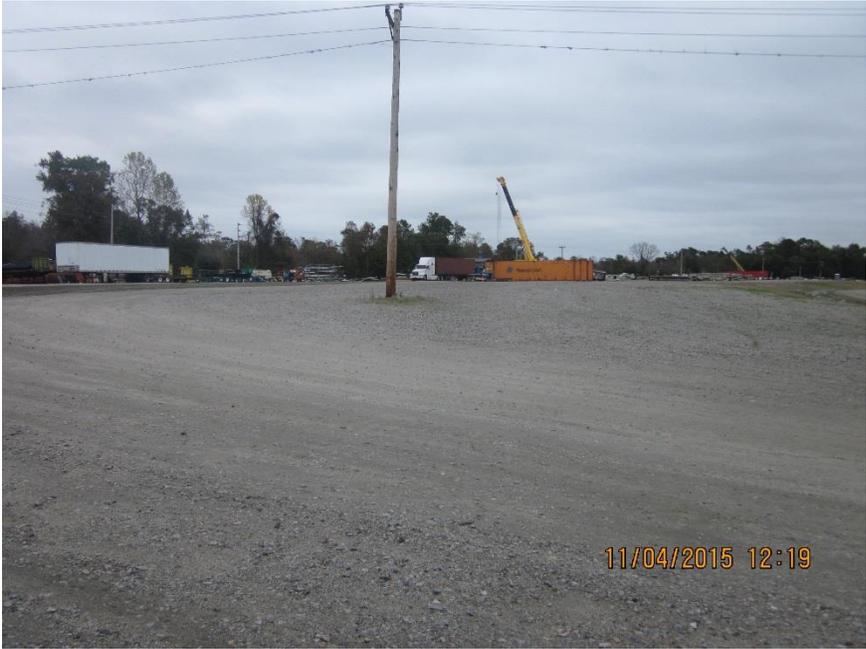
<b>Photo No.</b> 8	<b>Date</b> 11/04/15

<b>Description</b> Gravel portion of the landfill; looking northeast.
