**FACILITY COMPLIANCE AUDIT REPORT**  
**Division of Waste Management**  
**Solid Waste Section**

Date of Audit: 6/18/10                      Date of Last Audit: 9/30/09

Avery Co. Transfer Station  
 Brushy Creek Rd. (SR-1101)  
 Ingalls, NC

Partial Audit

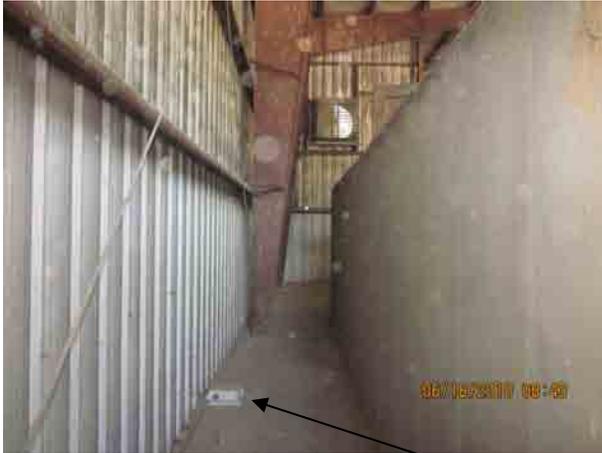
2. The area behind the push walls was free of debris and very clean. (See photo #1 below)

1. Area behind the left “push wall”. Note the rodent bait trap on the floor.

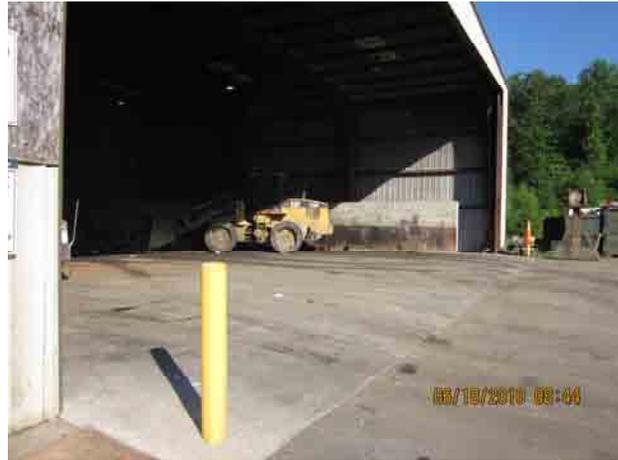
2. Front-end loader pushing waste into the receiving bay. Note the clean tipping floor.

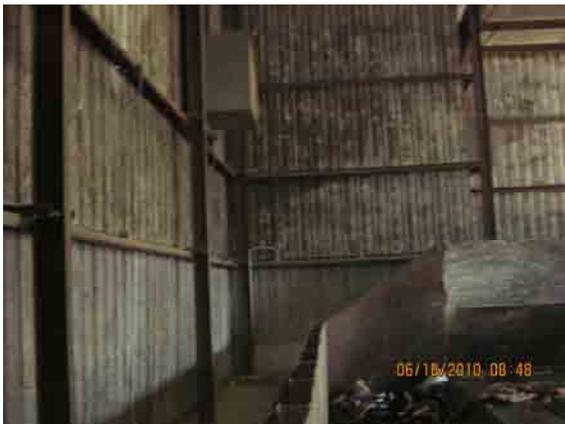
4. The interior walls of the transfer station will soon be in need of washing. (See Photo #3 & #4 below.)

3. The north interior wall of the transfer station in need cleaning. (Receiving bay and tipping floor are on the right.)

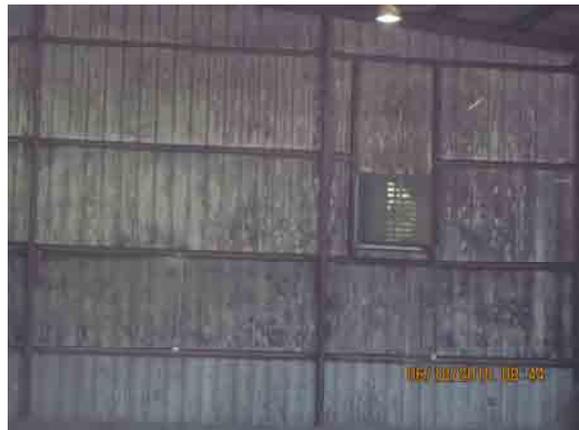
4. The back wall of the interior of the transfer station, badly in need of cleaning.

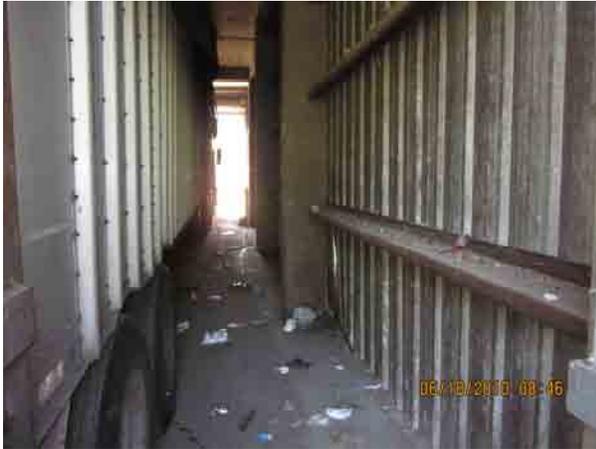
5. **The receiving bay walls are very dirty and must be washed down. The receiving bay, (the horizontal cross beams in particular) must be kept clean and free of debris. (See photos #5 and #6 below.)**

5. Looking east down the receiving bay. (Transfer truck on the left and the outside back wall is on the right.)

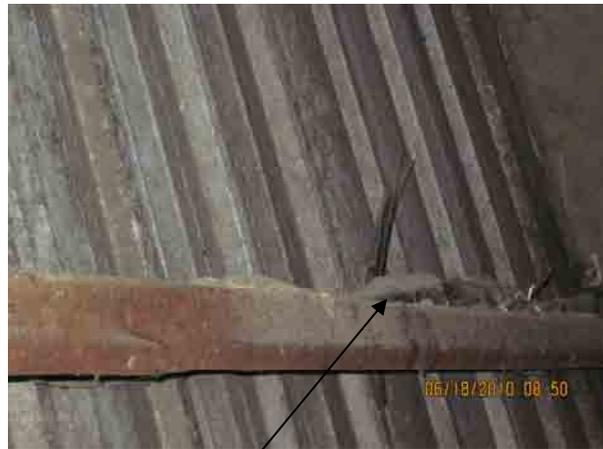
6. Looking up at debris trapped on the horizontal cross beam in the receiving bay.

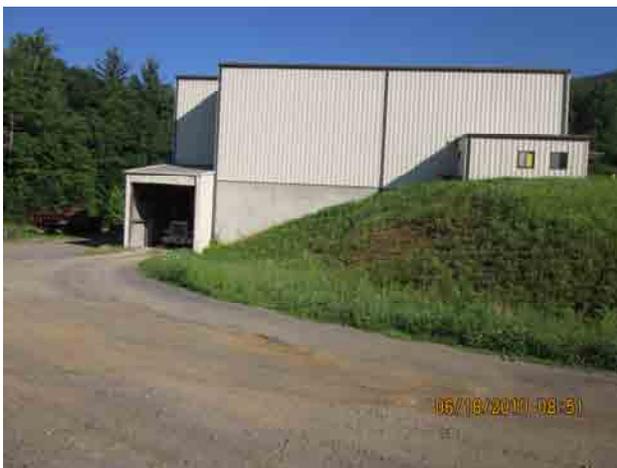
7. Looking at the south side of the transfer station.

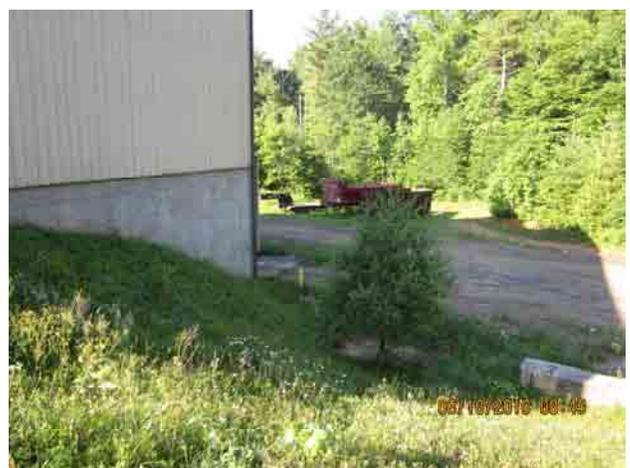
8. Looking at the northwest corner of the transfer station.
