**FACILITY COMPLIANCE AUDIT REPORT**  
**Division of Waste Management**  
**Solid Waste Section**

**Date of Audit:** 7 June 2011

Beaufort County Closed MSW Landfill  
 1342 Hawkins Beach Road  
 Bath, NC 27808

Partial audit; facility audit without records review

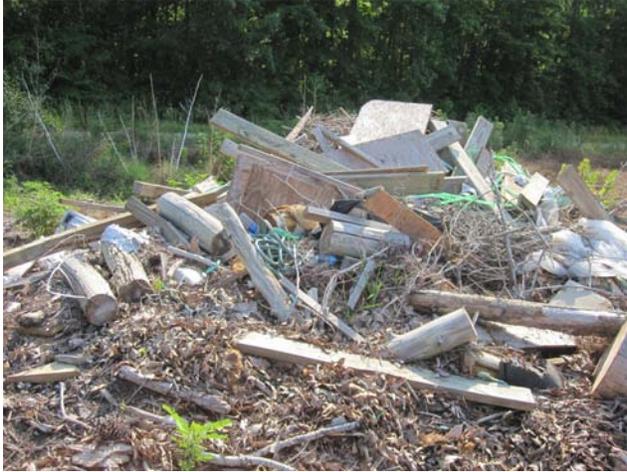
- 1) This facility is a closed MSW Landfill, Land Clearing Debris Treatment and Processing Notification, and tire collection site.
- 2) The site is secured by a locked gate at the facility entrance.
- 3) The facility access road is of all weather construction and is being well maintained.
- 4) Unpermitted waste consisting of household trash, construction and demolition materials, and other

- miscellaneous refuse has been disposed at the yard waste site. \*Please ensure that all unpermitted waste is removed from the facility and transported to a facility permitted to receive such wastes.

Unpermitted waste at the LCID T&P element

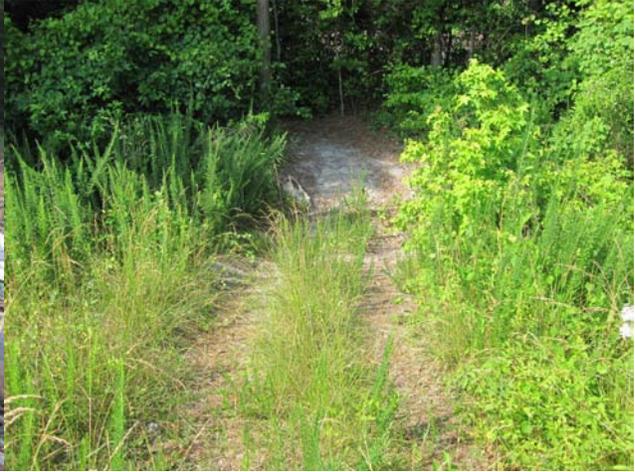
- 6) Continued evidence of trespass was noted during this audit. ATV trails were observed throughout the facility. Unauthorized activity on several of these trails is causing damage to the landfill cap system. An access trail was noted specifically from Camp Leach Road at the southwest corner of the property. \*Within thirty days of receipt of this report, actions need to be underway to provide for more adequate site security.

Unauthorized access from Camp Leach Road

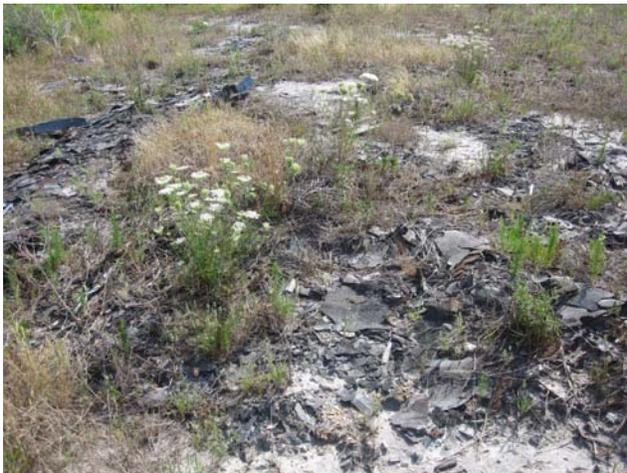
- 8) Exposed C&D waste was noted in the tire management area. \*Please ensure that this waste is re-covered and that the repaired area is graded at a slope not greater than 3:1, and that it is seeded and mulched to establish a groundcover suitable to prevent erosion of your landfill cap system. It is recommended that you move the tire collection area to an area on the property that will not impact your landfill cap system.

Exposed C&D waste in tire management area

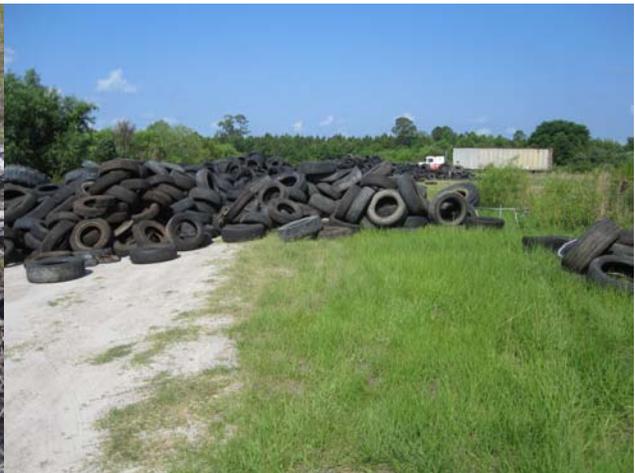
- 7) The tire collection area needs attention. The storage pile is too large and tires have been deposited in a disorderly manner throughout the facility. A storage trailer was on-site with no tires loaded. \*It is strongly recommended that transfer trailers be utilized at the site. All scrap tires should be placed directly into transfer trailers and stored there until transfer to the permitted tire management facility.

Tire management area

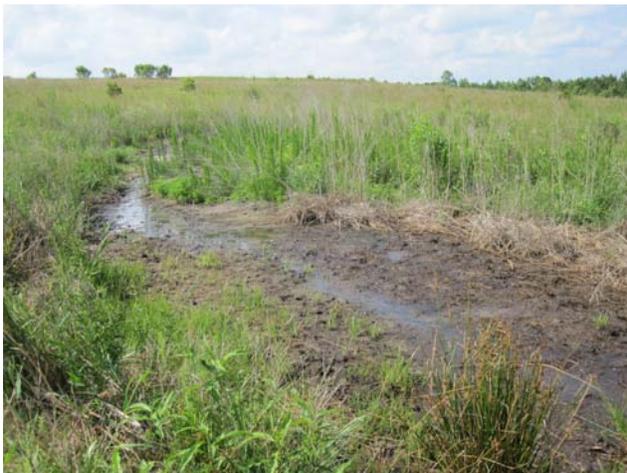
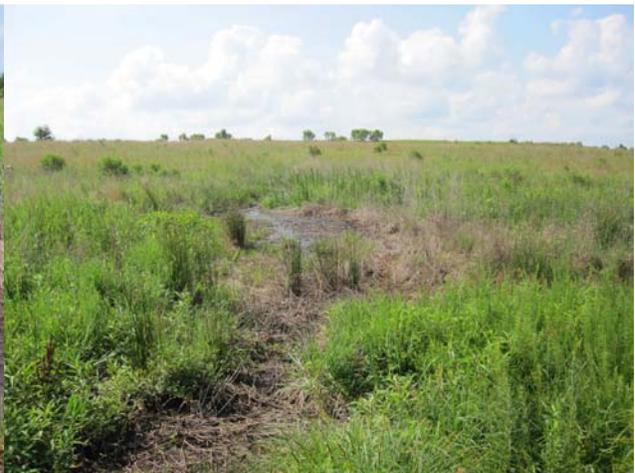
- 11) Leachate was noted as seeping from the northern sideslope of the upper lift approximately halfway up the lift in the center of the sideslope. No leachate was noted as leaving the disposal boundary. \*Within thirty days of receipt of this report, repair the landfill cap in the areas along the northern sideslope to prevent the further release of leachate from the landfill. All repaired areas should be graded at a slope not greater than 3:1, seeded, and mulched to establish a groundcover suitable to prevent erosion of the landfill cap system.

Leachate seeps from landfill sideslope
