FACILITY COMPLIANCE AUDIT REPORT
Division of Waste Management
Solid Waste Section

Date of Audit: 8 July 2011

Beaufort County Closed MSW Landfill
 1342 Hawkins Beach Road
 Bath, NC 27808

Partial audit; follow up to review corrective measures taken in response to FCAR 07-02, 060711

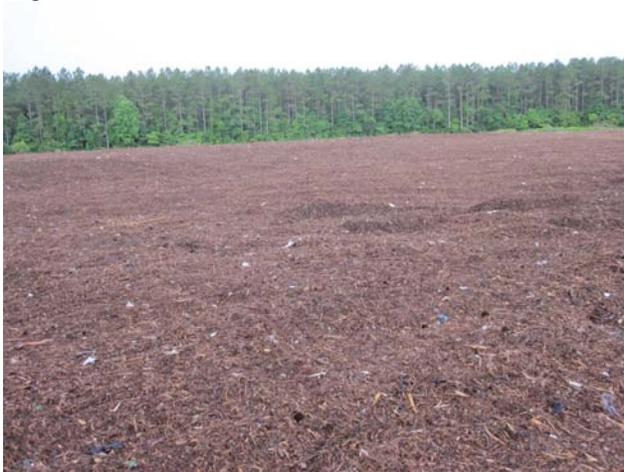
- removed and properly disposed.
- 5) The vegetative waste has been ground and is stored on-site at the landclearing debris element.
 - 6) The access trail from Camp Leach Road at the southwest corner of the property has been blocked off to prevent further unauthorized access.

Ground vegetative waste the LCID T&P element

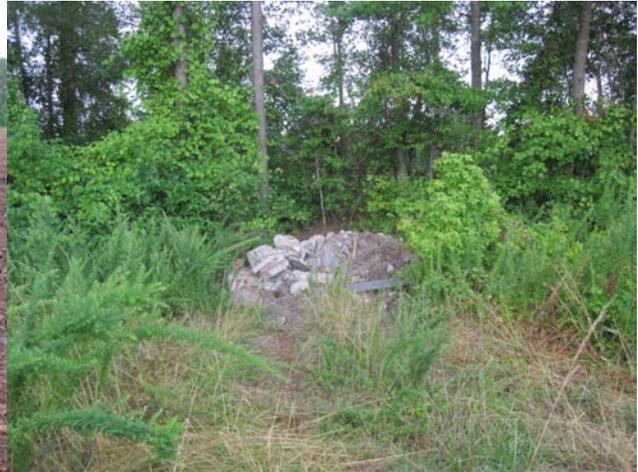
Unauthorized access from Camp Leach Road blocked

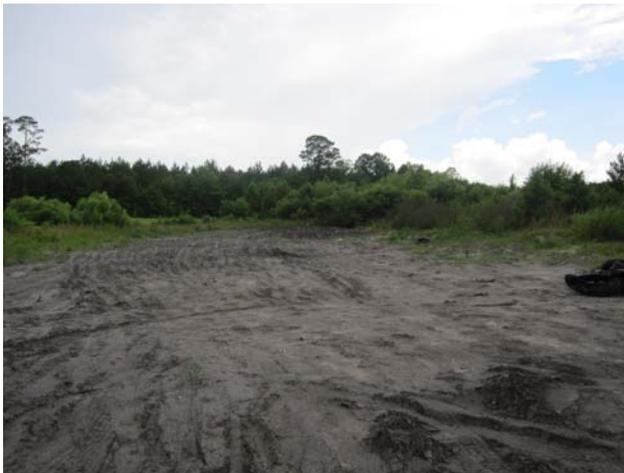
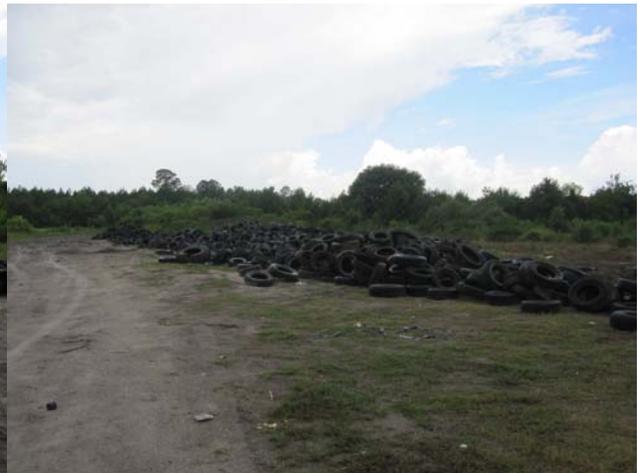
- 7) The size of the tire storage pile has been reduced; however, this element of your facility needs continued attention. The storage pile is still too large and the tires have been deposited in a disorderly manner throughout the facility. *It is strongly recommended that transfer trailers be utilized at the site. All scrap tires should be placed directly into transfer trailers and stored there until transfer to the permitted tire management facility.

- 8) Exposed C&D waste was noted in the tire management area. *Please ensure that this waste is re-covered and that the repaired area is graded at a slope not greater than 3:1, and that it is seeded and mulched to establish a groundcover suitable to prevent erosion of your landfill cap system. It is recommended that you move the tire collection area to an area on the property that will not impact your landfill cap system.

Scrap tire management area

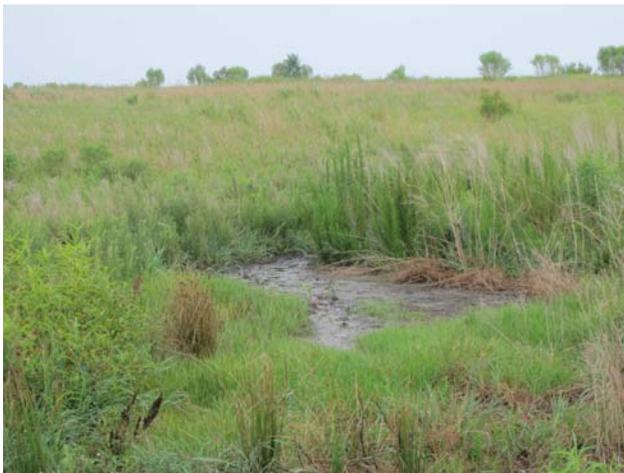
- 11) Leachate was noted as seeping from the northern sideslope of the upper lift approximately halfway up the lift in the center of the sideslope. No leachate was noted as leaving the disposal boundary. *Within thirty days of receipt of this report, repair the landfill cap in the areas along the northern sideslope to prevent the further release of leachate from the landfill. All repaired areas should be graded at a slope not greater than 3:1, seeded, and mulched to establish a groundcover suitable to prevent erosion of the landfill cap system.

Leachate seep from landfill sideslope

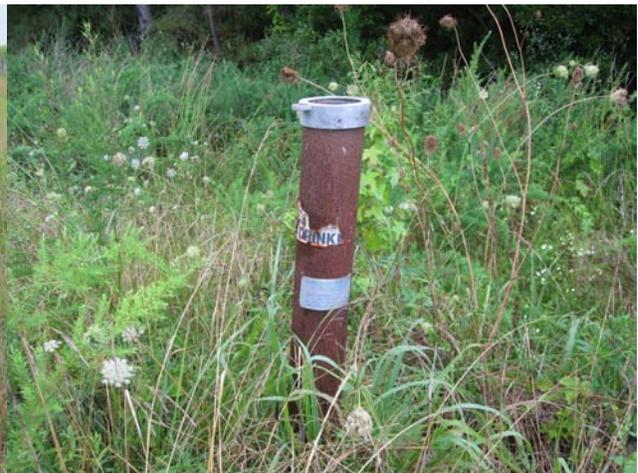
- 13) MW-14 was noted as lacking its cap and lock. *Please ensure that all groundwater monitoring wells are secured with caps and functional locks.
 - 14) Digital photographs were taken during this audit; *please see photographs attached below.*

Monitoring well lacking cap and lock
