FACILITY COMPLIANCE AUDIT REPORT
Division of Waste Management
Solid Waste Section

Date of Audit: 15 March 2011

Carteret County Closed MSW Landfill
 Landfill Road
 Newport, NC

Closed MSWLF under Subtitle D

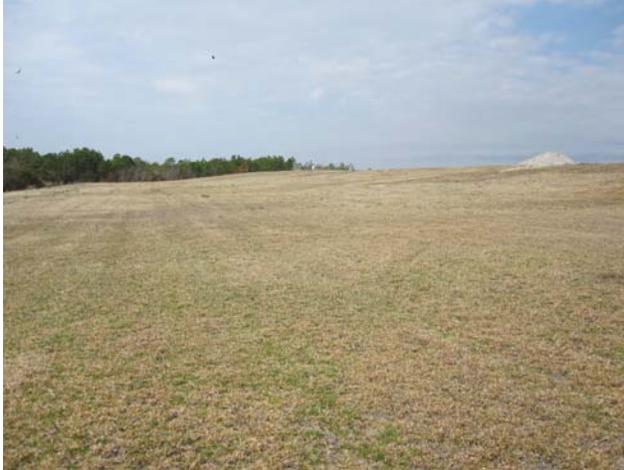
- 6) Highly visible edge-of-waste markers have been installed and are being maintained throughout the facility.
- 7) Overall, the landfill has a well established and maintained cover crop of native warm season grasses.

Overall healthy cover crop, stable access

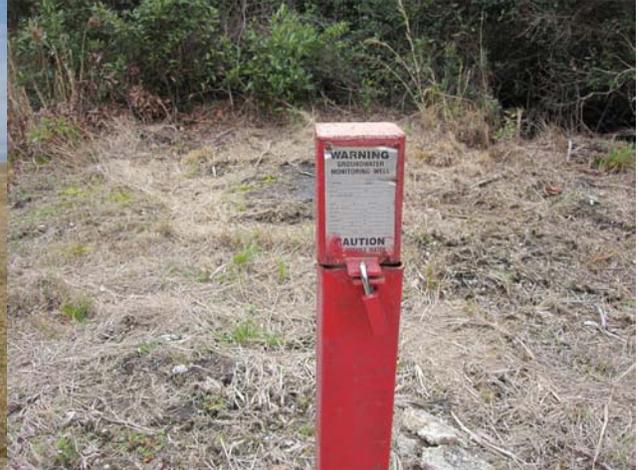
- 5) Facility monitoring wells were reviewed during this audit. All of the wells are easily accessible and secured by locks. None of the wells were observed to be properly labeled. *Please ensure that all wells are properly labeled with metal tags permanently affixed to each well.

Accessible monitoring well, locked, unmarked tag

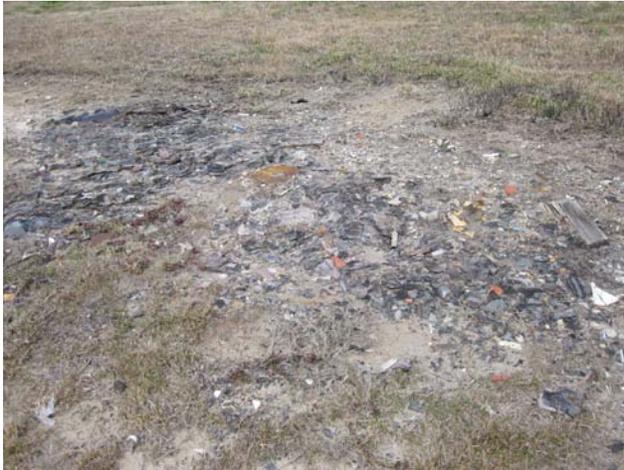
- 9) An area of significant erosion was noted approximately 100 yards down the southeast sideslope. The area measured approximately 24 square feet and was located near the top of the lower lift. A small amount construction and demolition waste has been exposed in this area. *Within thirty days of receipt of this audit report, please repair these eroded areas by grading, seeding, and mulching to establish a groundcover suitable to prevent erosion of you landfill cap system. All repaired areas should be graded at a slope not greater than 3:1.

Exposed C&D waste on southeast sideslope

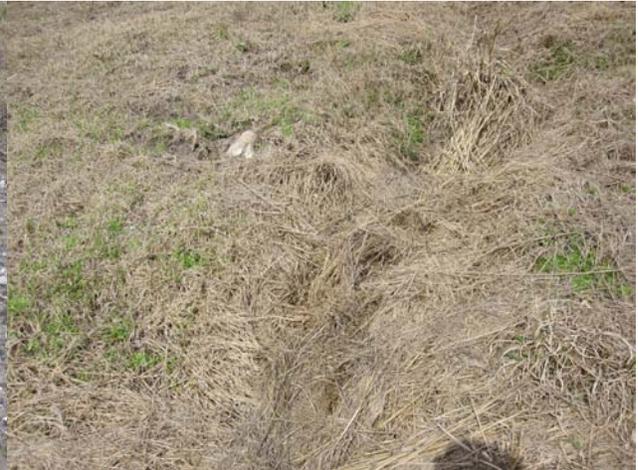
- 8) Areas of erosion were noted at various places throughout the landfill sideslopes. Overall, the erosion was minor however, if left unaddressed, serious erosion could result. *Within thirty days of receipt of this audit report, please repair these eroded areas by grading, seeding, and mulching to establish a groundcover suitable to prevent erosion of you landfill cap system. All repaired areas should be graded at a slope not greater than 3:1.

Erosion of cap on facility sideslope

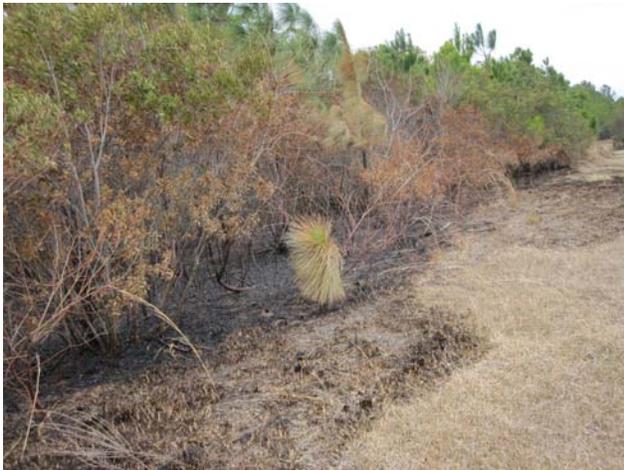
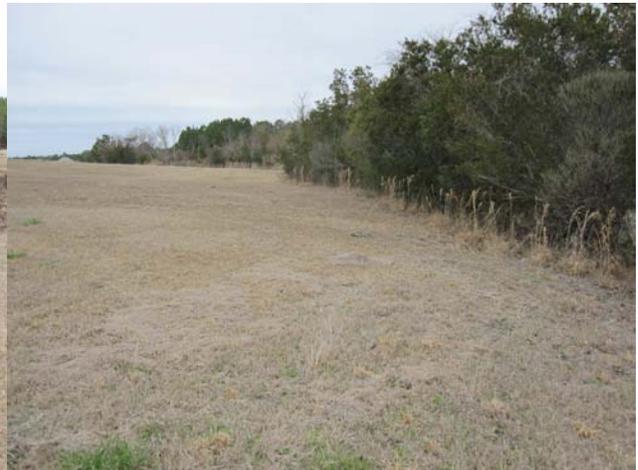
- 10) Trees and other woody vegetation have been allowed to grow on the southwest and northeast sideslopes. *Please remove all trees and woody growth from the landfill. Grade all the cleared areas at a slope not greater than 3:1, seed, and mulch to establish a groundcover suitable to prevent erosion of the landfill cap system.

- 14) Surface water and groundwater sampling was most recently conducted on 5 October 2010, by Environment 1 of Greenville, NC.
- 15) The Croatan National Forest property surrounding the landfill has recently been control burned. A small amount of the landfill cover crop was unintentionally burned at this time. *It is recommended that a permanent firebreak be maintained around this facility to reduce the possibility of fire at the landfill being caused by future control burn events conduct by the US Forest Service or by wildfire.

Trees and woody brush on the southwest and northeast sideslopes-note USFS control burn affecting southwest sideslope
