FACILITY COMPLIANCE AUDIT REPORT
Division of Waste Management
Solid Waste Section

Date of Audit: 3 May 2011

Carteret County Closed MSW Landfill
 Landfill Road
 Newport, NC

16-02, 050311

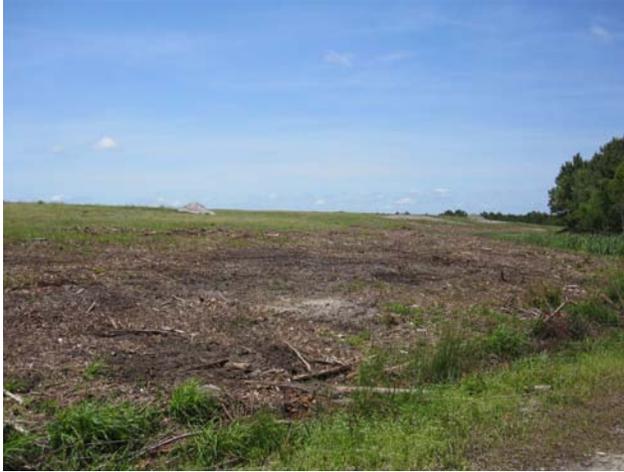
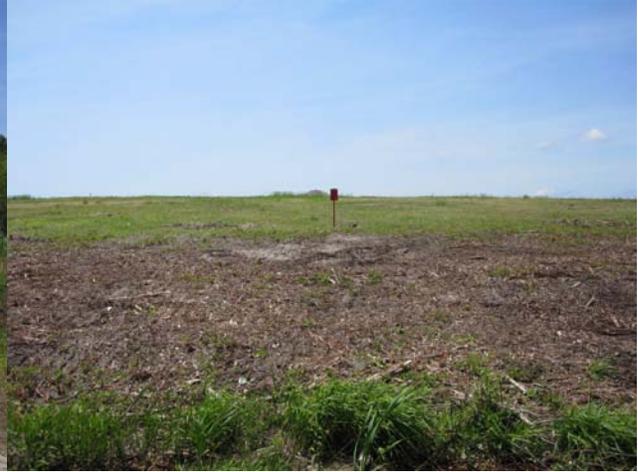
- 9) The trees and other woody vegetation have been removed from the southwest and northeast sideslopes.
- 10) A firebreak has been created along the southwest sideslope to reduce the possibility of controlled burning activities performed on the neighbouring USFS property affecting the landfill.

Trees and woody brush removed from northeast landfill sideslope

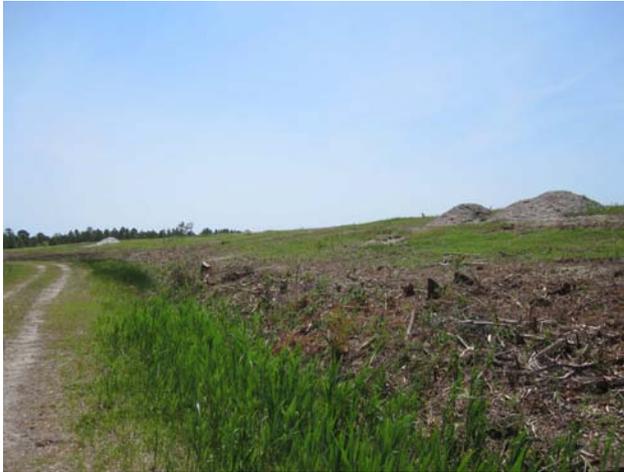
- 11) The surface water drainage ditch that runs along the northeastern perimeter of the landfill has been cleared of brush and woody vegetation to provide for more positive drainage of surface waters from the facility.

Trees and brush removed from northeast surface water ditch

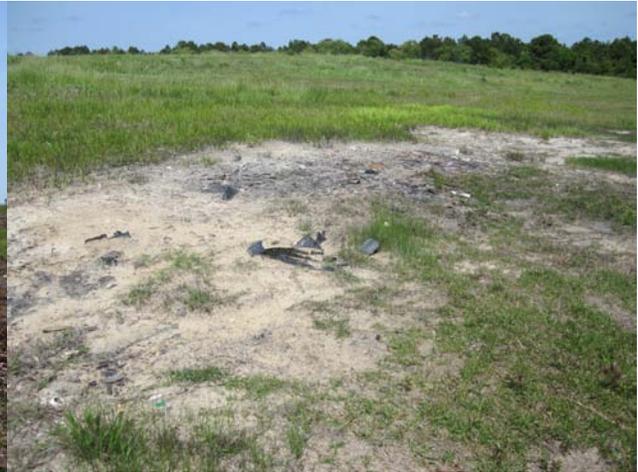
- 7) Areas of erosion were noted at various places throughout the landfill sideslopes. *Please continue working to repair these eroded areas by grading, seeding, and mulching to establish a groundcover suitable to prevent erosion of your landfill cap system. All repaired areas should be graded at a slope not greater than 3:1.

Erosion of cap on facility sideslope still needing repair

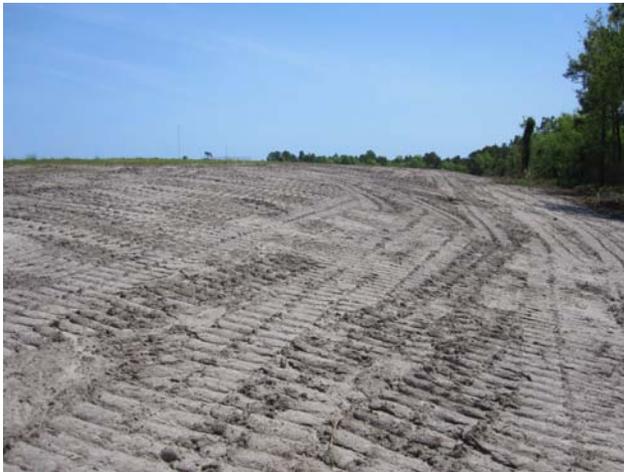
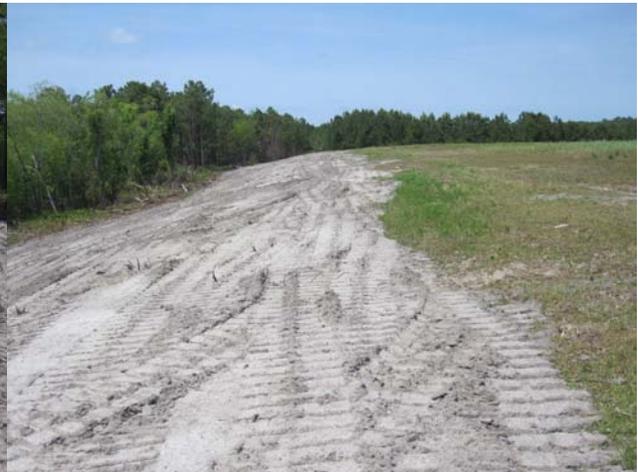
- 12) Soil is being stockpiled at the landfill for use in filling and grading areas of settlement and erosion throughout the landfill.
- 13) Repair of the eroded areas noted throughout the landfill has begun.

Repaired areas on southwestern sideslope
