FACILITY COMPLIANCE AUDIT REPORT
Division of Waste Management
Solid Waste Section

Date of Audit: 1 February 2011

Craven County Landfill
 7400 Old Highway 70
 New Bern, NC

Partial Audit to review corrective measures taken in response to FCAR 25-03, 121310NOV

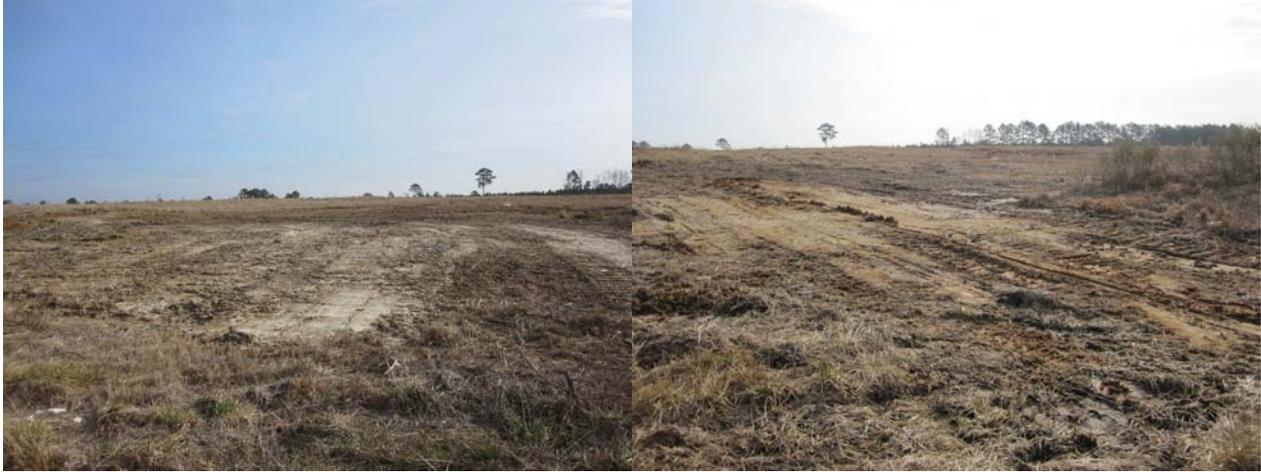
- 3) The facility access road is of all weather construction and is being well maintained.
- 4) The leachate seeps noted in the previous audit have been excavated, packed with clay, and graded. No leachate was observed seeping through the landfill cap system during this audit. *Please ensure that the repaired areas are seeded and mulched to establish a groundcover suitable to prevent erosion as soon as possible.
- 5) *There are areas of continuing settlement throughout the landfill that will require further maintenance to provide positive drainage of surface waters from the landfill cap system.
- 6) Digital photographs were taken during this audit; *please see photographs attached below.*
- 7) *Corrective actions are needed as a result of this audit.

Repaired leachate seepage areas

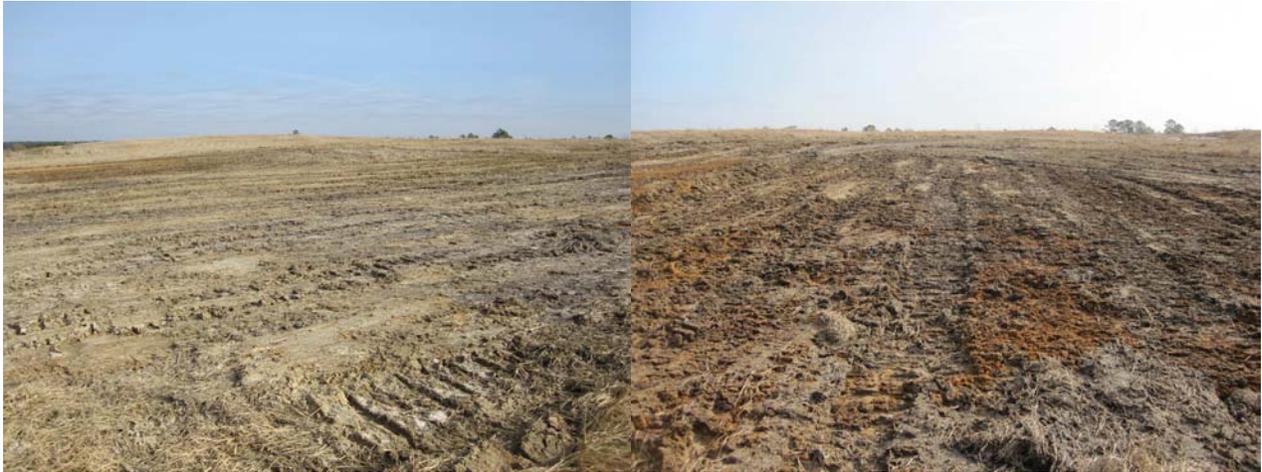
Repaired leachate seepage areas

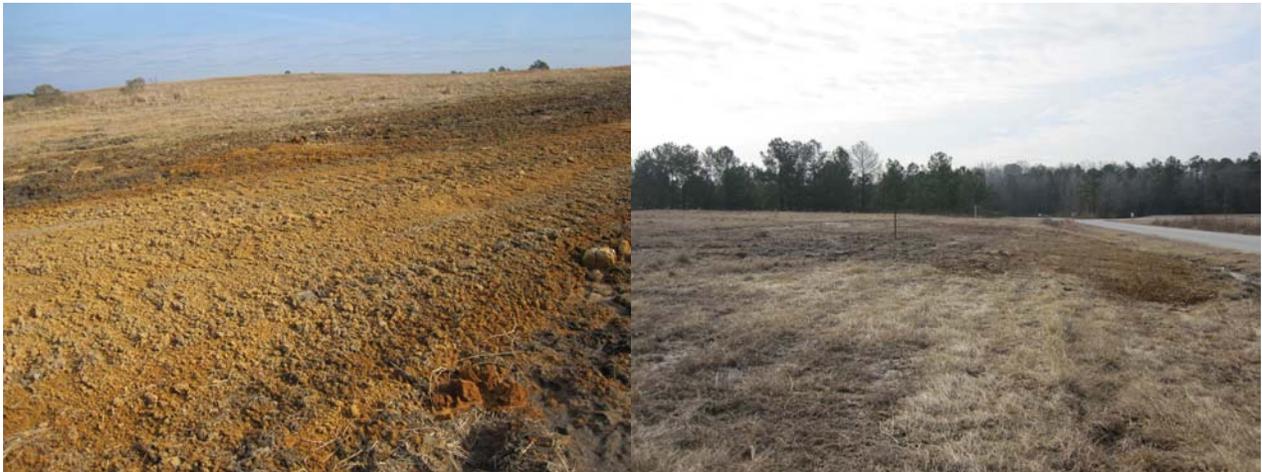
Repaired leachate seepage areas
