**FACILITY COMPLIANCE AUDIT REPORT**  
**Division of Waste Management**  
**Solid Waste Section**

**Date of Audit:** 21 March 2011

Craven County Landfill  
 7400 Old Highway 70  
 New Bern, NC

Closed: Unlined MSW Landfill

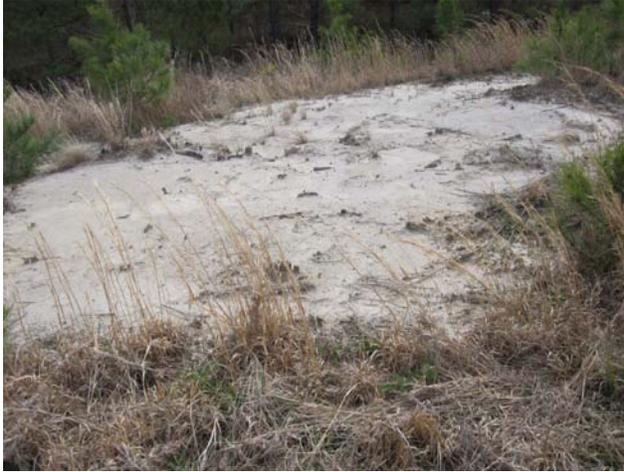
- 8) Edge-of-waste markers have been installed and are being maintained at the facility.
- 9) Overall the cover crop has been well established and maintained on the landfill sideslopes. However, several small areas along the western sideslope were noted as having sparse cover with the potential of allowing erosion of the landfill cap system. \*Please ensure that these areas are graded, seeded, and mulched to establish a cover crop suitable to prevent erosion and that the cover is maintained to protect the integrity of your landfill cap system.

Area of sparse cover needing seeding and mulching

- 13) \*Please continue working to establish a groundcover suitable to prevent erosion of the landfill cap system in the previously repaired areas along the western sideslope.

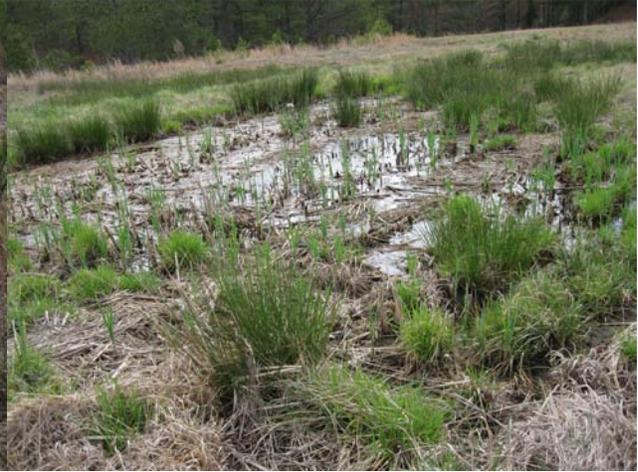
- Surface water has been impounded on the landfill cap.
- Leachate has seeped from the eastern sideslope of the landfill into the stormwater/sedimentation control basin.

- 11) \*There are areas of continuing settlement throughout the landfill that will require further maintenance to provide positive drainage of surface waters from the landfill cap system. Several of these areas were noted as impounding surface waters.

Area impounding water needing fill, grading, seeding

-Fill and grade the areas found to be impounding surface waters to promote positive drainage of surface waters from the landfill. All filled and graded areas should be graded at a slope not greater than 3:1, seeded, and mulched to establish a groundcover suitable to prevent erosion of the landfill cap system.

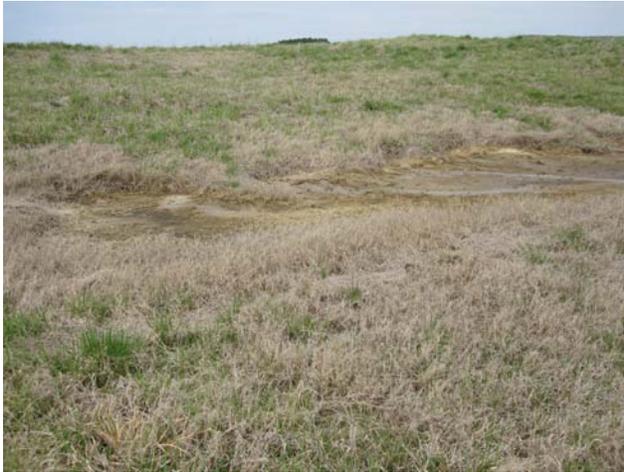
- 12) A leachate seep was noted on the surface of the landfill on the eastern side of the lower lift approximately 100 yards from the toe of the upper lift. This seep was not noted as leaving the facility. \*Please repair the cap in this area with a soil suitable to prevent the release of leachate. The repaired area should be graded at a slope not greater than 3:1, seeded, and mulched to establish a groundcover suitable to prevent erosion of the landfill cap system.

Leachate seep on eastern side of lower lift

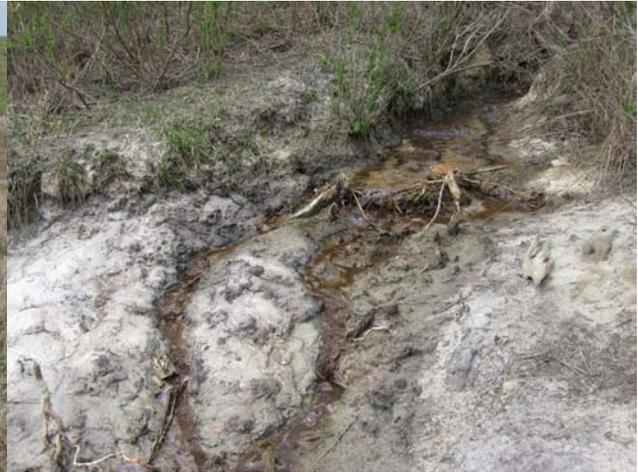
- 10) Leachate was noted as seeping from the eastern sideslope of the landfill into the stormwater/sedimentation control basin. \*Please see the conditions for compliance listed in the NOTICE OF VIOLATION(S) section of this audit report.

Leachate seep on eastern sideslope

-Repair the landfill cap in the areas along the eastern sideslope to prevent the further release of leachate from the landfill. All repaired areas should be graded at a slope not greater than 3:1, seeded, and mulched to establish a groundcover suitable to prevent erosion of the landfill cap system.

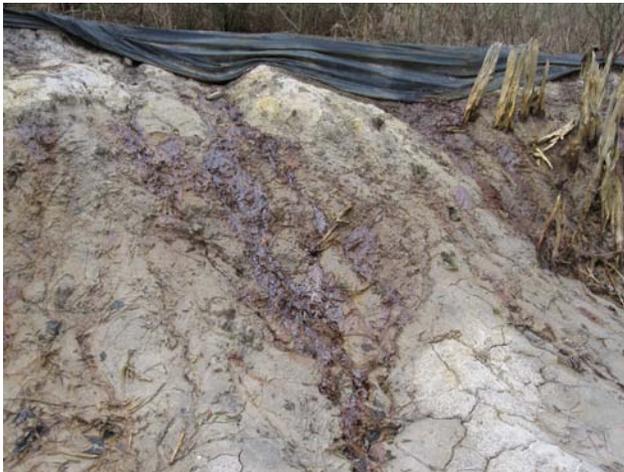
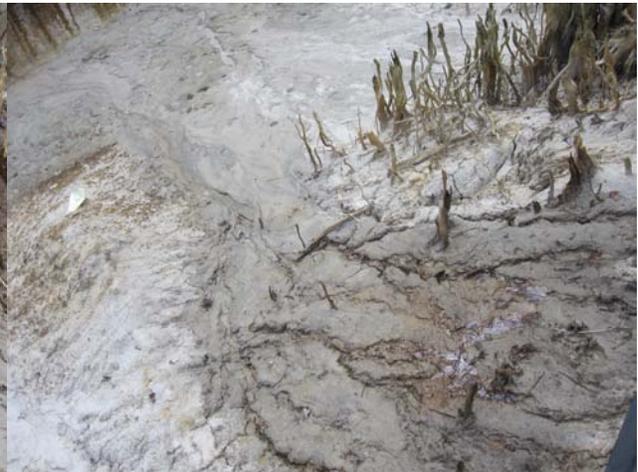
Leachate seep on eastern sideslope-note seep flow to stormwater/sedimentation control basin
